Soil Conservation Compartment Inspection Visit

Property Inspection

Property	Huirimu Farms Ltd - J and A Sherriff
Asset ID	32079
File Number	Z12 P1512
Inspection Date	18-19 December 2018

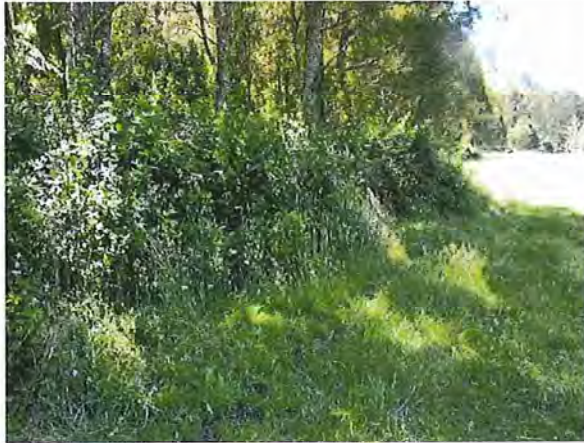
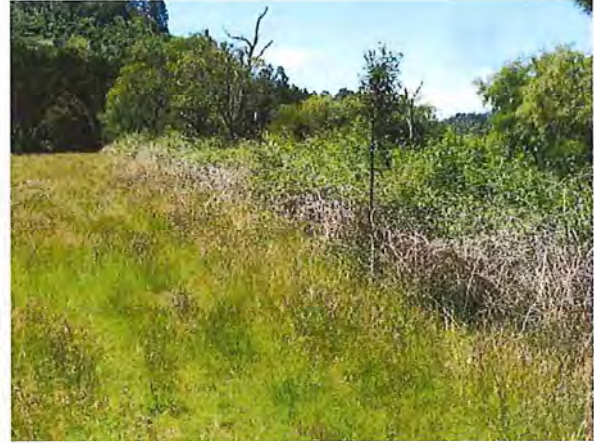
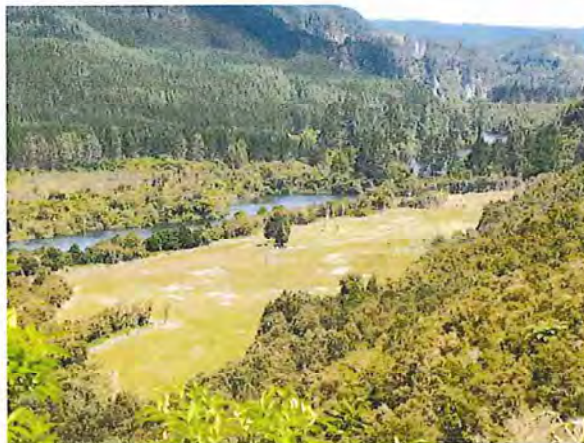
Compartment No.	224-01 and 03
<p>A steep slope on the true left of the Waikato River trench that was included as part of the former farm management at the time of settlement. It has not been grazed for many years, now with active native scrub regeneration.</p> <p>Fences leading down slope from the top are no longer visible and mostly overgrown with scrub and trees. No value in any works on these two fences.</p> <p>Fence along the top and bottom of the slope is an older 8 wire post and batten soil con fence is fair but stock proof condition. Blackberry growing over the lower fence.</p> <p>A 4 WD track through the bush links the two lower terrace paddocks, gated at each end. Low-load small wooden stock bridge across the stream. Stream is clear, no mobile sediment load.</p> <p>Cpt 03 is located along the river margin, 8 wire fence in fair condition. An extensive blackberry spraying program has been conducted within the last year. All areas are stock proof and have not been grazed.</p> <p>Acacia melanoxylon planted along the bottom slope, mostly good form. Providing good cover for natural regeneration. Fence along this section not sprayed due to potential damage to</p>

Owner may permanently retire the rest of the steep slope to the southern boundary as it provides only rough grazing and has stock management issues. The only stock access to this area is via the lower terraces.

Vegetation: native regeneration 90%, exotic 10%

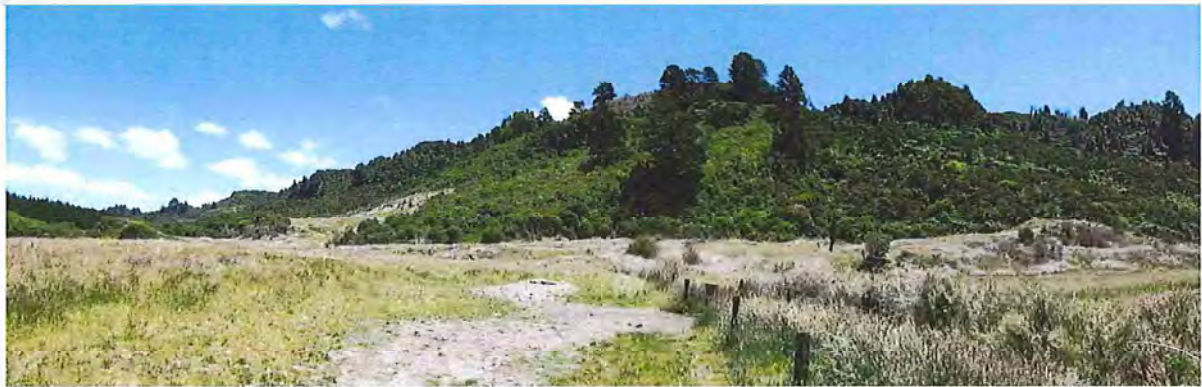
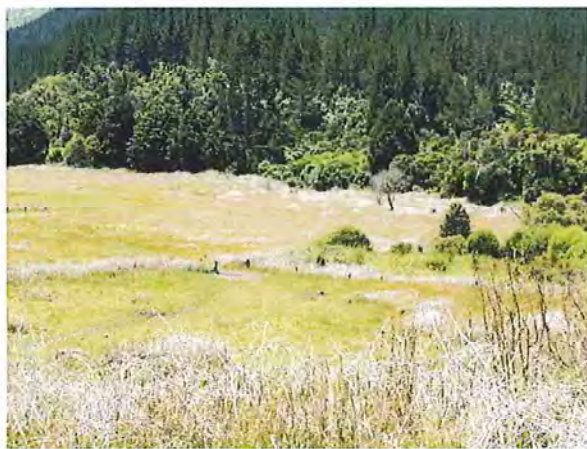
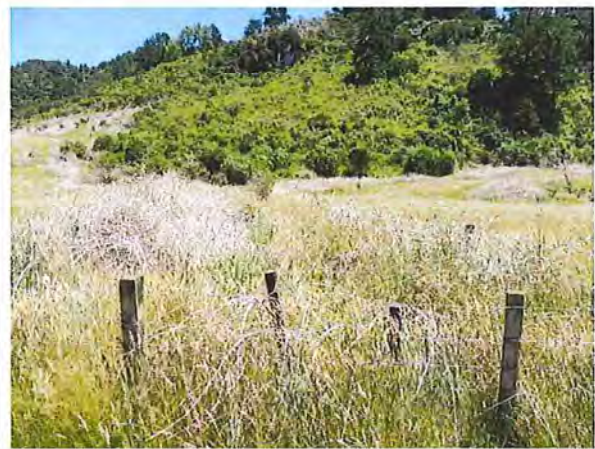
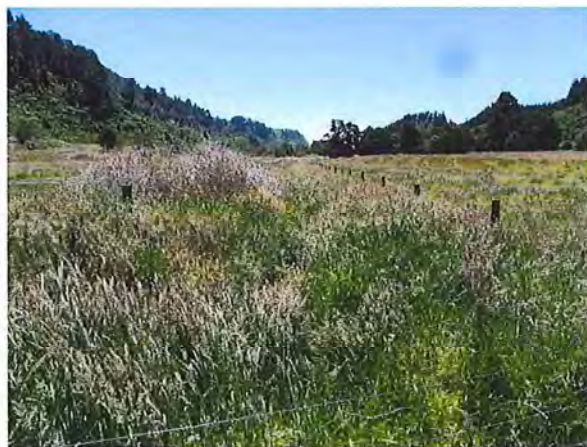
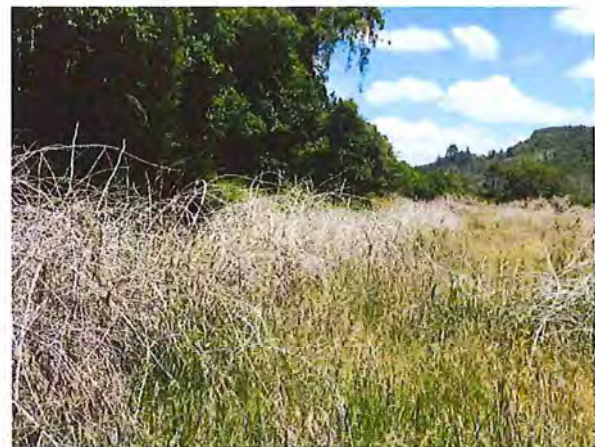
Compartment No.	01 and 02
<p>A steep slope on the true left of the Waikato River trench that was included as part of the former farm management at the time of settlement. It has not been grazed for many years, now with active native scrub regeneration and emergent tree species. The Te Rimu Stream flows through cpt, waterfall at the top of the slope. Entire stream on farm land upstream of this cpt is fenced and stock proof.</p> <p>Limited cattle grazing on grass areas between cpt 01 and cpt 224-01. Generally rank grass and regenerating scrub and some woody weeds.</p> <p>Three small discrete areas of native regeneration along the top cpt boundary (west) containing rewarewa and emergent secondary forest species have been included within the larger Cpt 01, which comprises the steep slope. Fences here are 2 wire electric in fair condition, and 6 wire 4 electric in good condition. Balance of fence along top boundary is 8 wire post and batten fence in fair condition. Three areas are stock proof and not grazed.</p> <p>Rough 4WD track provides stock access to the bottom river terrace. Cpt lies on the bottom side of the track. The 8 wire post and batten fence along track is in fair condition and some</p>

sections is not visible due to the scrub. Fence along track is stock proof. No sign of stock grazing.

Fence leading down slope from the track is no longer visible and mostly overgrown with scrub and trees. No value in any maintenance work on this fence as the bush and fence provides a physical barrier.

Cpt 02 comprises the riparian margin and small streams along the lower terrace. Fences are post and 8 wires, no battens in fair condition. Blackberry all sprayed within last 12 months, area stock proof and not grazed.

Three culvert crossings on small low perennial flow streams on terrace. All fenced, blackberry extensively sprayed. Stockproof. No sediment load in these spring fed creeks.

Vegetation: Native regeneration 100%
