Estuarine Vegetation Survey

Wharekawa Harbour

Prepared by: Meg Graeme, Natural Solutions – Marine and Terrestrial Ecologists Ltd

June 2008

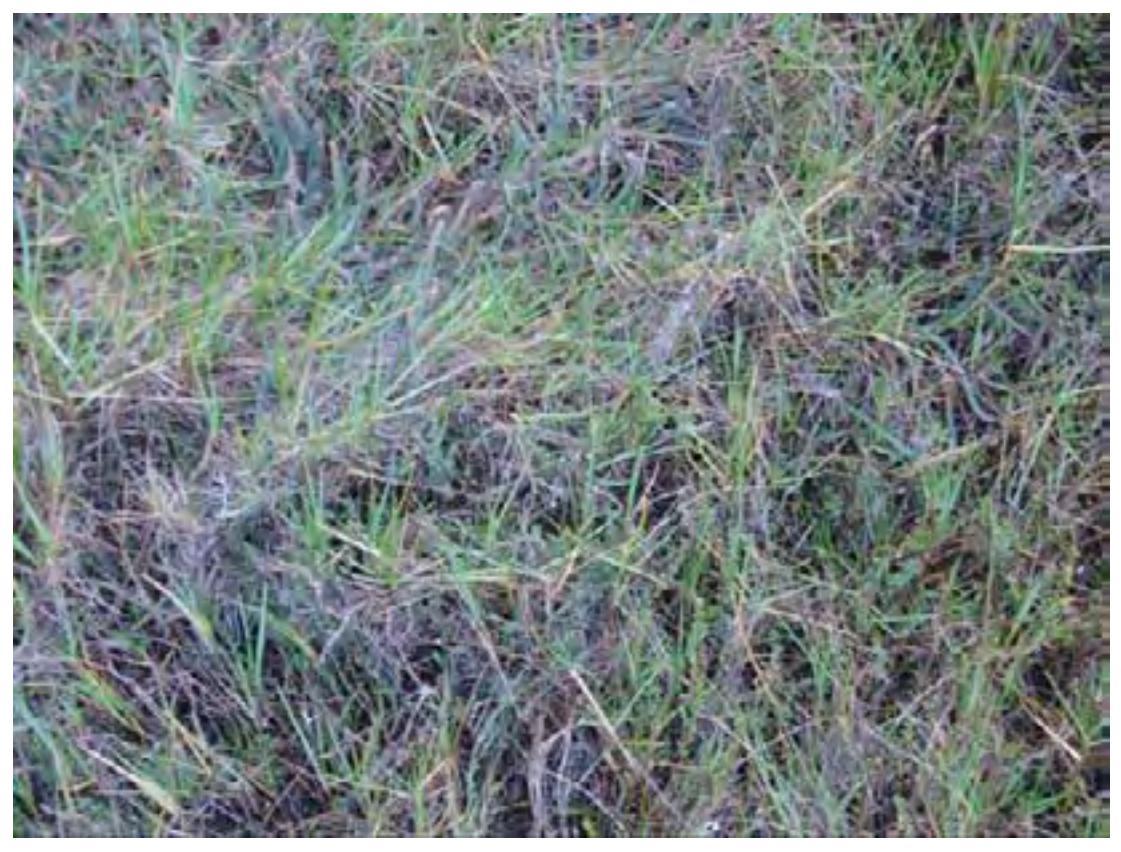
Figure 6: Saltwater paspalum overgrowing glasswort and sea primrose on the sand spit.

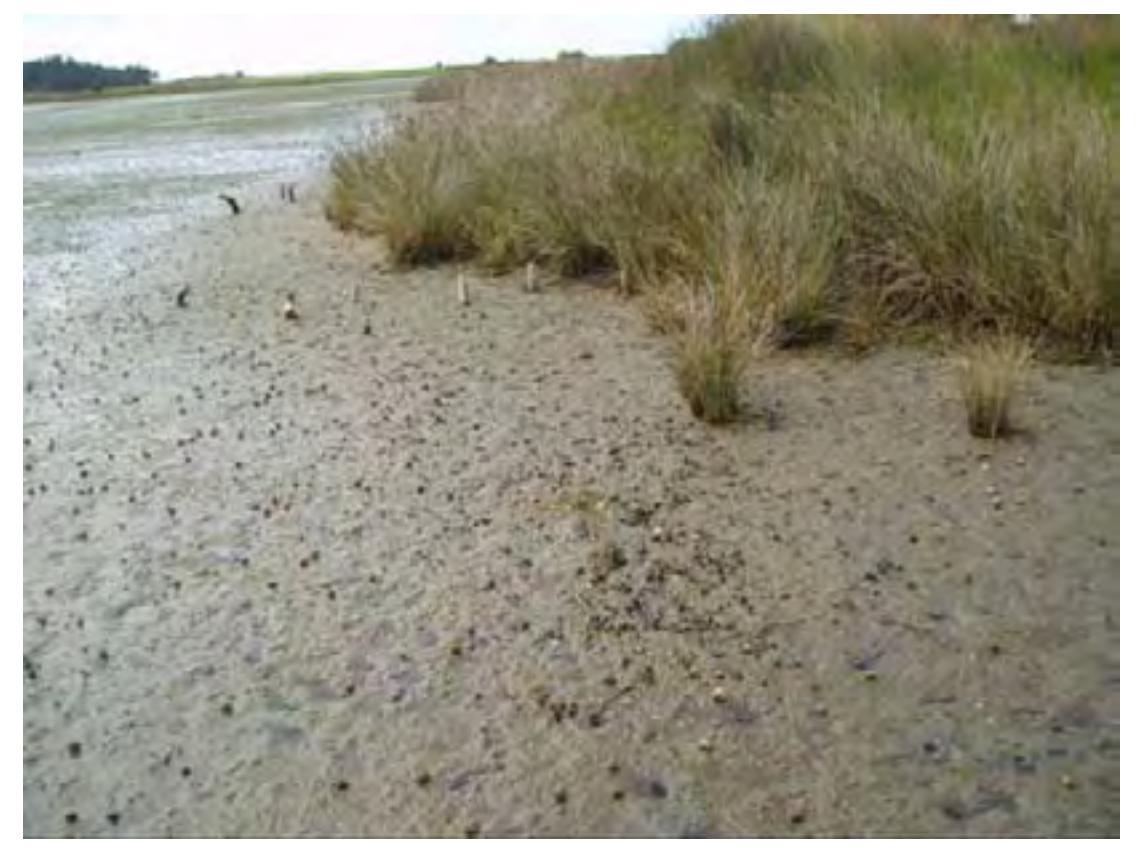
Figure 9: This photo shows small areas of eroded sea rush (dead rhizomes in mid foreground) suggesting the seaward rush edge may now be more erosion prone following the removal of protective mangroves. Other seaward edges of rush and saltmarsh ribbonwood are also showing signs of being undercut.

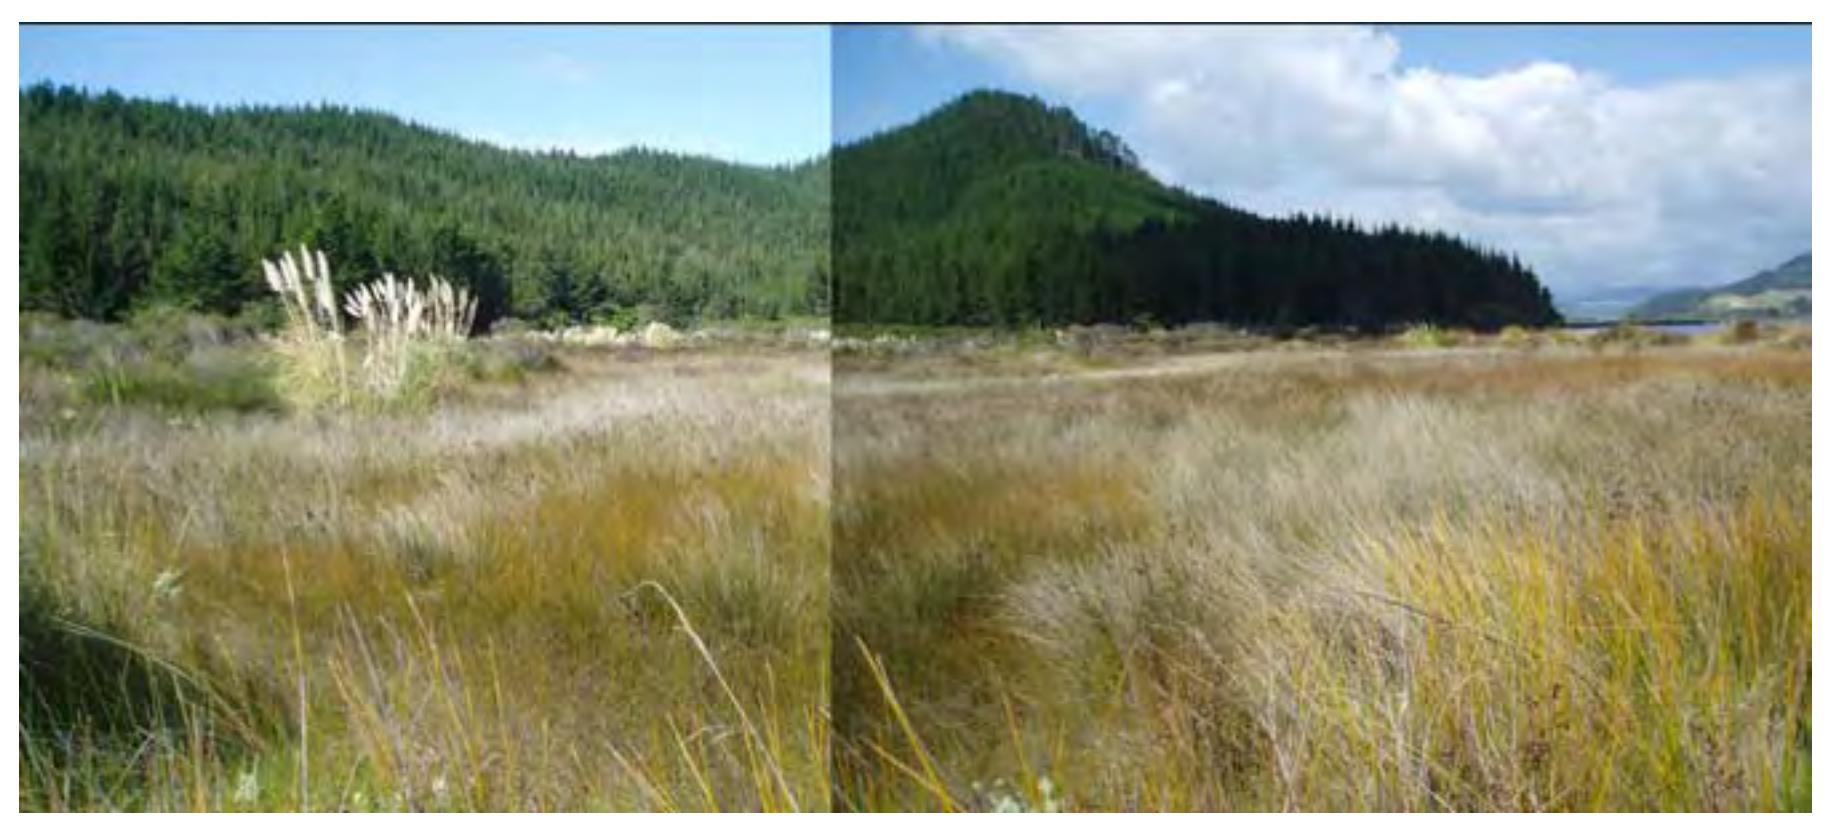
Figure 10: A view of the saltmarsh taken from beside two pohutukawa. Pampas is a problem along some of the higher ground amongst manuka and mingimingi scrub.

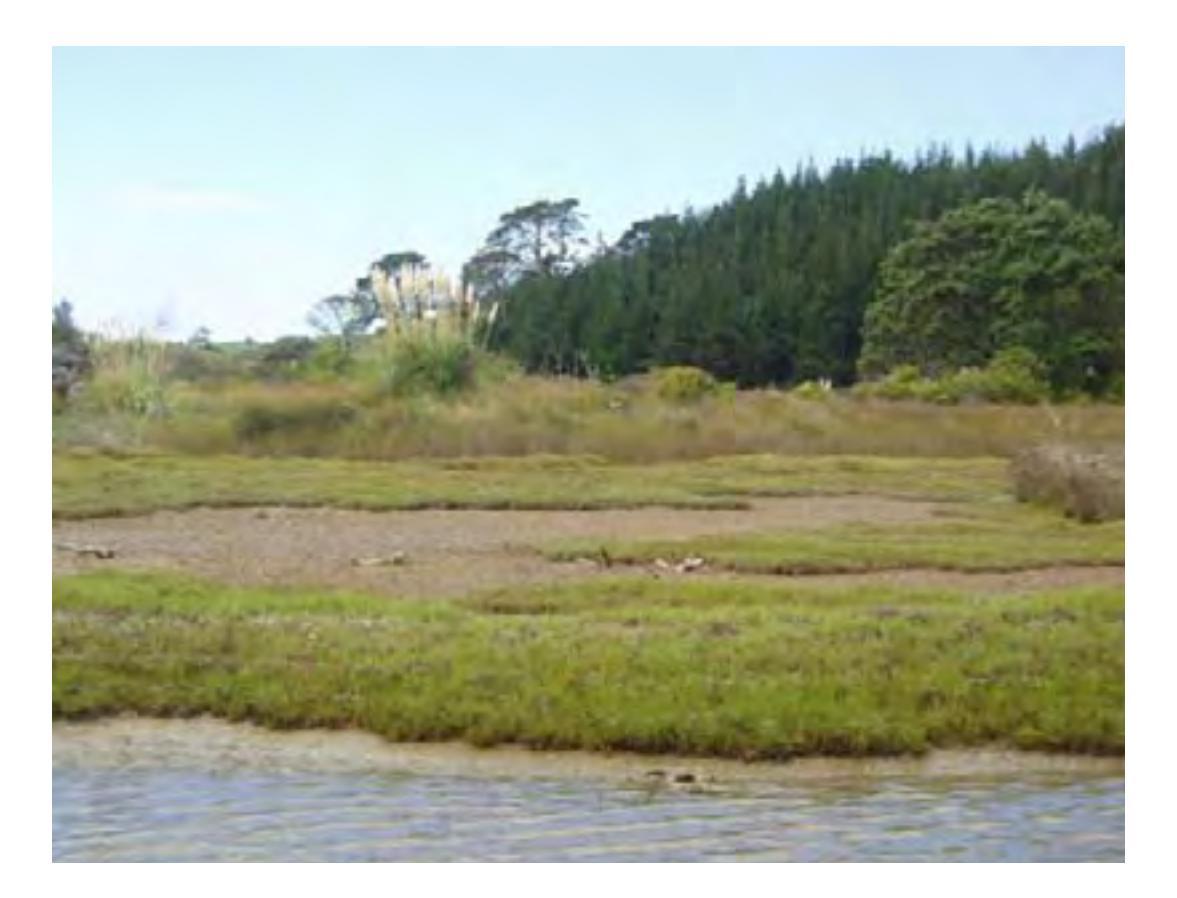
Figure 11: This photo is a repeat of the 1997 photo [36].The pines have been removed (on centre bank to left of picture and left of pohutukawa) and mangroves cleared. The sea rush in the centre right is thought to be sea rush visible in photo [36]. The saltwater paspalum appears less lush and vigorous without the protection of the mangroves.

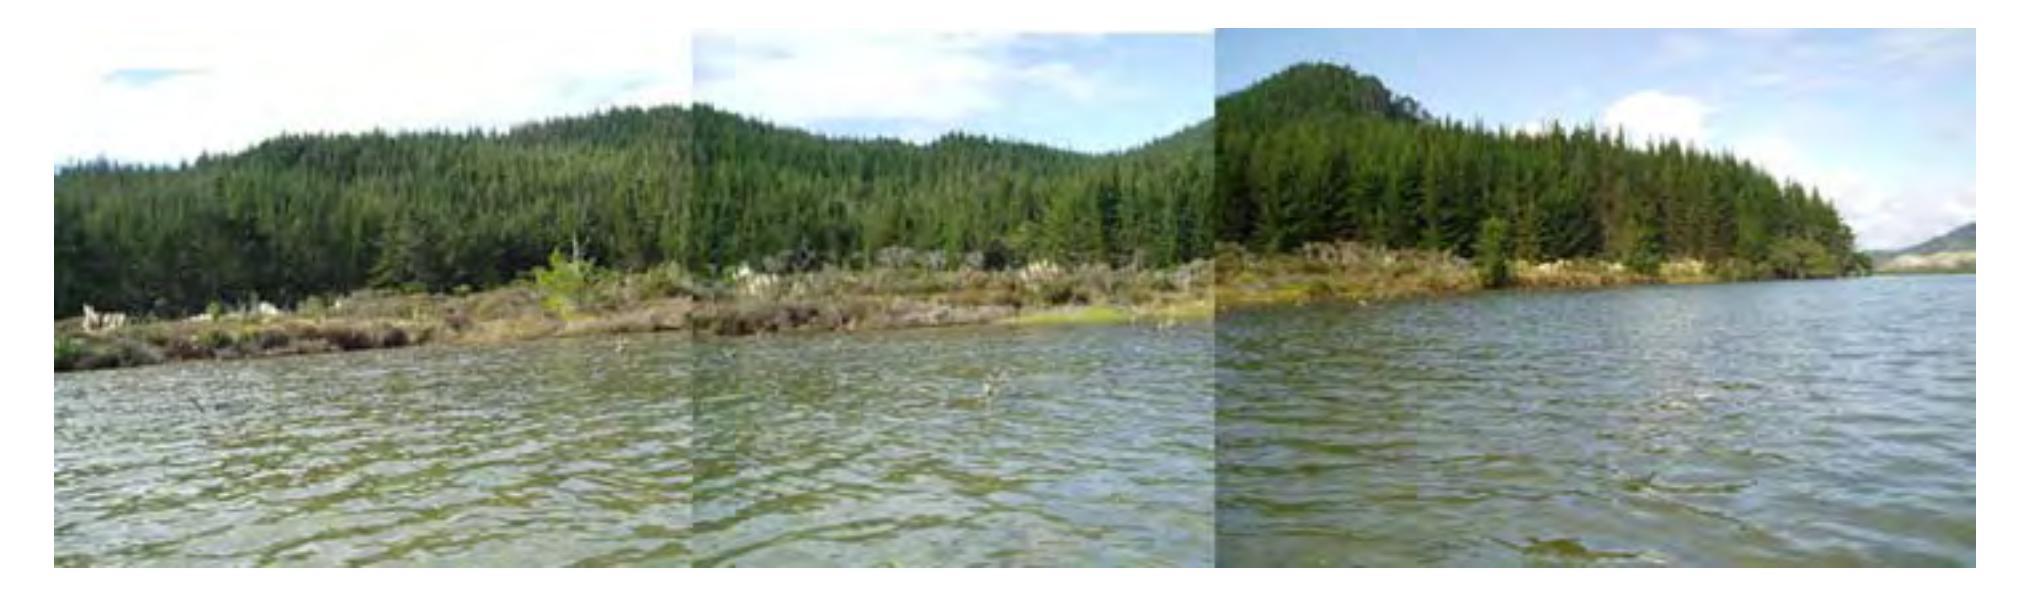
Figure 12: This photo is a repeat of the 1997 photo [38].Cut mangrove stumps can be seen just above the water surface. The rush/ribbonwood edge here appears to be undercut by increased wave action.

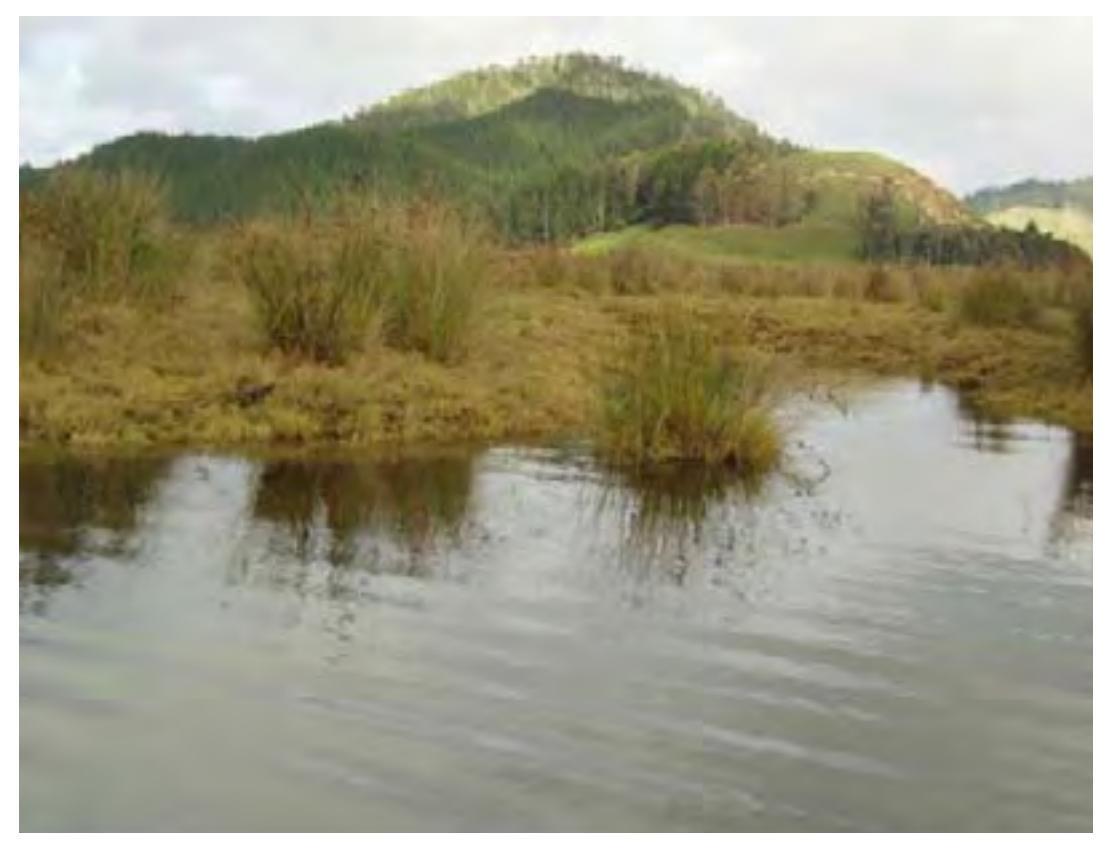
Figure 15: Heavy stock grazing of the saltwater paspalum amongst sea rush along the TRB of the lower Wharekawa River.

Any area that is vulnerable to damage from stock should be permanently fenced. Sites noted on the field survey include:

- the tidally influenced floodplains of the lower Wharekawa River and Rangipo Stream (Figures 15 & 16).
- the saltmarsh near Opoutere Road south of the causeway bridge (Figure 24 & 25).

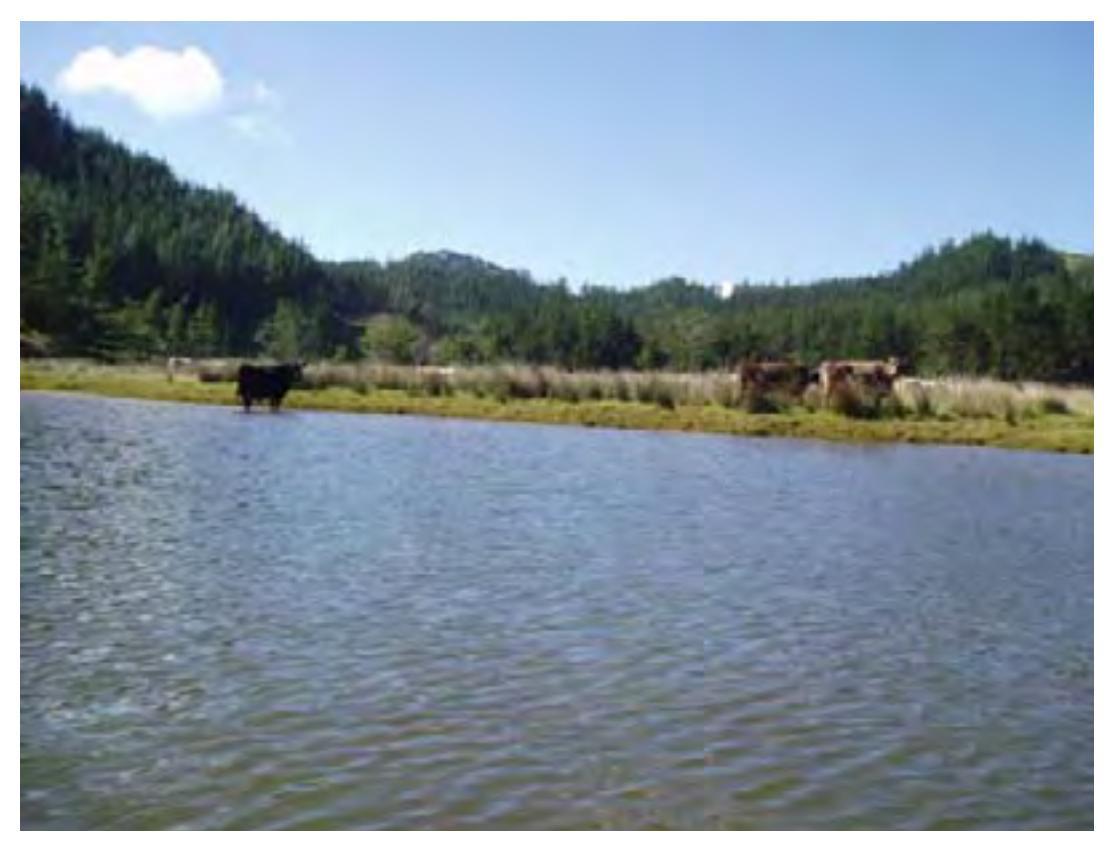
Figure 16: Cattle in the Wharekawa River grazing the saltwater paspalum and sea rush lined banks. Fernbird were present here.

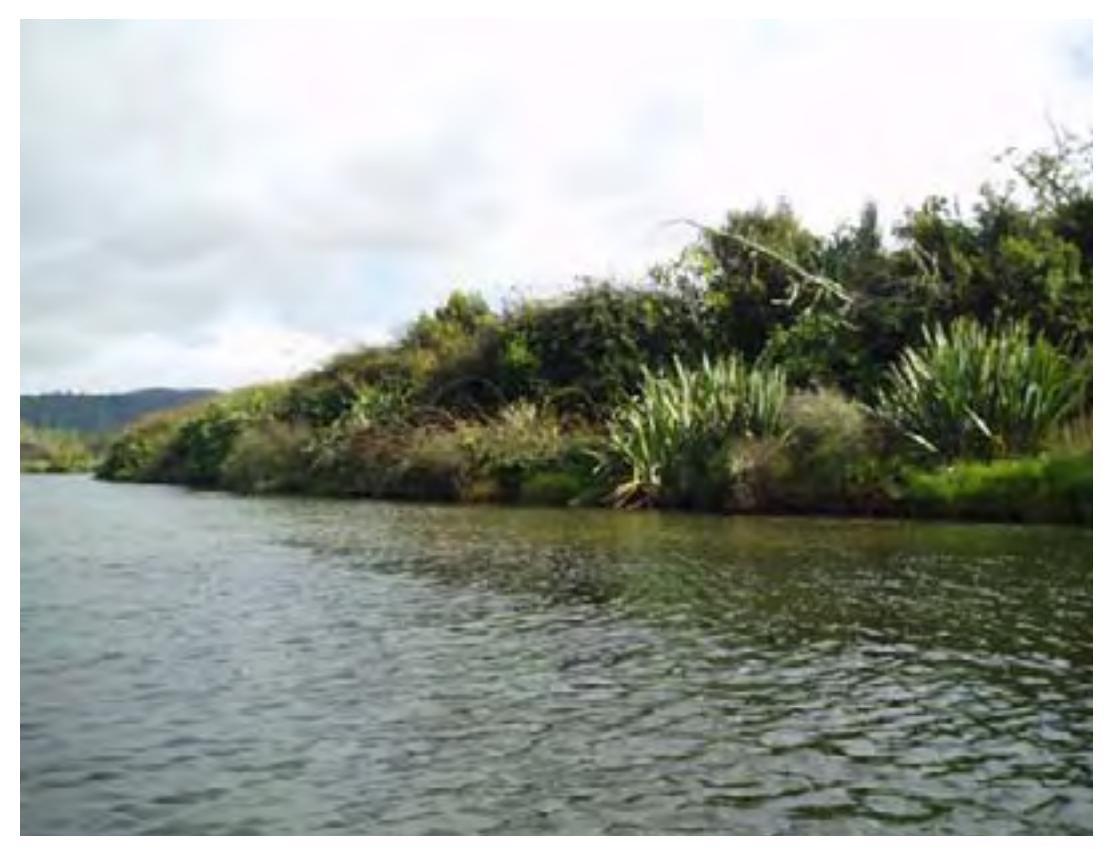
Figure 17 is a repeat of the 1997 photo [42] showing eleagnus dominating part of the Wharekawa River bank. The eleagnus provides some erosion protection for the bank but smothers the native riparian vegetation.

Figure 17: This photo is a repeat of the 1997 photo [42] showing eleagnus along the Wharekawa River edge. Remnants of the large pine shown in the earlier 1997 photo are visible on the right of the picture.

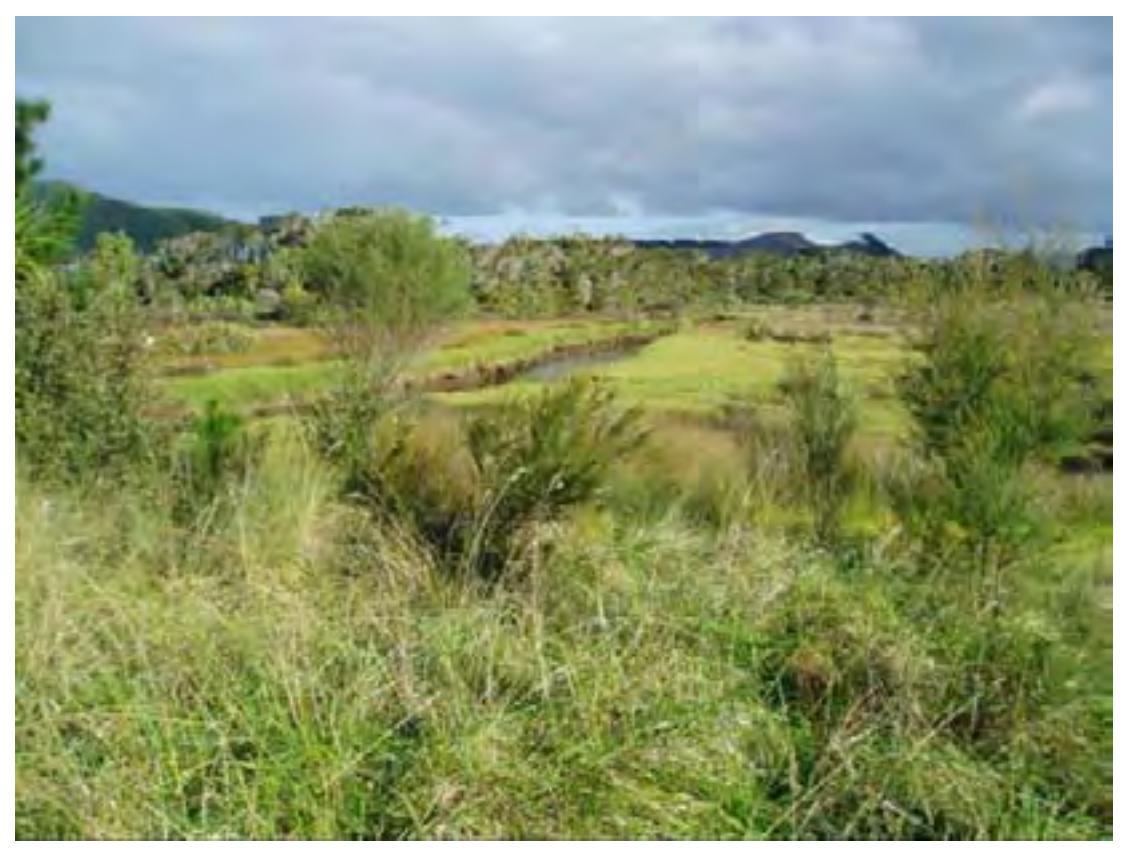
Figure 20: This photo is a repeat of the 1997 photo [48]. Saltwater paspalum is totally dominant of the estuary channel edge.

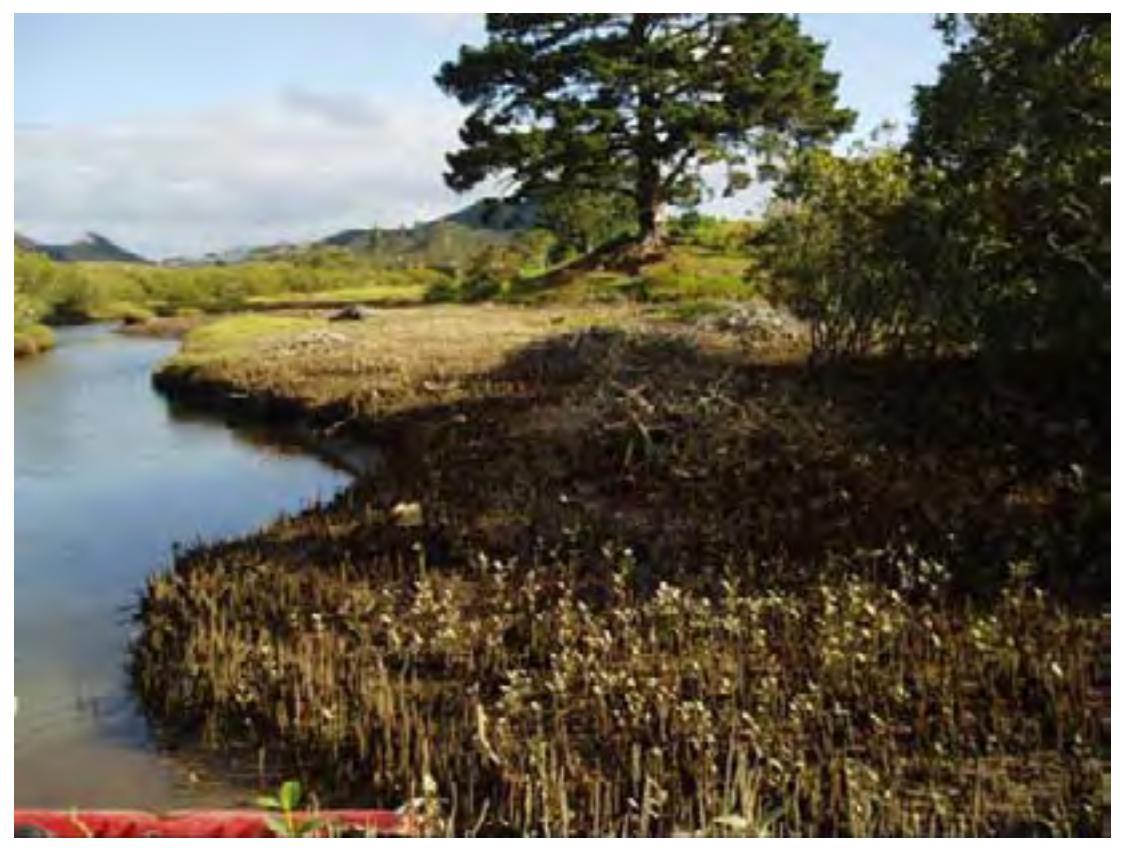
Figure 22: Mangroves have been cleared from the stream bank near housing. The view is from the mouth of a side creek looking up towards where the 1997 photo [44] was taken.

Illegal mangrove removal – Strict controls are required for any further removal of mangroves. Illegal mangrove destruction often occurs where mangroves 'block' individual's views of open water. Some mangrove clearance has potentially exposed the seaward edge of saltmarsh and back swamp communities to erosion. The extensive mangals in the middle of the harbour provide important habitat for marsh birds and fish feeding at high tide. These communities should not be compromised unless a clear ecological benefit can be demonstrated. Situations where mangrove control may be deemed appropriate could include restricting the expansion of the outer mangrove edge where it is expanding into seagrass. The un-natural rate of estuary 'infilling' due to elevated sediment run-off from the catchment is likely to be expanding the zone suitable for mangrove colonisation. This is occurring more rapidly than normal due to poor land management practises. Sheltered situations are predisposed to sediment accumulation. Other areas can also accumulate sediment during years without major storm events. Removing mangroves from these situations will not necessarily cause the long-term dispersal of the sediment nor the restoration of macroinvertebrate communities that are characteristic of open sandy flats. For this to occur, the ongoing sediment input would need to reduce significantly and the fine sediment already present in the harbour would need to be washed out of the system.

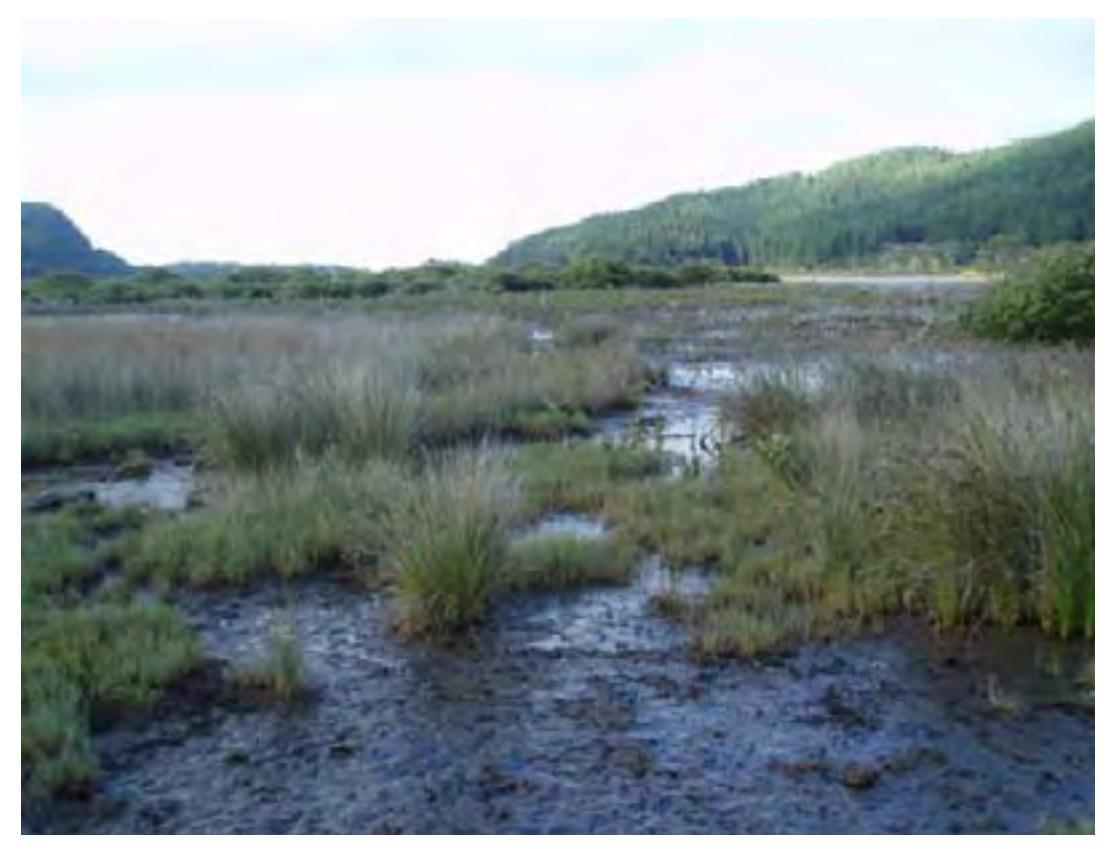
Figure 23: The photo shows the wide swath of cleared mangroves, again near housing. Saltwater paspalum and sea rush are in the foreground.

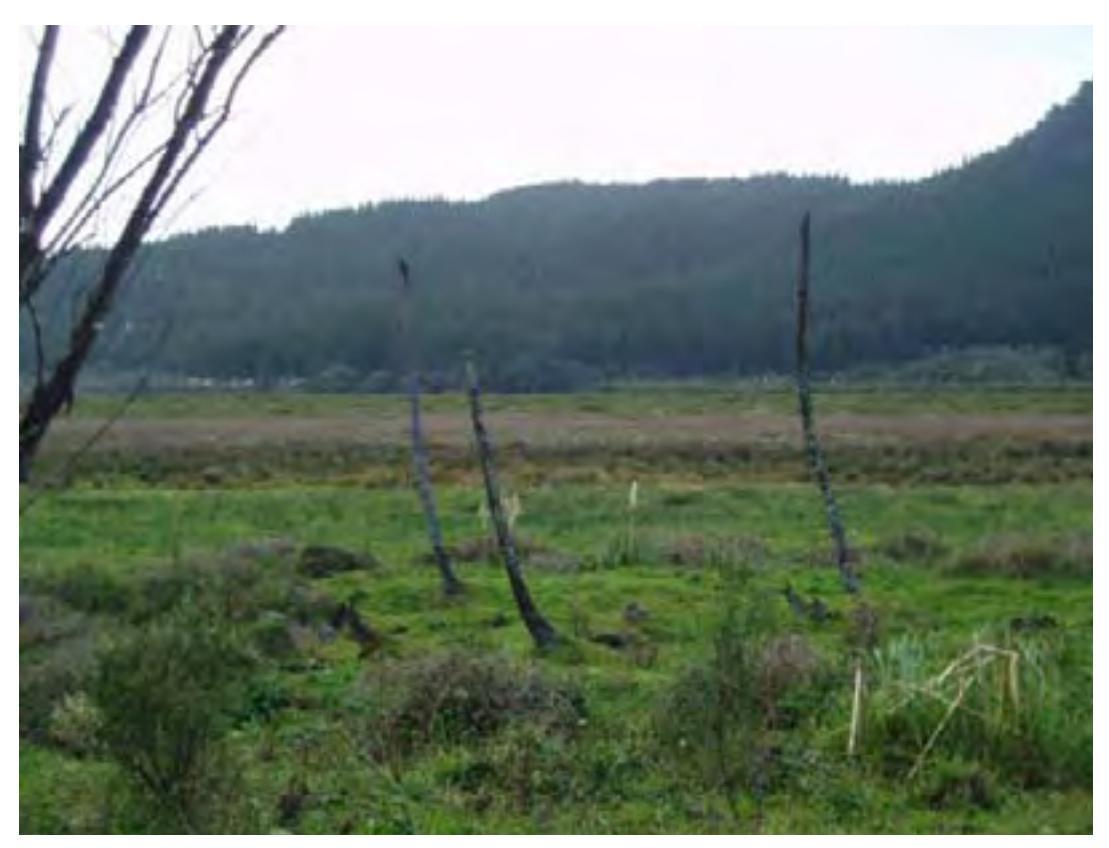
Figure 24: A repeat photo of the 1997 photo [54] overlooking farmland to the rush/sedgeland and mangroves. Stock still have unlimited access to the estuary and there is pugging, tracking and defecation within the wetland.

- b. Ensure the Crown-owned farmland between Opoutere Road and the saltmarsh (SOP 59417 Section 1, 76239) is fenced to keep stock out of the wetland. Stock disturbance in this saltmarsh will only be increasing the likelihood of saltwater paspalum spreading as well as degrading the habitat value and water quality. Explore the option of retiring the area of farmland and encouraging native coastal forest regeneration to re-create an estuarine to coastal forest sequence.

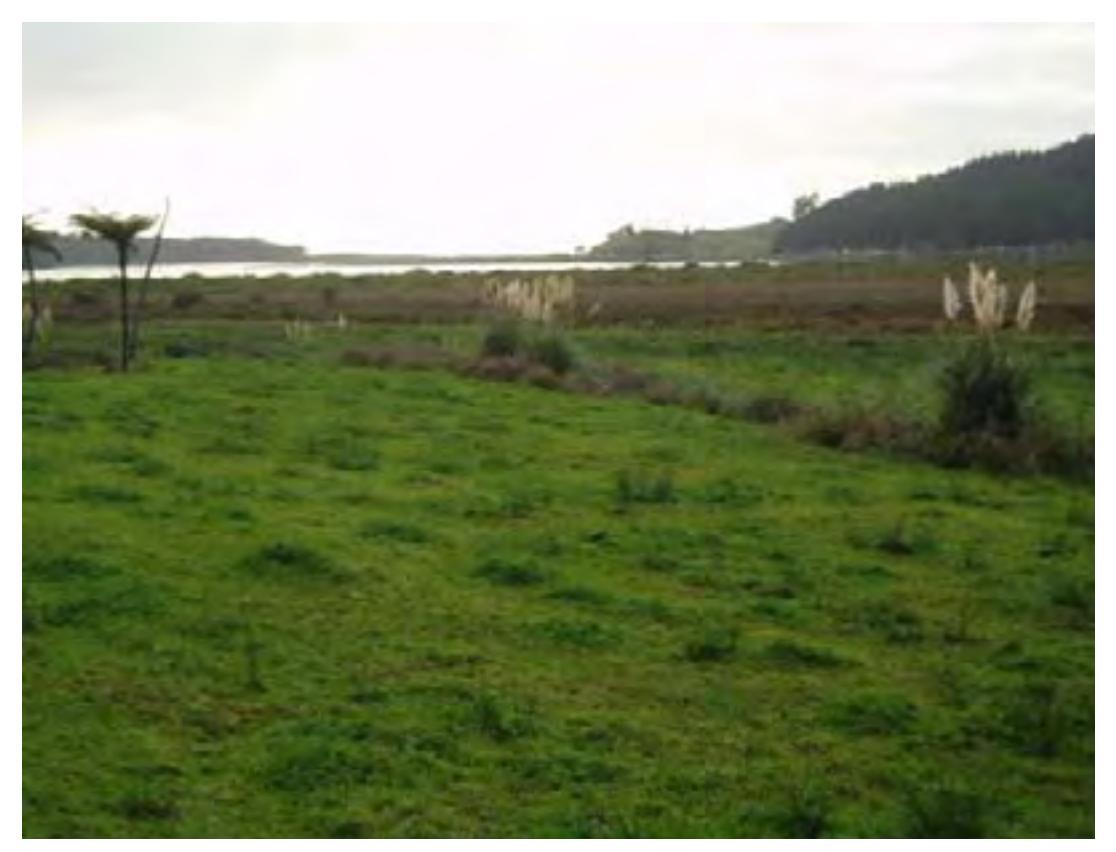
Figure 25: View from Opoutere Road looking over farmland to the harbour mouth. This photo is taken to the south of the 1997 photo [55]. Note the pines on the farmed spit in the centre background of the photo have been removed.

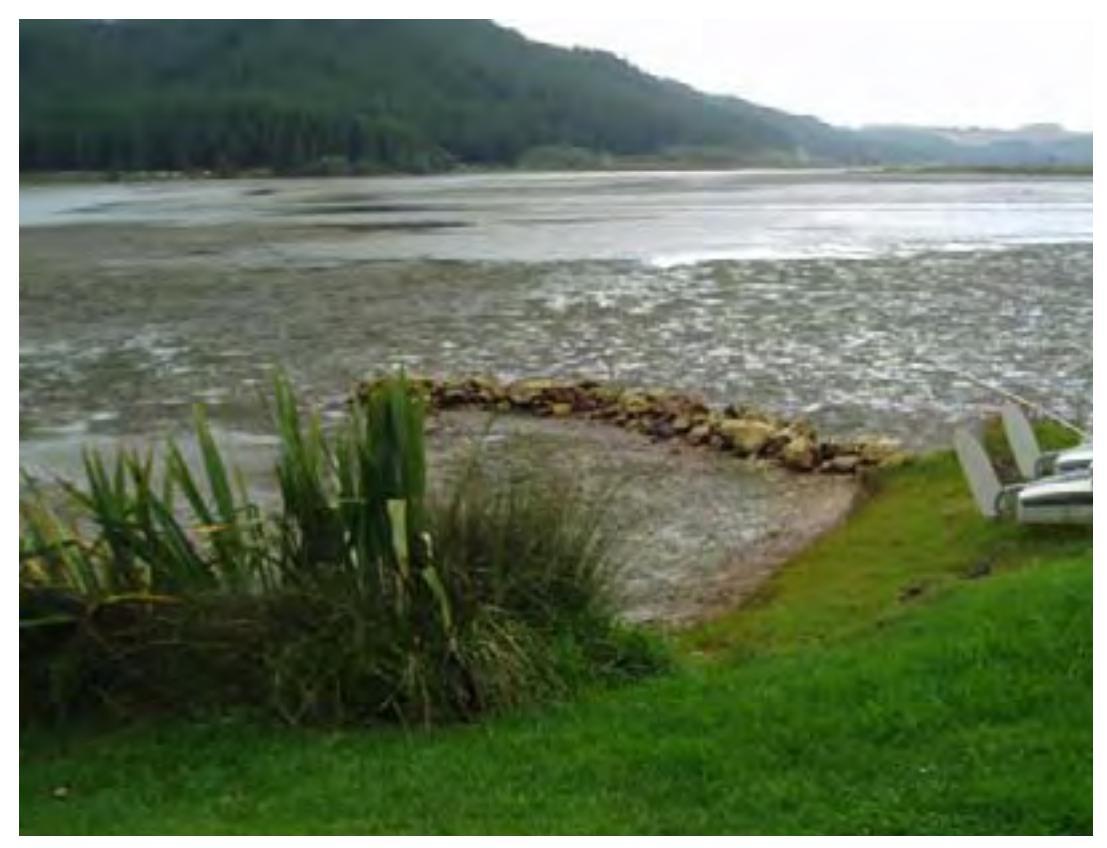
Figure 27: This photo is a repeat of the 1997 photo [62] which shows a reduction in area of seagrass. The oioi behind the boat rudders is struggling to compete with saltwater paspalum.

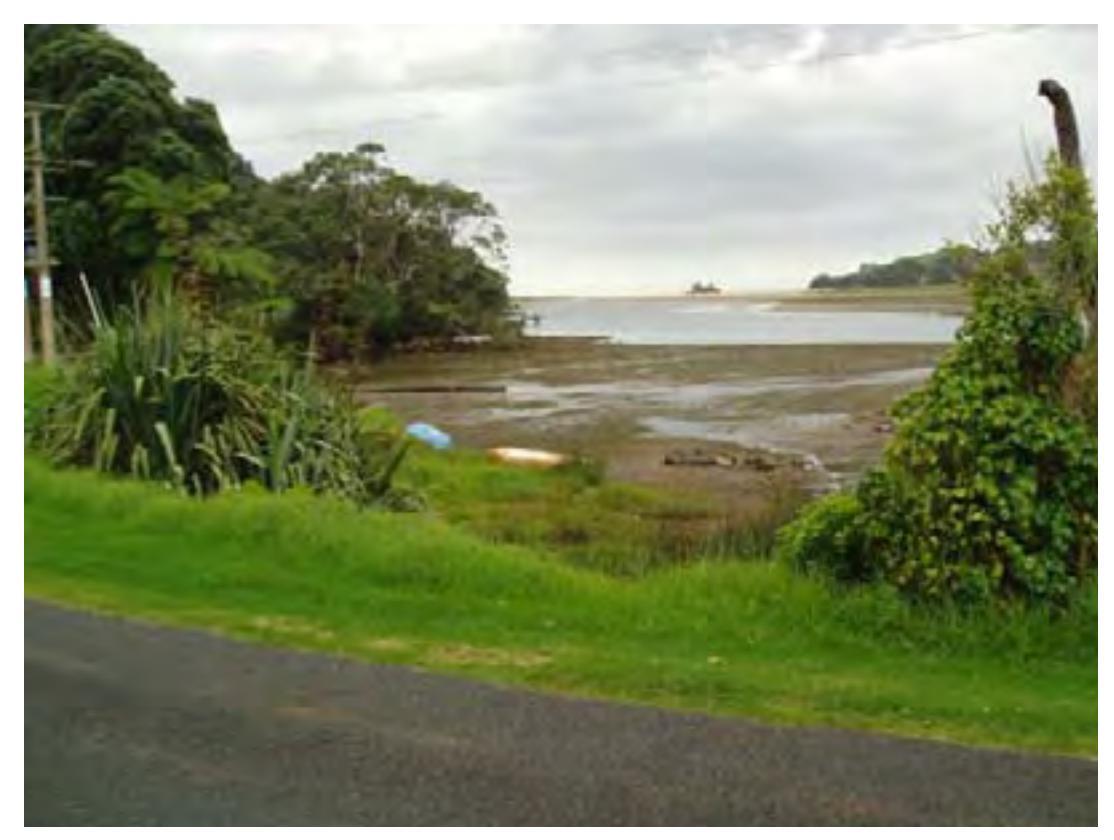
Figure 28: This photo is a repeat of the 1997 photo [63] showing the absence of mangroves which have been cleared from the foreground. Also the pines have been removed from the farmed spit in the middle background.

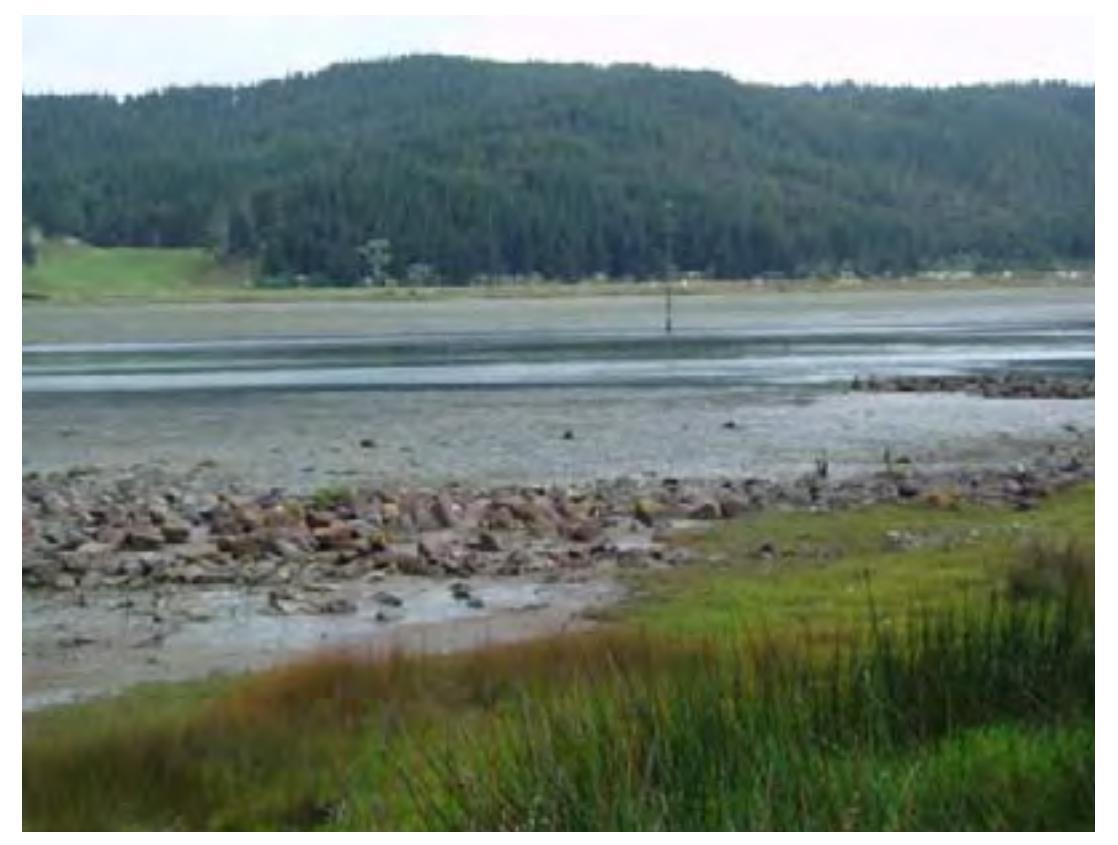
Figure 29: This photo is a repeat of the 1997 photo [64]. Saltwater paspalum is now the dominant harbour edge vegetation. Mangroves have been removed from both sides of the harbour.

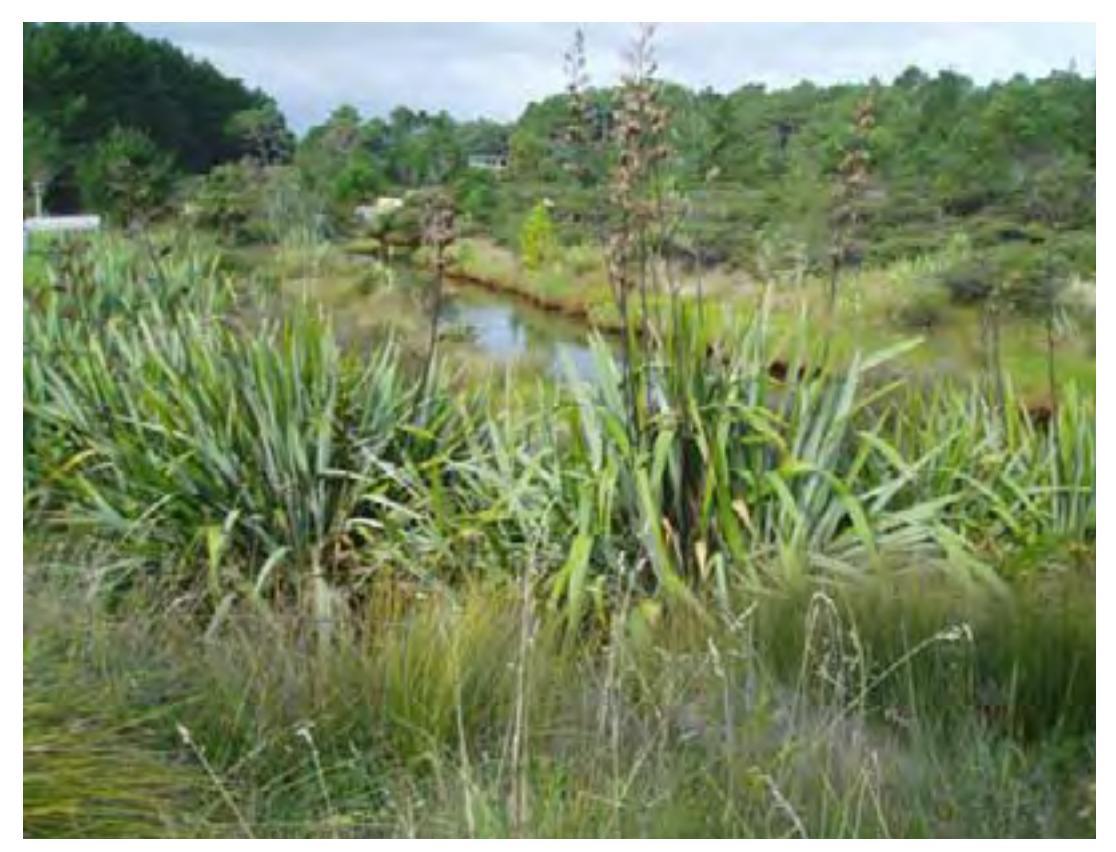
Figure 33: This photo is a repeat of the 1997 photo [69] showing the Wahitapu Stream edge vegetation from the entrance to the camping ground. Note the saltwater paspalum dominating the channel edge.
