Report No. HR/TLG/2015-2016/1.5A

Short term field investigations of groundwater resources in Waipa River Catchment - January to April 2015

**Short term field investigation of groundwater
resources in the Waipa River Catchment:
January – April 2015**

Rawlinson, Z.; Riedi, M.; Schaller, K.; Bekele, M. 2015. Short term field investigation of groundwater resources in the Waipa River Catchment: January – April 2015, *GNS Science Consultancy Report 2015/54*. 195 p.

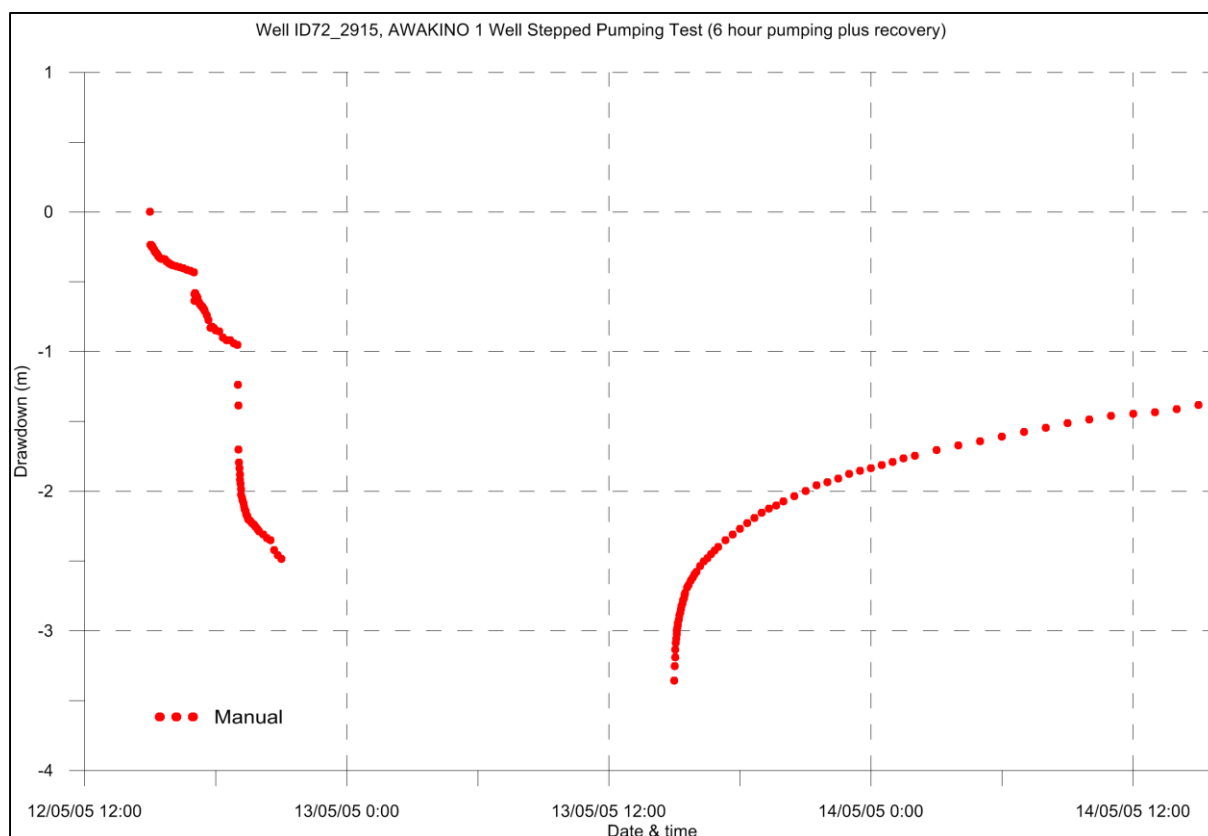
Figure A 3.5 Drawdown and recovery plot for well 72_2915.

Pumping test comments for 72_2915: A 24 hour step well test was completed on 13/05/2005 by Aqua Consultants Limited to test for feasible production rate. The data was supplied by the Waitomo District Council in February 2015. The aquifer was pumped at 2.7 L/s for 120 minutes, then at 5 L/s for 120 minutes and lastly at 10 L/s for another 120 minutes. Recovery was measured for 1440 minutes after the pump was turned off. The aquifer only recovered to just over 58% of the drawdown generated after 24 hours of recovery. This suggests that there may be some restriction to the area extent of the aquifer.

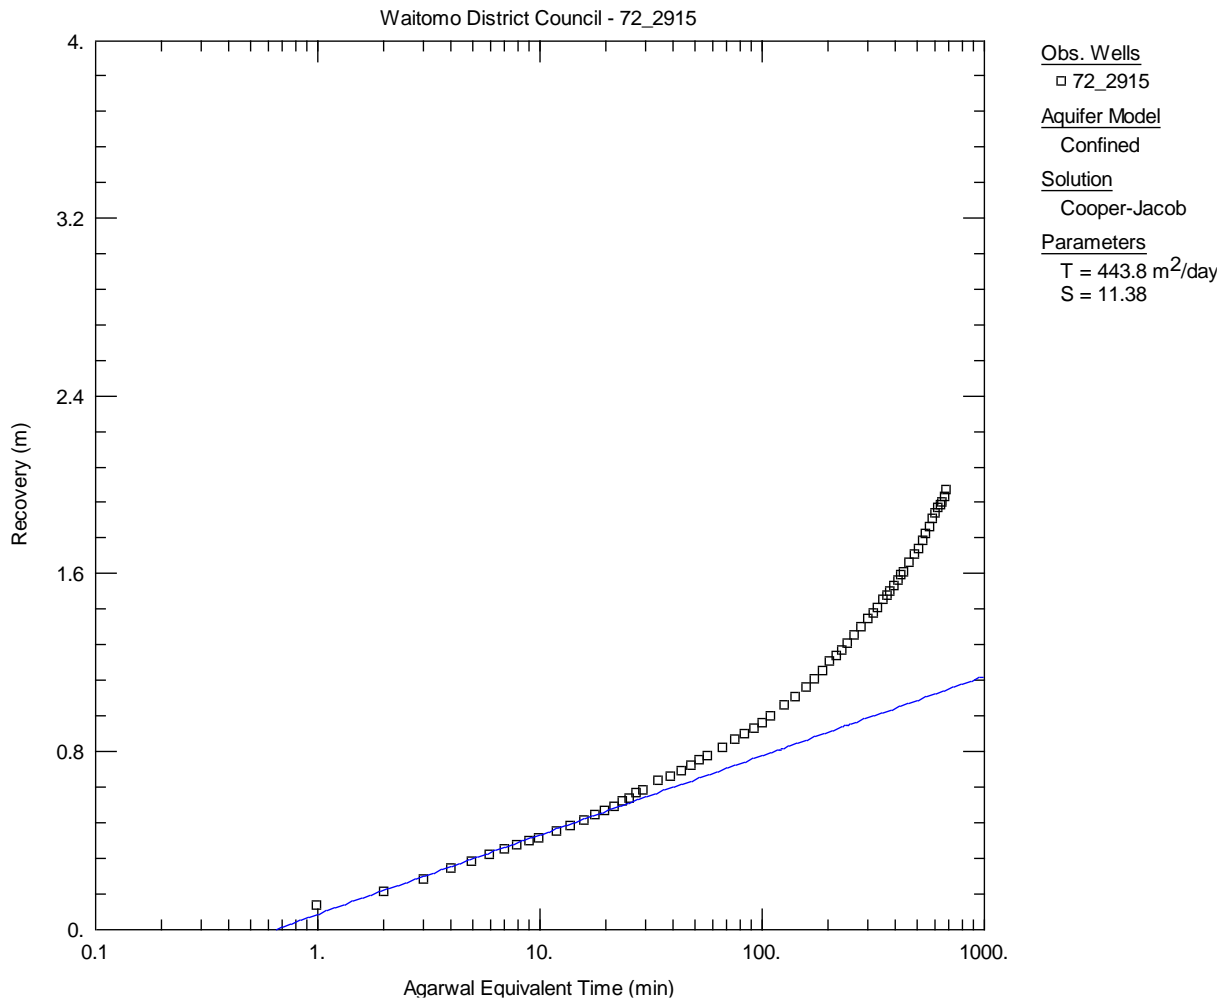
Figure A 3.7 Recovery data analysis for well 72_2915 fitting to the initial part of the curve, resulting in $T = 443.8 \text{ m}^2/\text{day}$.
