# State of coastal water quality for the west coast of the Waikato region 1994-2021

Prepared by: Janine Kamke

For: Waikato Regional Council Private Bag 3038 Waikato Mail Centre HAMILTON 3240

December 2021

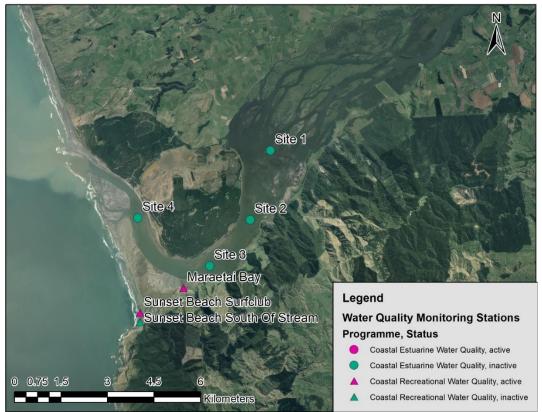
Figure 3-1. Map showing sampling stations at Port Waikato Estuary and Beach.

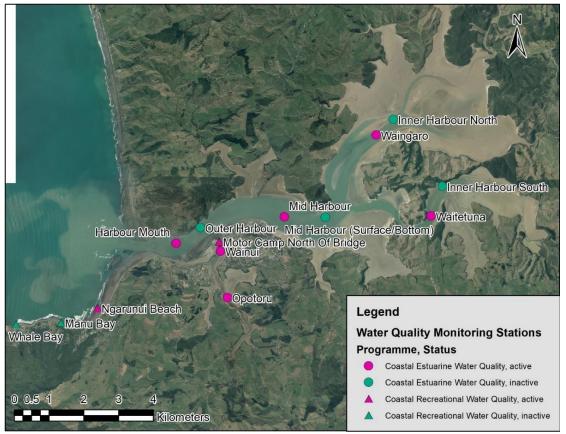
Figure 4-1. Map showing sampling sites at Whāingaroa Harbour and Beaches.

Recreational water quality has been monitored at four stations in the Whāingaroa area including Manu Bay, Motor Camp North of Bridge, Ngarunui Beach and Whale Bay. Ngarunui Beach and Motor Camp North of Bridge are the only monitoring stations currently sampled. Ngarunui Beach has been monitored weekly each swim season (Nov-March) since 2015/16 for enterococci and Motor Camp North of Bridge was reintroduced to the programme in 2020 for enterococci and *E. coli*. Recreational monitoring before 2015 was not regular for all stations and parameters. An overview over monitoring periods, sample number per station and parameter is shown in Appendix B. Monitoring stations are shown in Figure 4-1 and listed in Table 4-1.

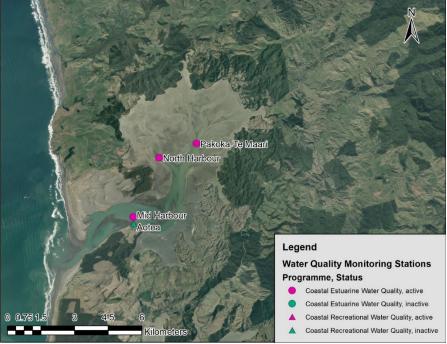
Figure 5-1. Map showing sampling stations at Aotea Harbour. Red dots donate to sites sampled for the estuarine water quality monitoring programme and orange dots sites for the recreational water quality programme.
