# Matamata-Piako and Patetonga Flooded Landowners Meeting

23 November 2017

# Piako River Scheme Review update

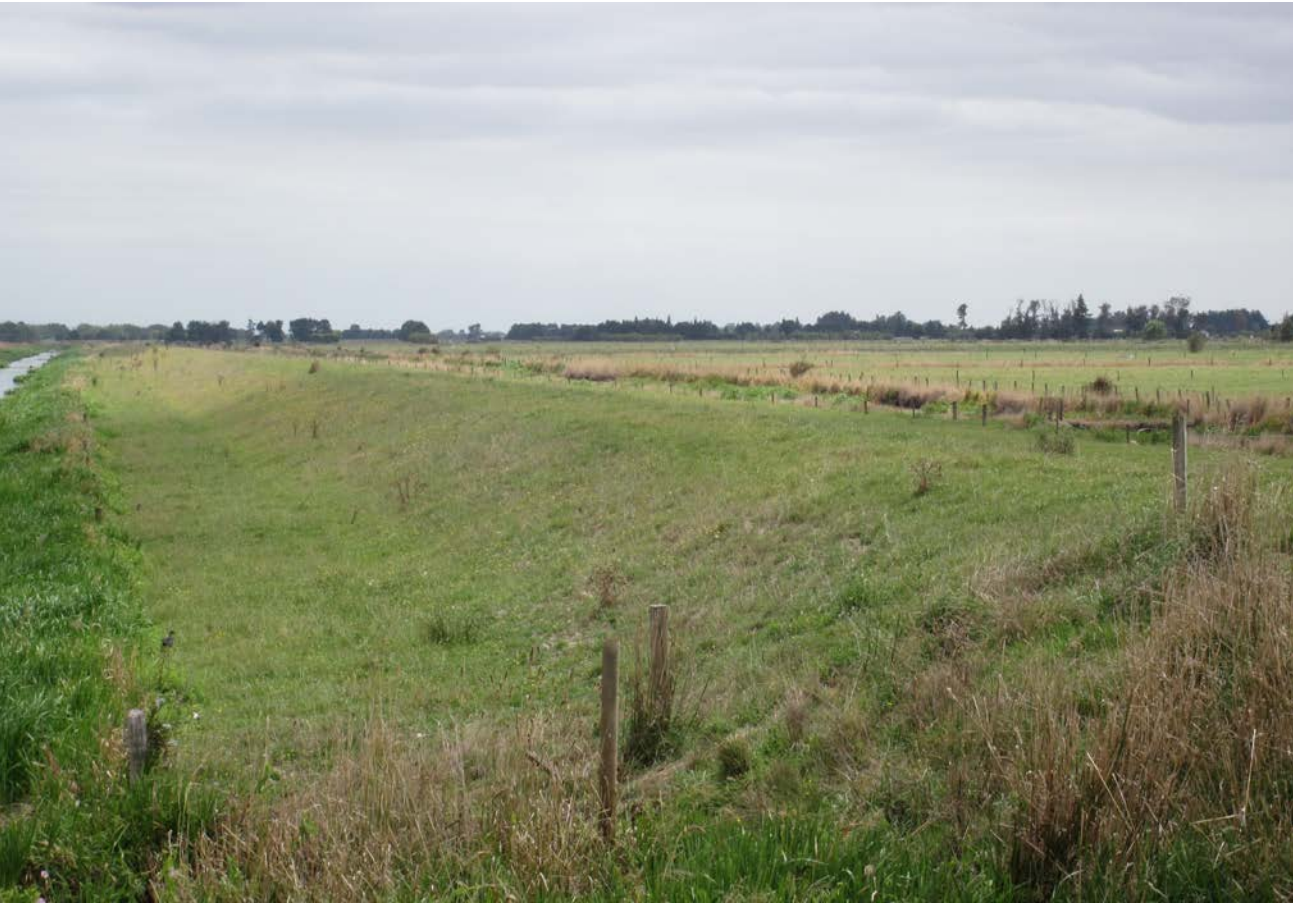
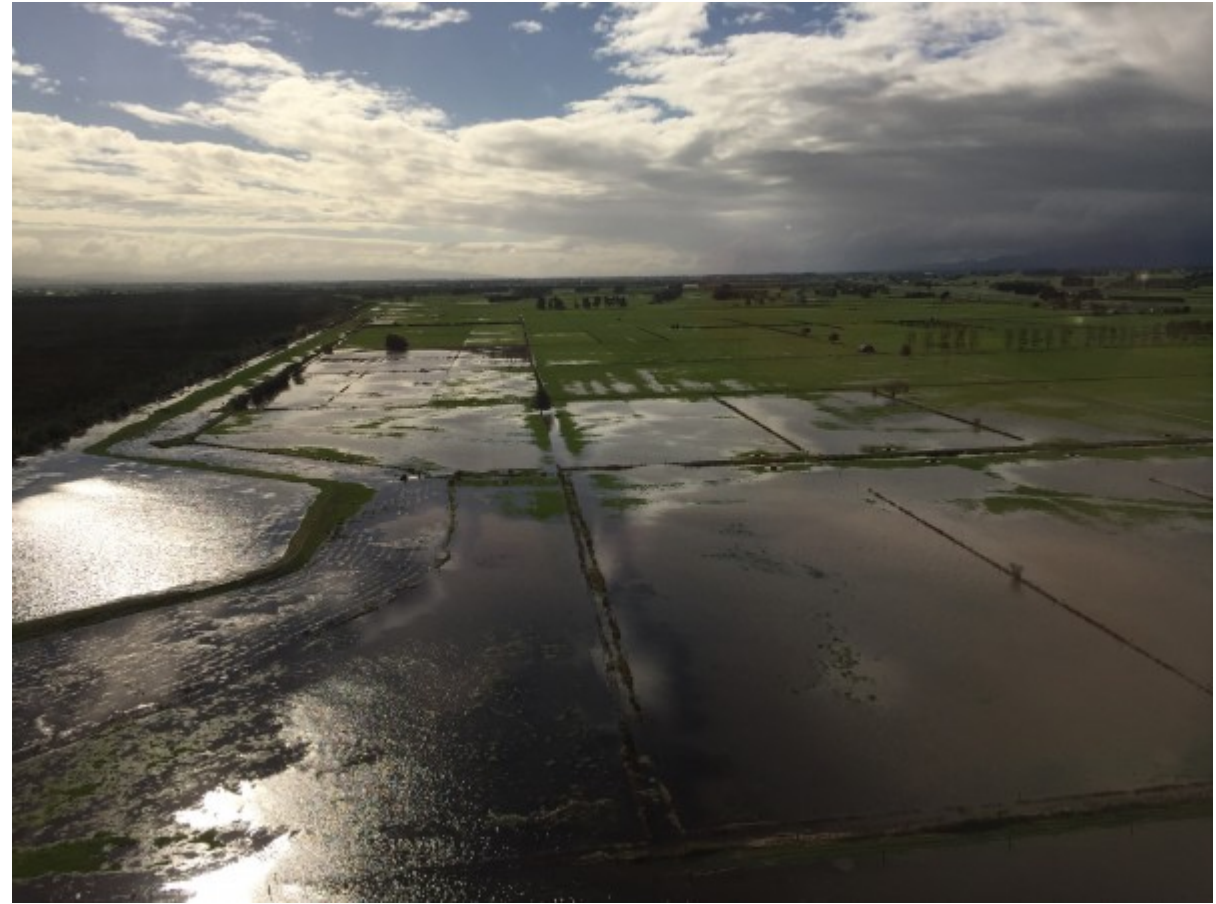
# Kerepehi extension stopbank remediation

Drain reinstated under emergency works, Design flood level (50yr) RL2.1, freeboard additional yet to be approved. Upgrade construction early 2018. Challenges – Material, Peat foundations

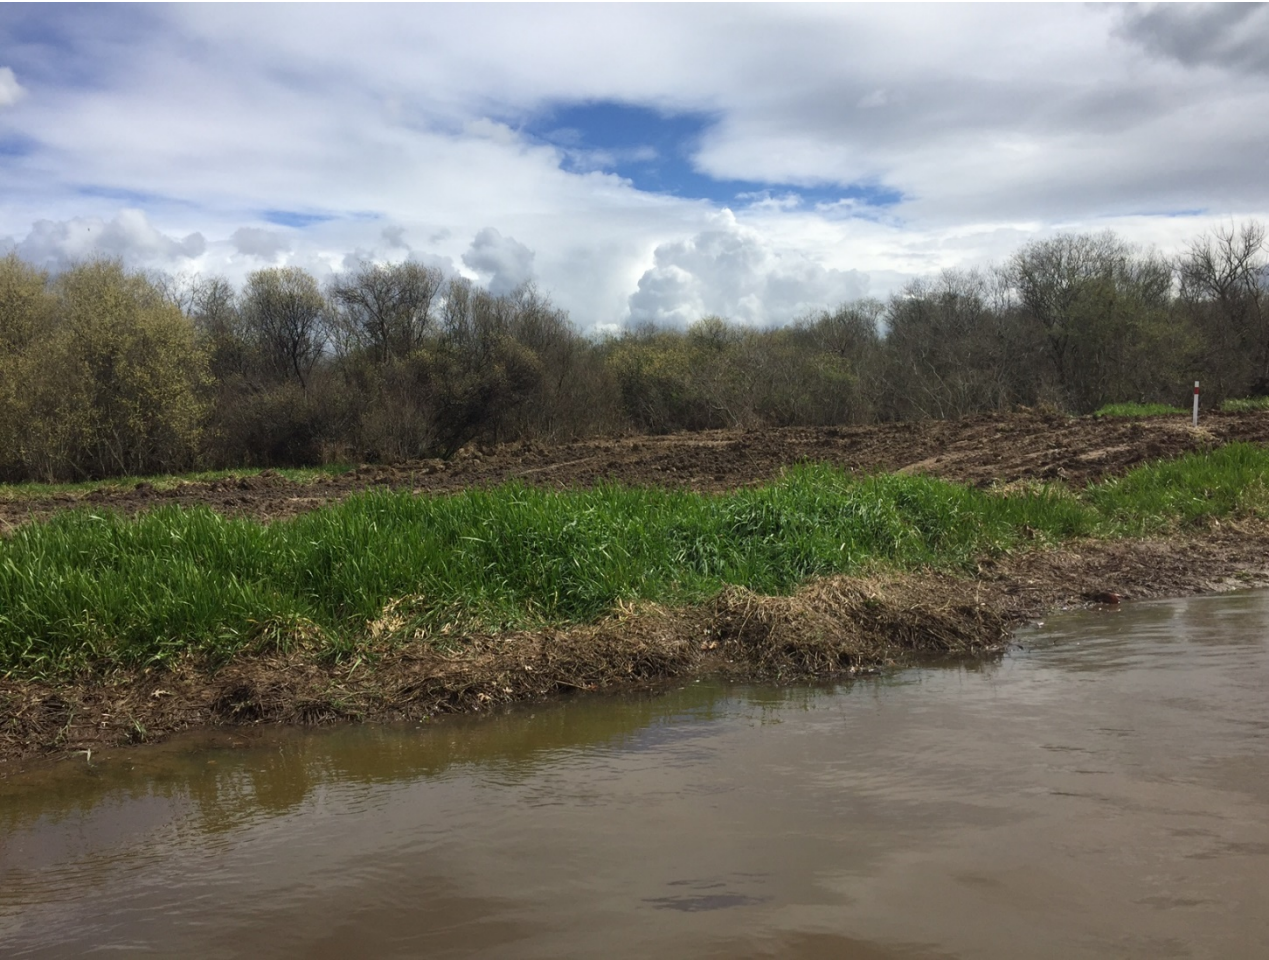
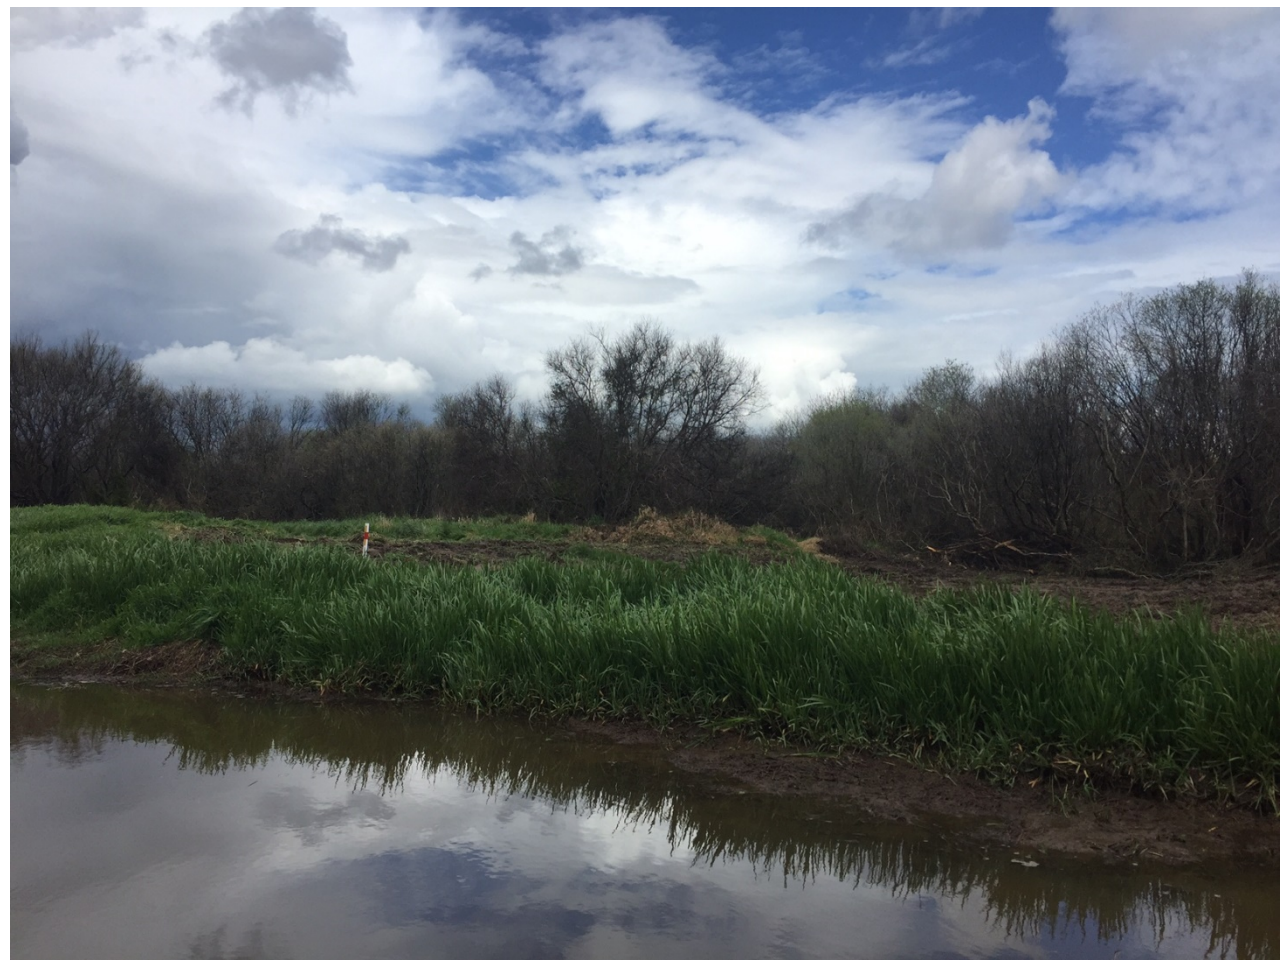
# Castellation Drains – ABCD Flaxblock

- Land owned by DoC
- Agreement reached for a management agreement to be developed between WRC, Doc & IWI
  - WRC role would be to manage flood protection assets including castellation drains, moat, water levels, stopbanks and culverts
- ABCD Weir agreement has been reached with Upper Piako Wetland Society for WRC to manage Weir levels to agreed levels
- Challenges –
  - Working on resource consent for moat, Waikaka track and remaining castellation drains
- Work completed –
  - ABCD weir set to correct height, some castellation drains reinstated to correct level, DoC have sprayed the moat.

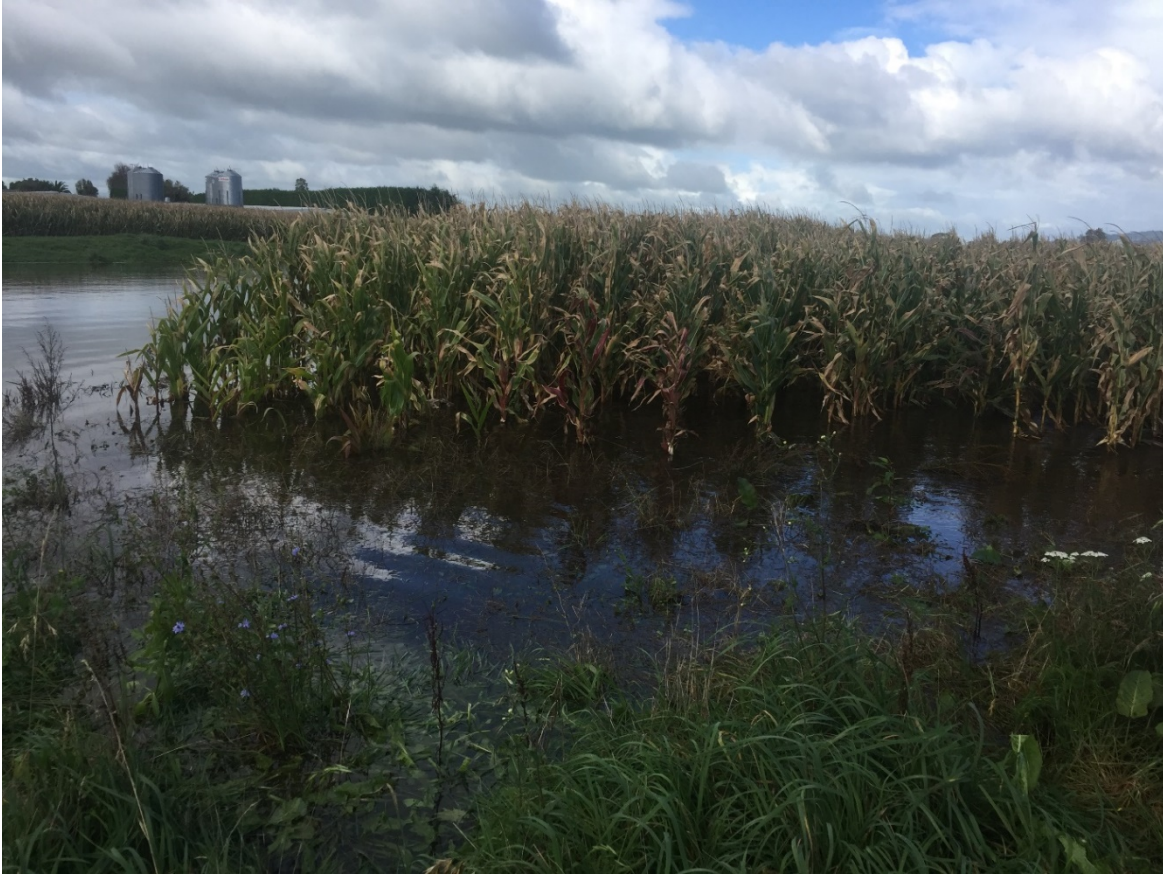
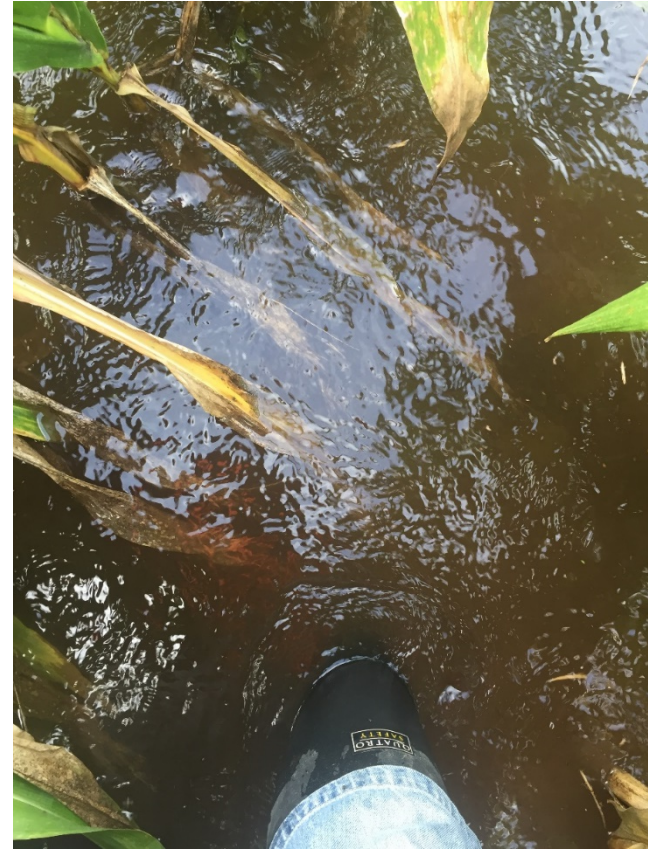
# Whakahoro canal stopbank overtop

- WRC stopbank on private land, overtopped along a length where maize was cultivated. Review of Councils process on informing landowners of their responsibility is underway – not isolated to Hauraki.
- Service level is 20yr ARI. Programmed for upgrade this year

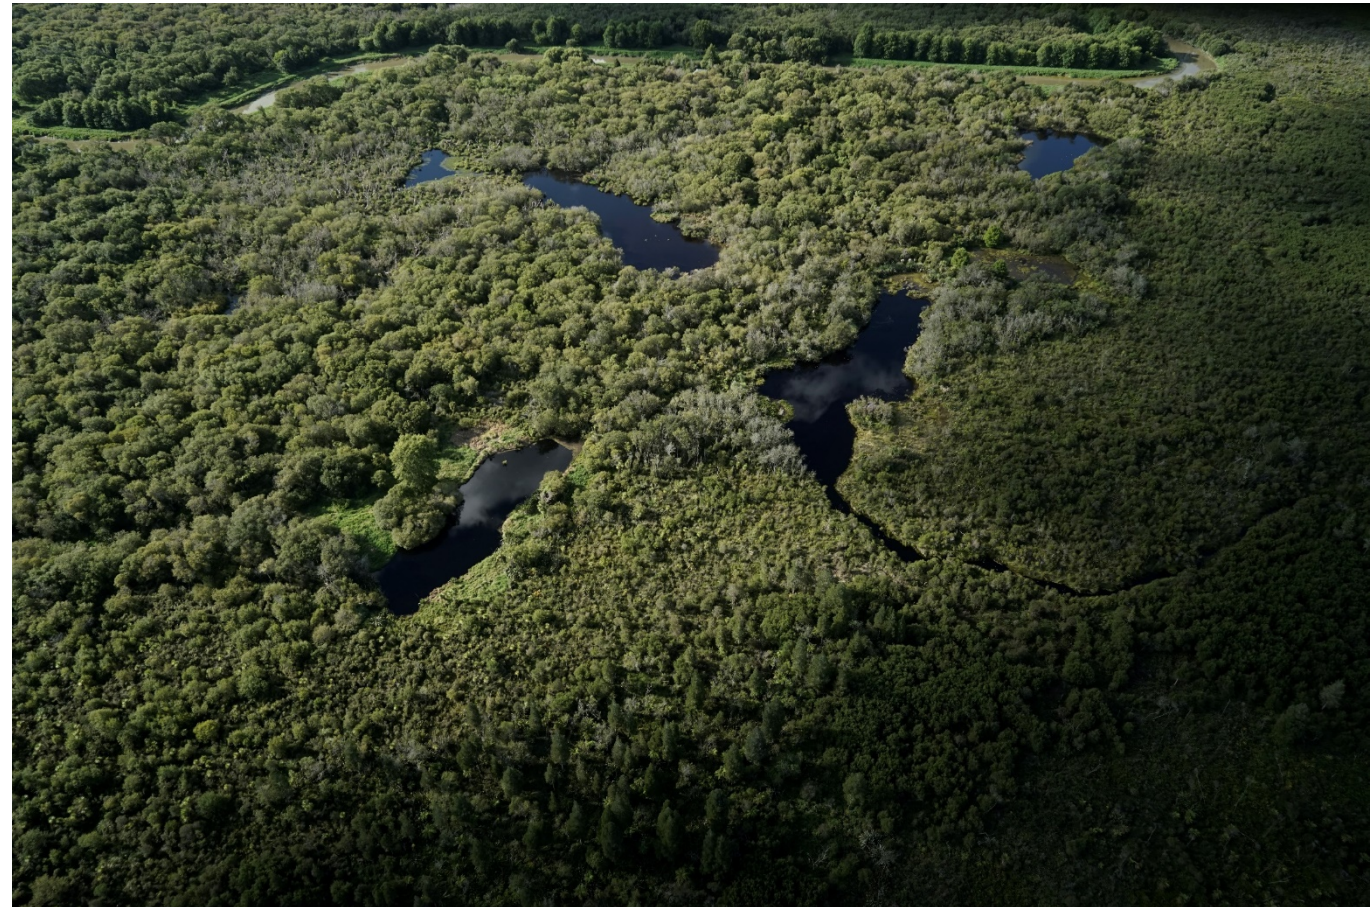
Draft report received

Final report due soon

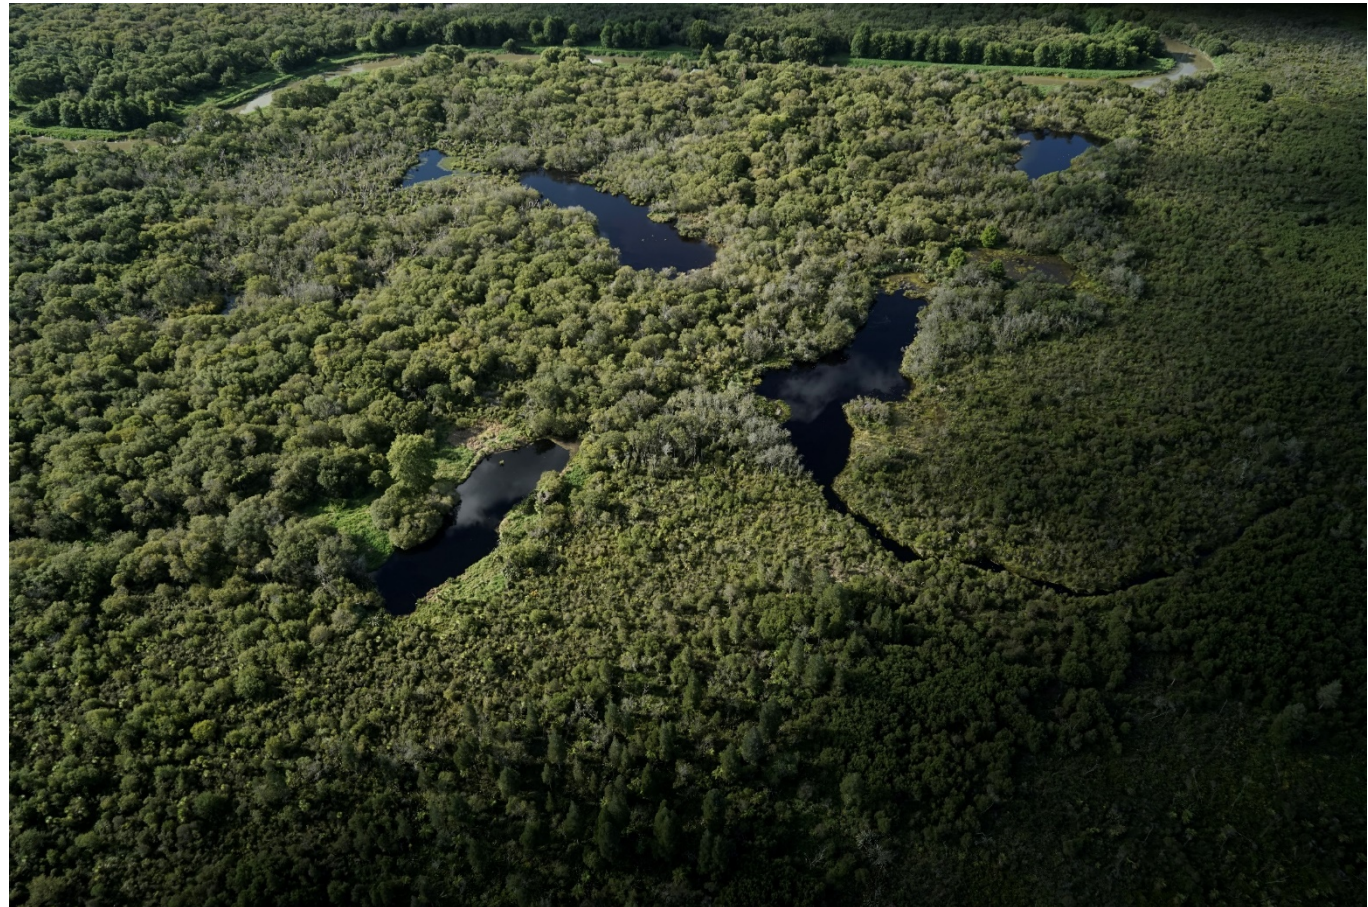
# Piako River Scheme, performance to design and service level paid for

Scheme met its performance standard through all events

Piako River Scheme LOS =

100yr tidal, 50yr River flood excluding ponding zones which are 10 and 20yr ARI

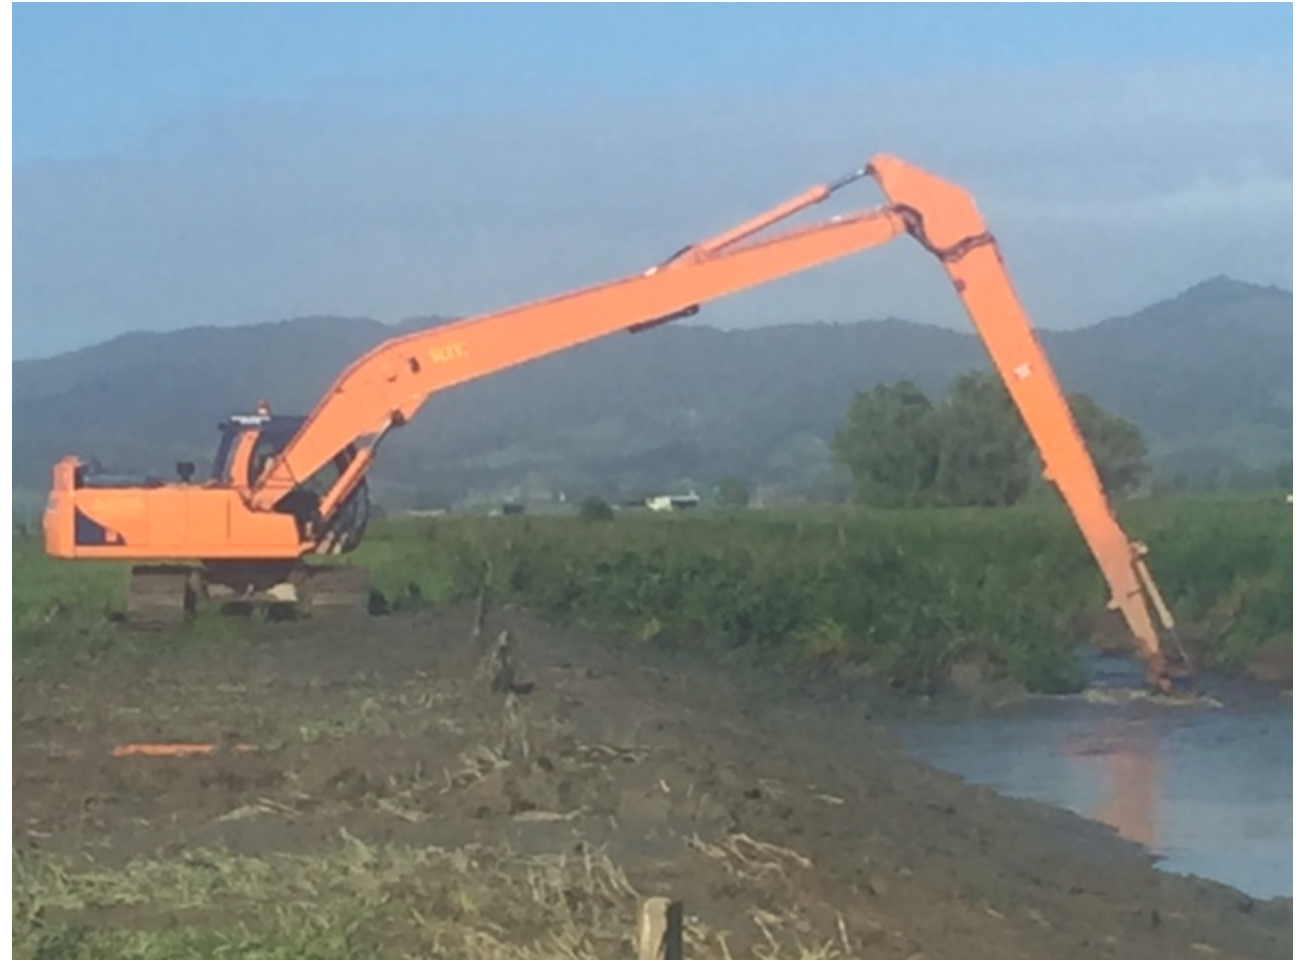
# Mangawhero area assets

Central Drain –

Desilting in progress, Resource consent condition meant start date > 1 November

Kaihere Stream –

Desilting completed post event

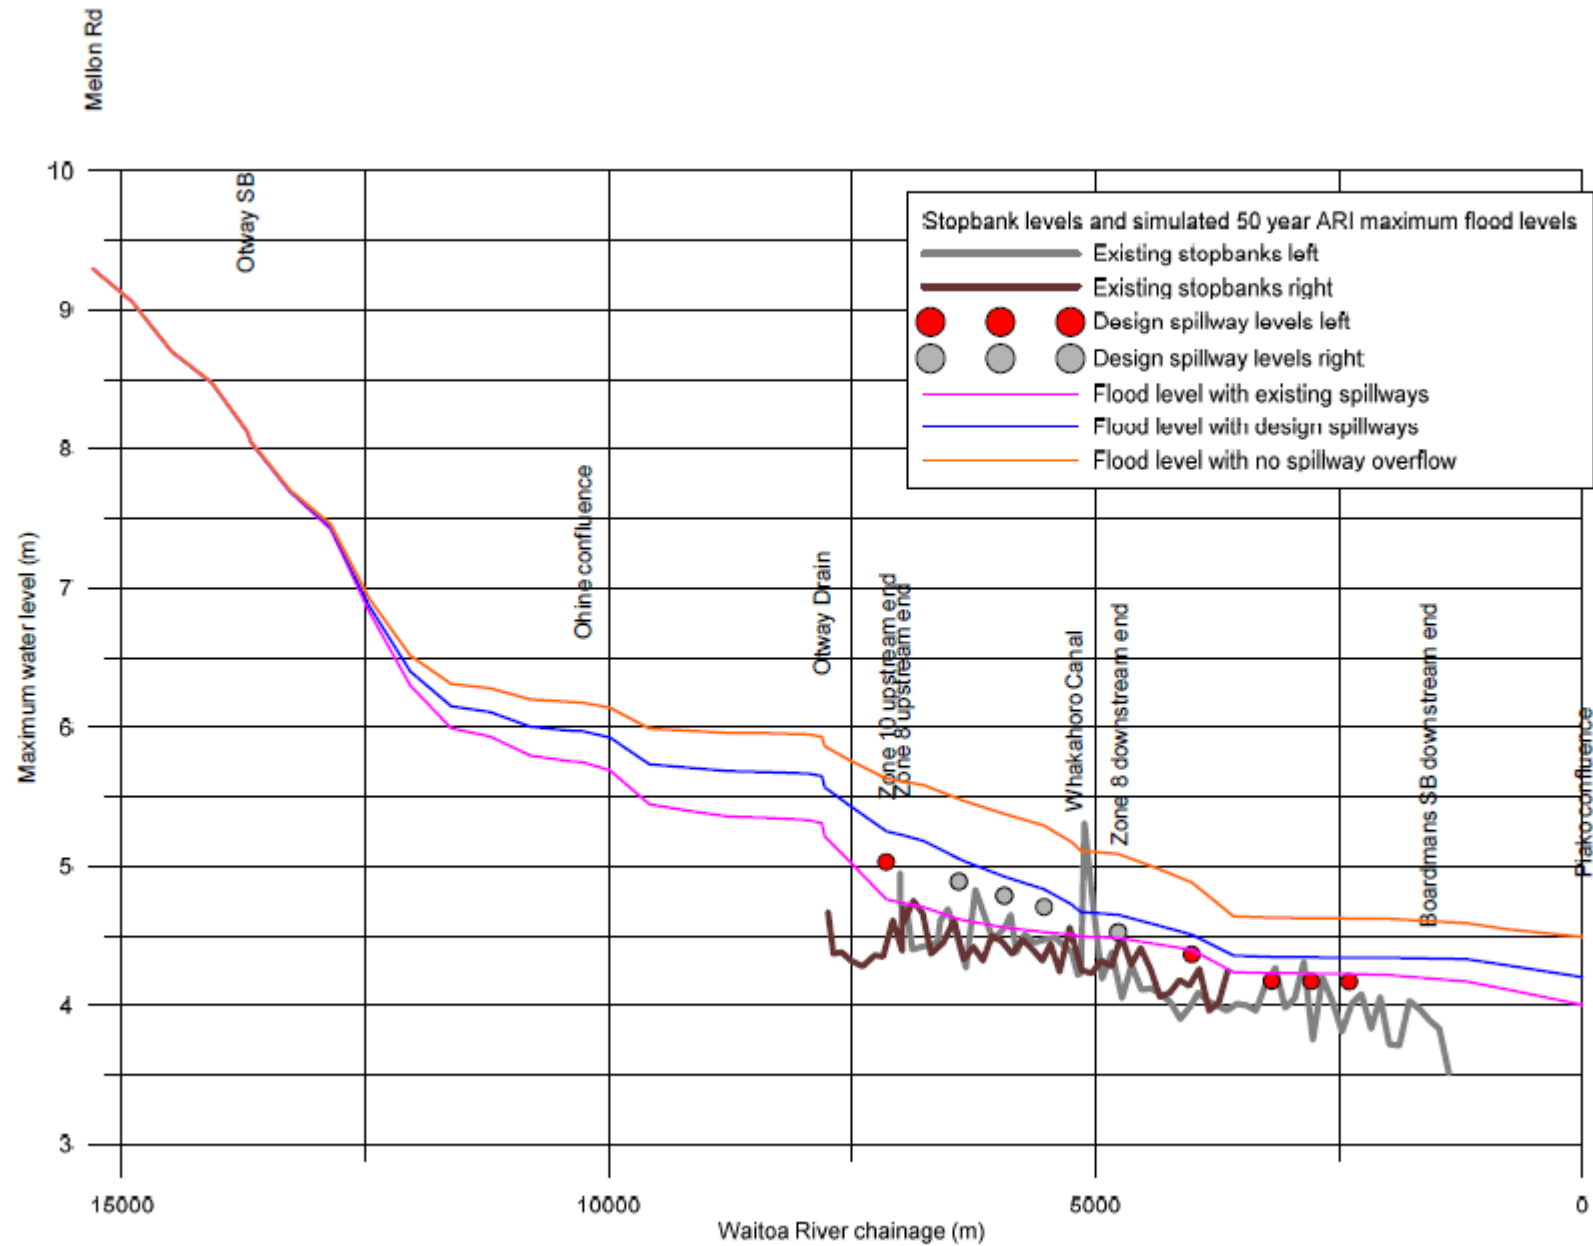
# 50yr ARI - Waitoa

Figure 50: Maximum water levels on the Waitoa River between Mellon Rd and the Piako confluence with existing and design spillway levels, in the 50 year ARI event

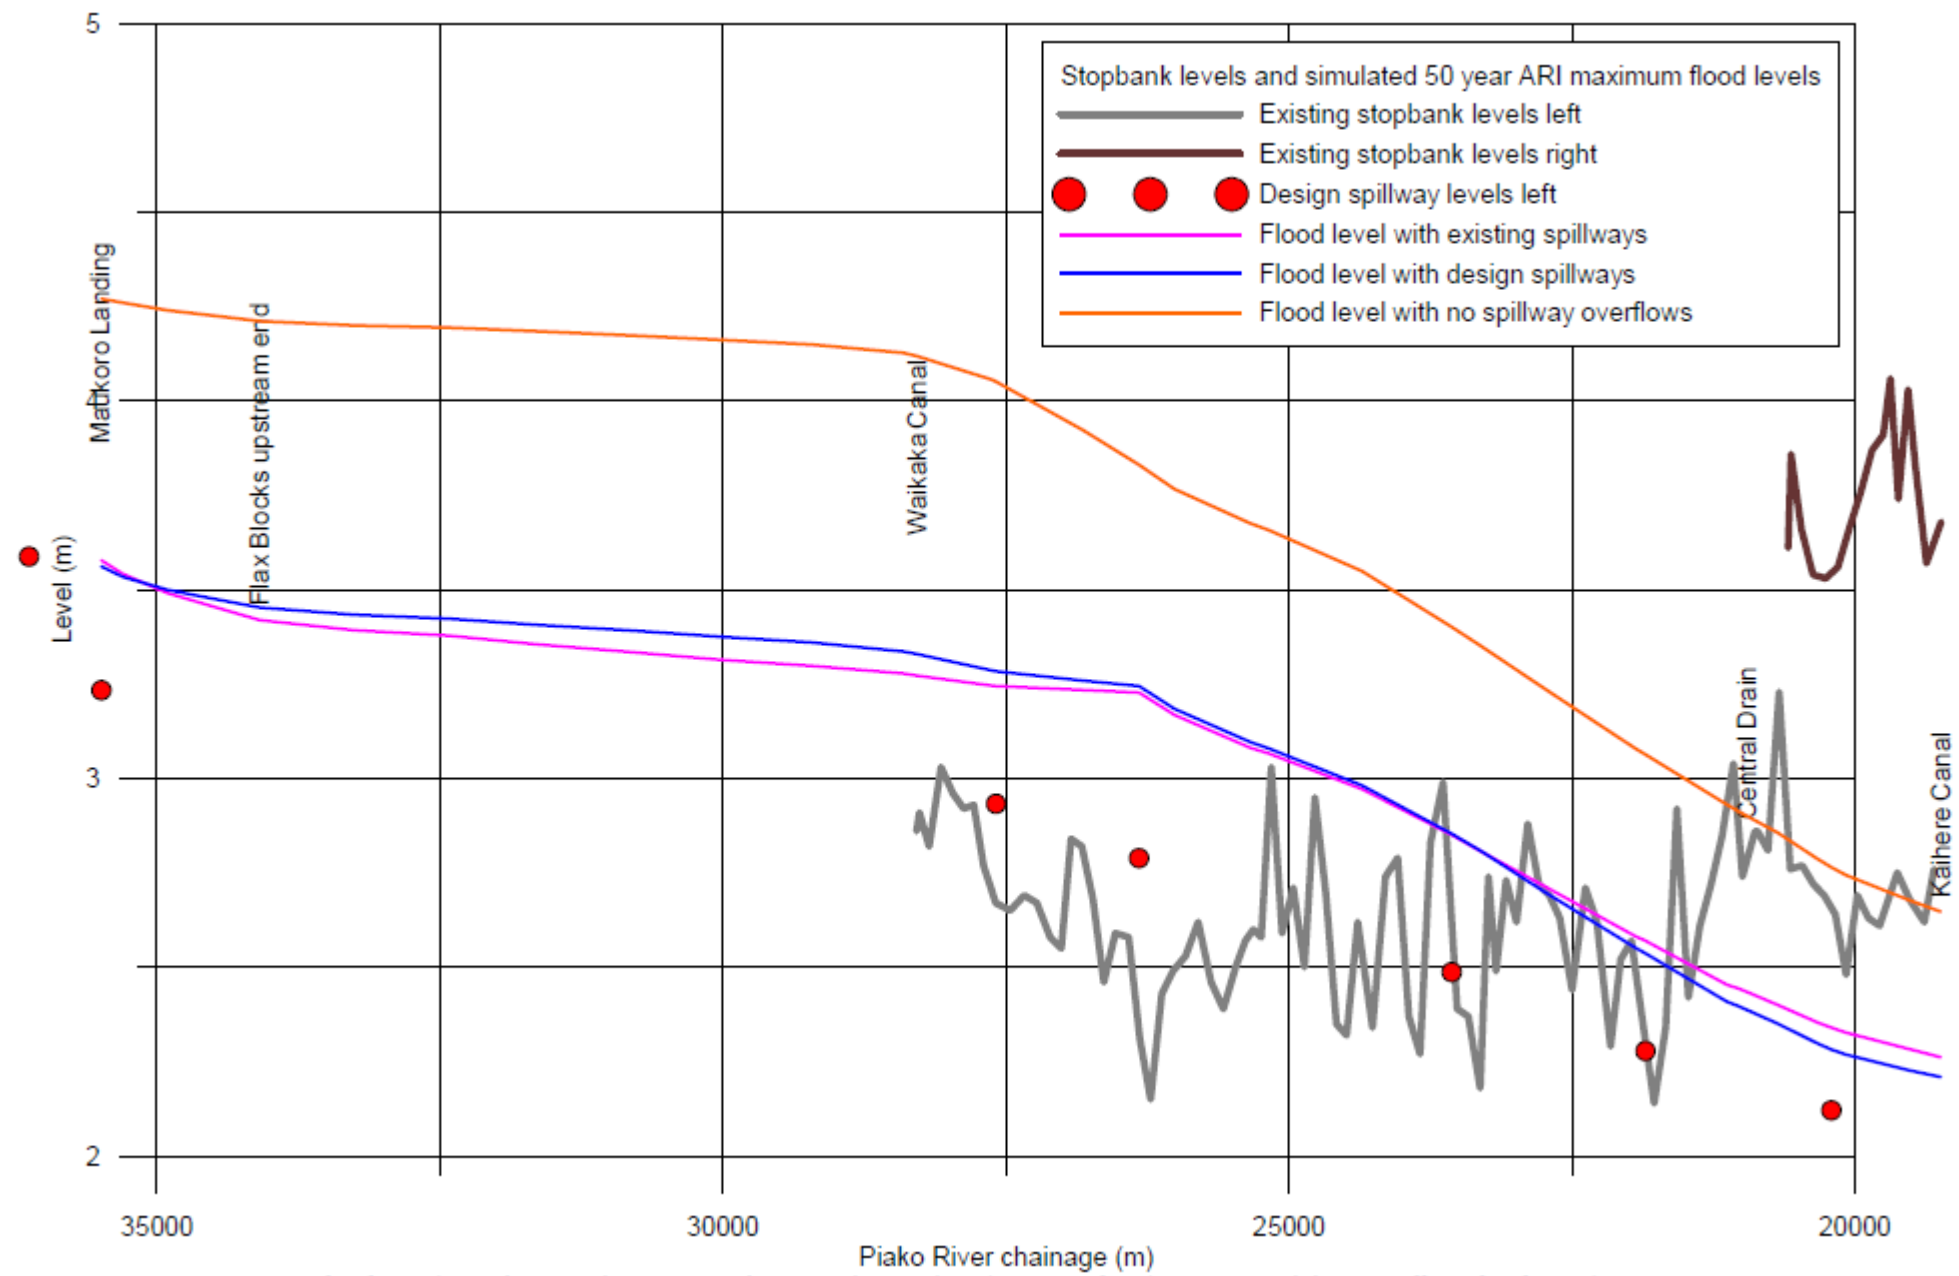
Figure 52: Maximum water levels on the Piako River between Maukoro Landing and Kaihere Canal with existing and design spillway levels, in the 50 year ARI event

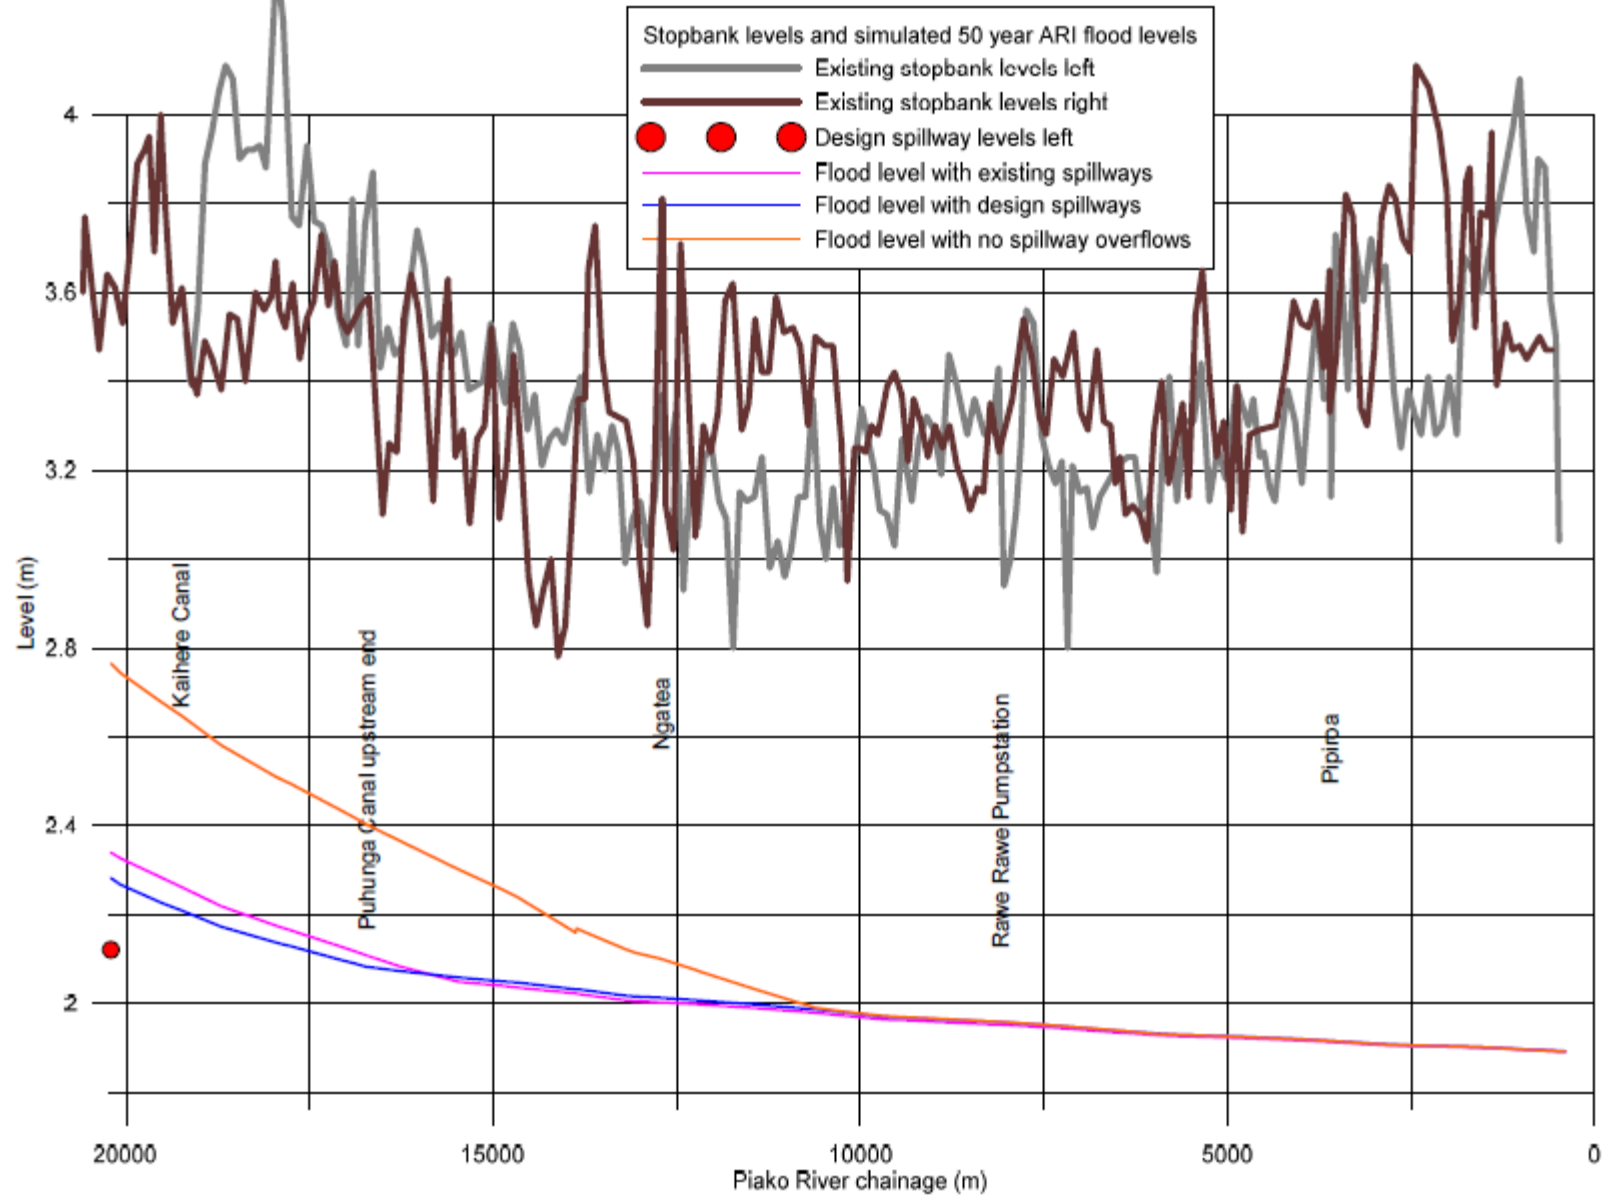
Figure 53: Maximum water levels on the Piako River between Kaihere Canal and the mouth with existing and design spillway levels, in the 50 year ARI event

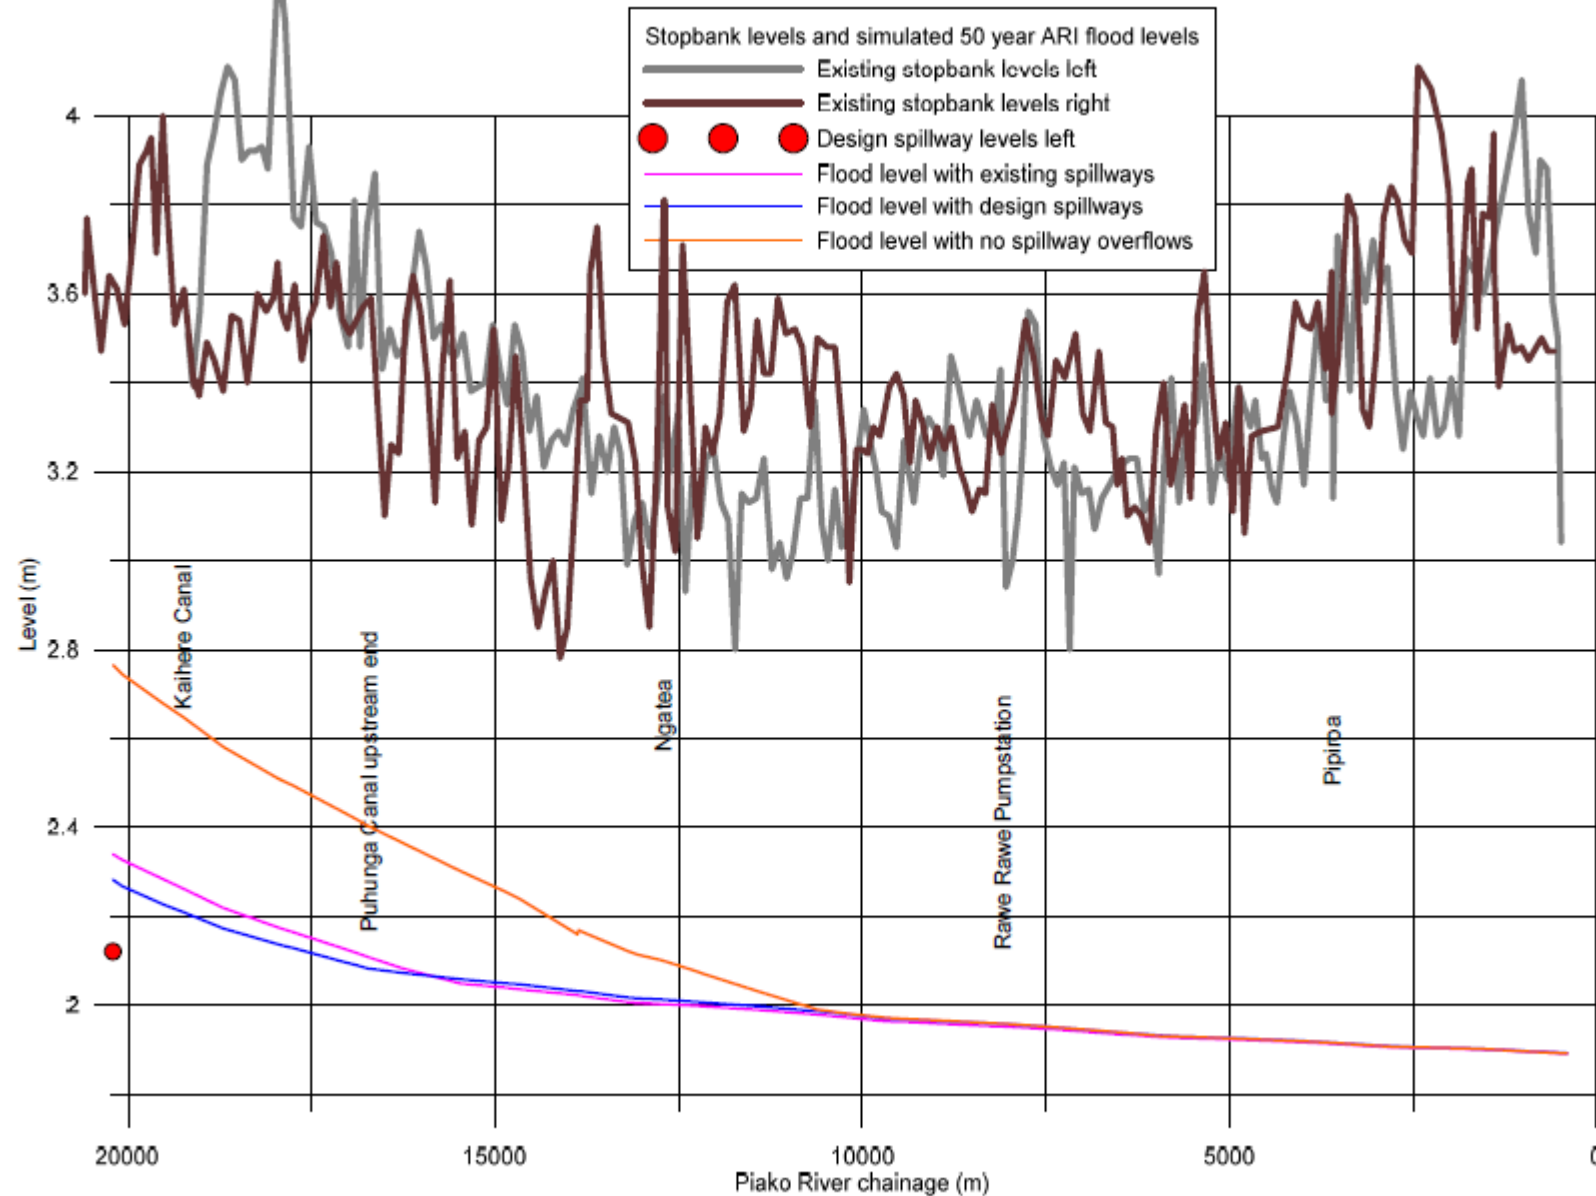
Figure 53: Maximum water levels on the Piako River between Kaihere Canal and the mouth with existing and design spillway levels, in the 50 year ARI event

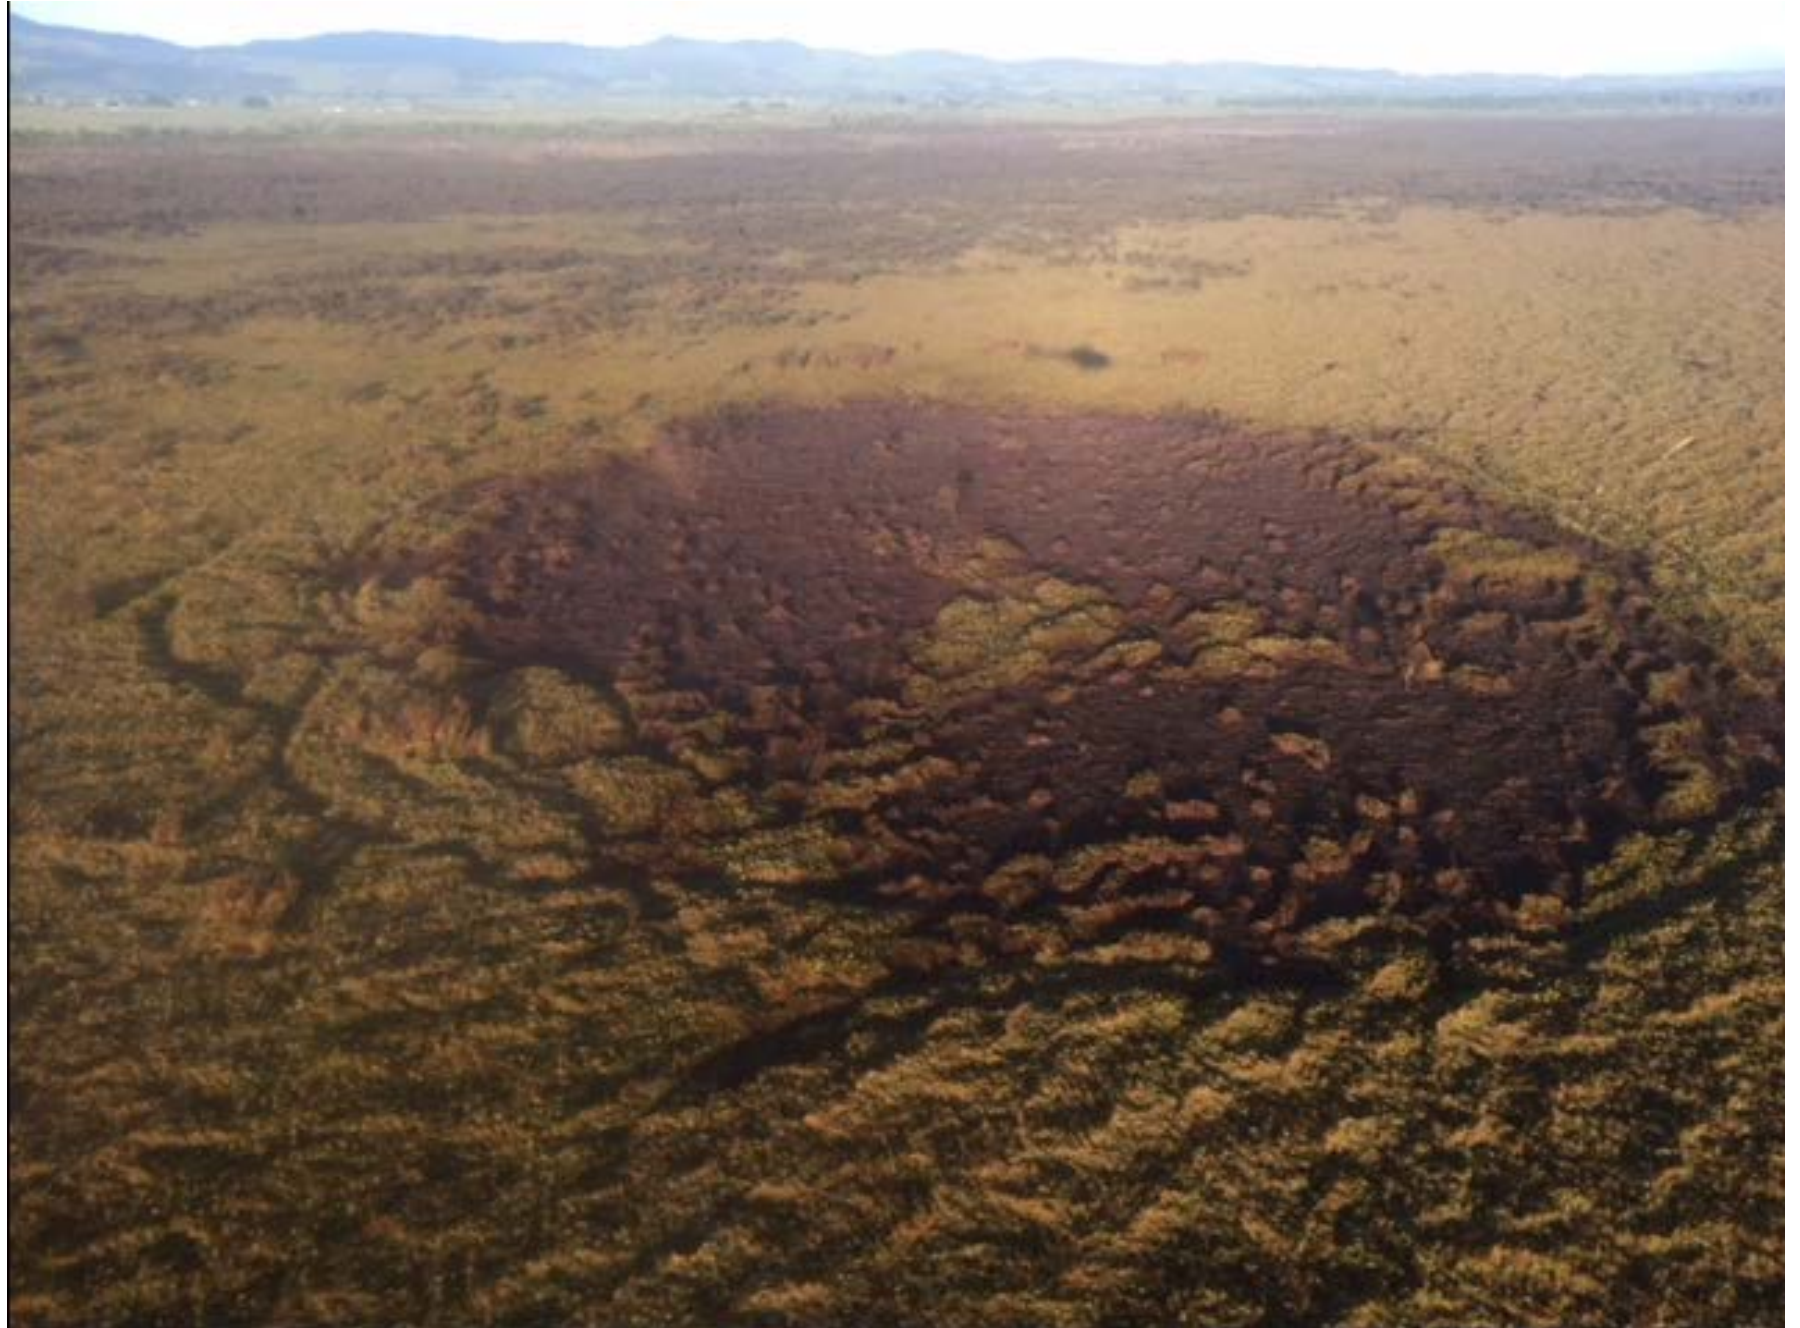
# Interesting fact

- Lightning strike on Kopuatai peat dome, fire extinguished by helicopter
