Thames Coast Project

Summary of Technical Investigation

Revision 1

June 2004

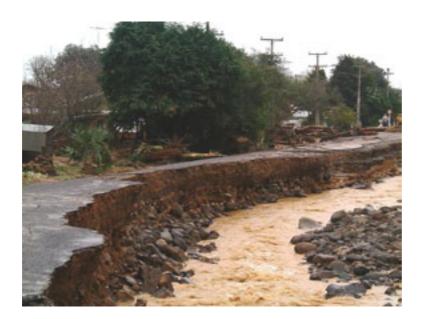
Figure 1.1: Streambank erosion on Te Puru Creek Road following the 'weather bomb'

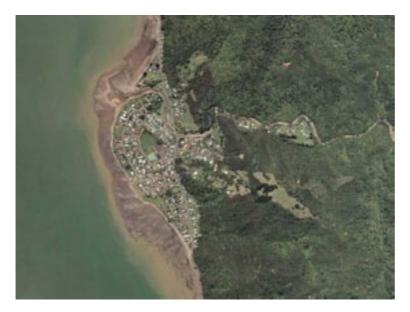
Figure 2.2: A typical example of urban development on a coastal alluvial fan (Te Puru)

During the past century, a number of coastal communities have been established on the flat land that is typical of these coastal alluvial fans. These communities, which consist of permanent homes, holiday homes, camping grounds and businesses, have progressively encroached onto the floodplains of a number of waterways. As a result, flood events on the Thames Coast seldom occur without some damage to people and property.

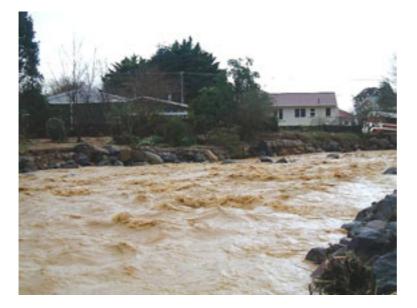
Figure 2.4: The Tararu Stream in flood during 2002.

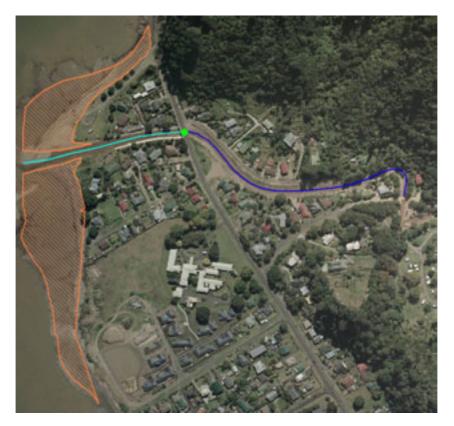
Diagram 8.2.1.1: Map of proposed base-level maintenance works in the Tararu Stream

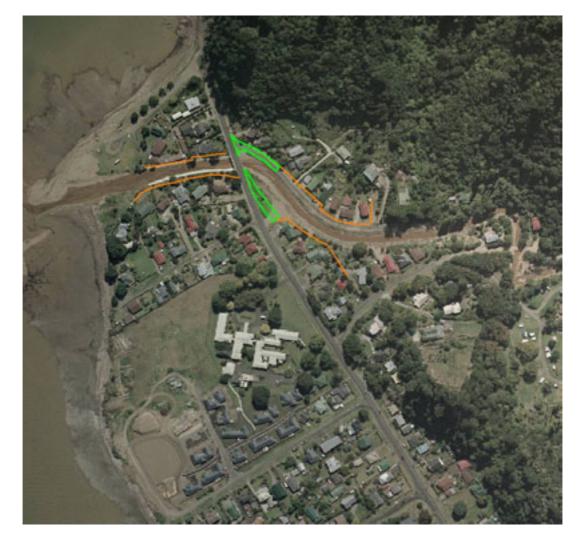
This involves the design, authorisation and implementation of new flood protection works that are designed to improve the capacity of the Tararu Stream to contain the 20 year flood event.

Diagram 8.2.1.2: Map of proposed flood protection works around the Tararu Stream

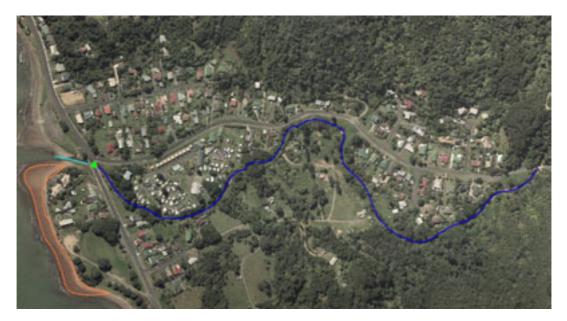
Diagram 8.4.1.1: Map of proposed base-level maintenance works in the Waiomu Stream

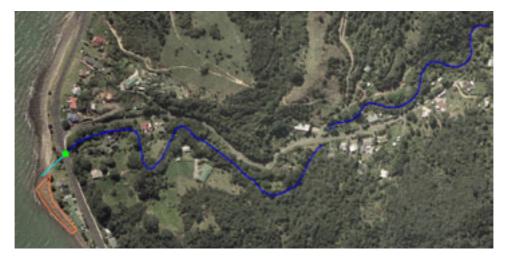
Diagram 8.5.1.1: Map of proposed base-level maintenance works in the Pohue Stream

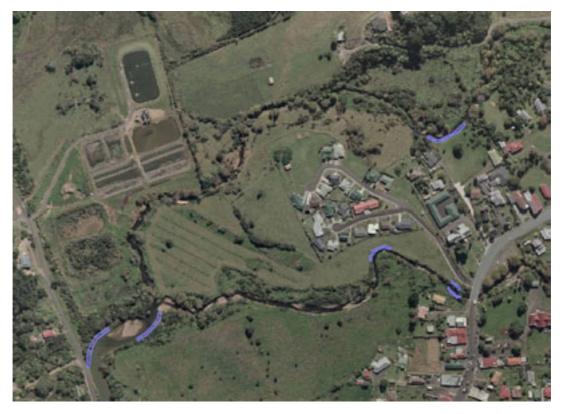
This involves the design, authorisation and implementation of works to improve the Whangarahi Stream and Karaka Stream channels.

Diagram 8.7.1.2: Map of proposed erosion protection works on the Whangarahi and Karaka Stream

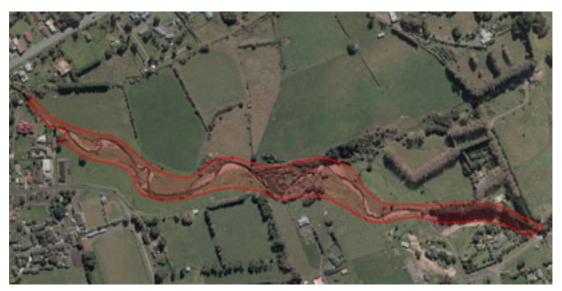
Diagram 8.7.1.3: Map of proposed fencing and planting along the Karaka Stream

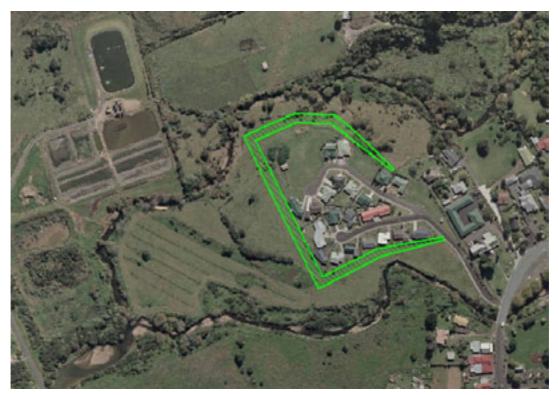
This involves the design, authorisation and implementation of works to improve the capacity of the Whangarahi Stream channel in the vicinity of the Elizabeth Park Retirement Village through the construction of a stopbank. The design standard for this stopbank is the 100 year flood event.

Diagram 8.7.1.4: Map of proposed flood protection works around the Elizabeth Park Retirement Village
