Waikato on-site wastewater risk assessment - phase two: factors, weighting and rating calibration study

Prepared by:
Andy Haigh, Beca Infrastructure Ltd (Beca)

For:
Waikato Regional Council
Private Bag 3038
Waikato Mail Centre
HAMILTON 3240

January 2012

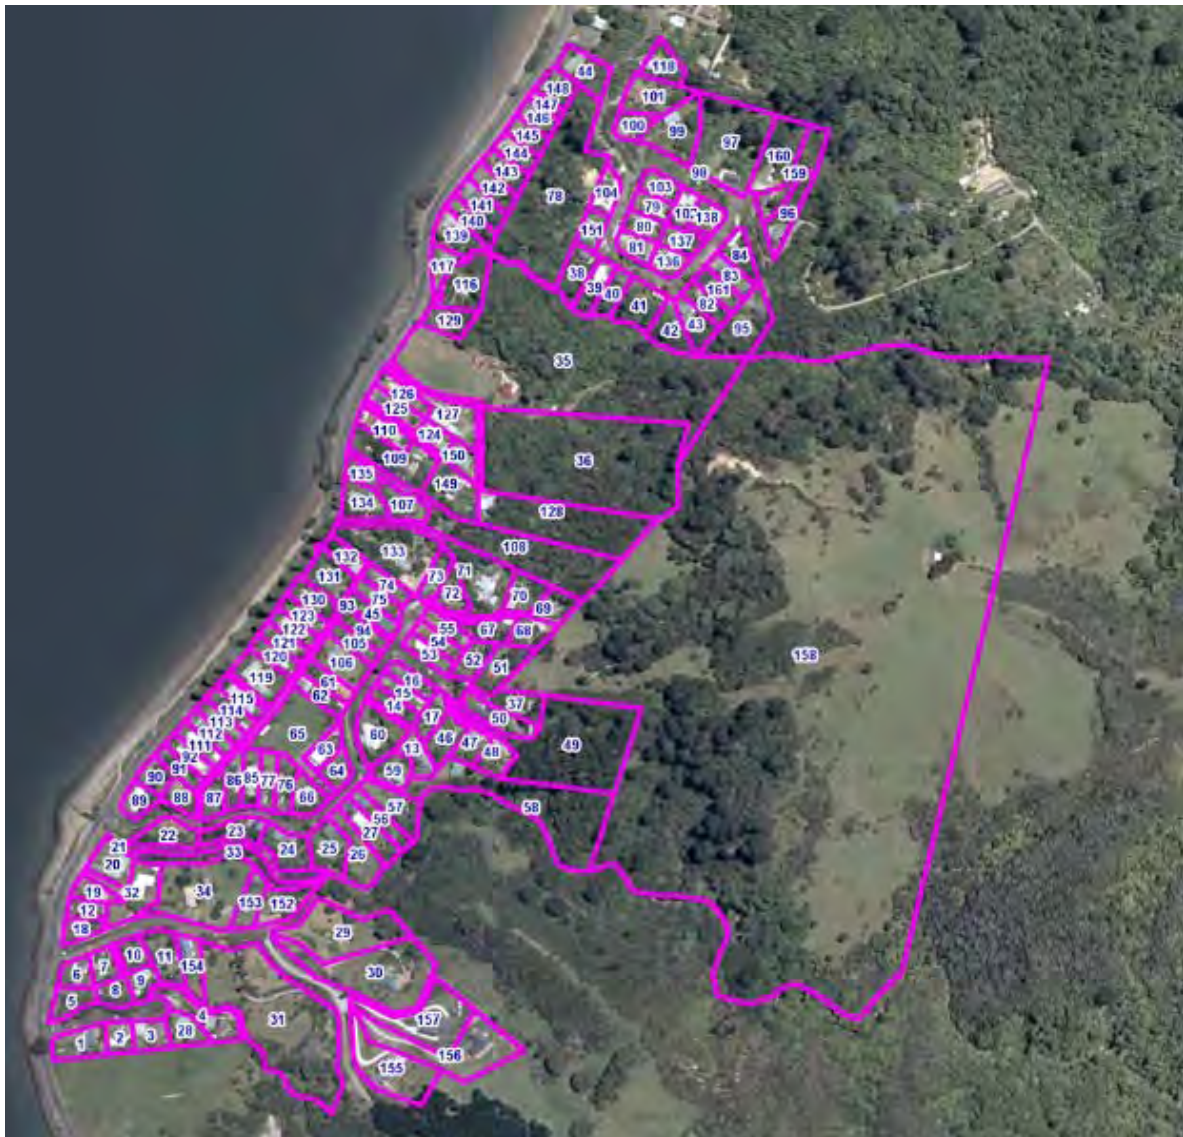
Figure 2 – Proposed survey extent for Ngarimu Bay community

The following map illustrates the Ngarimu survey extent, as supplied by EW to the field survey contractor.

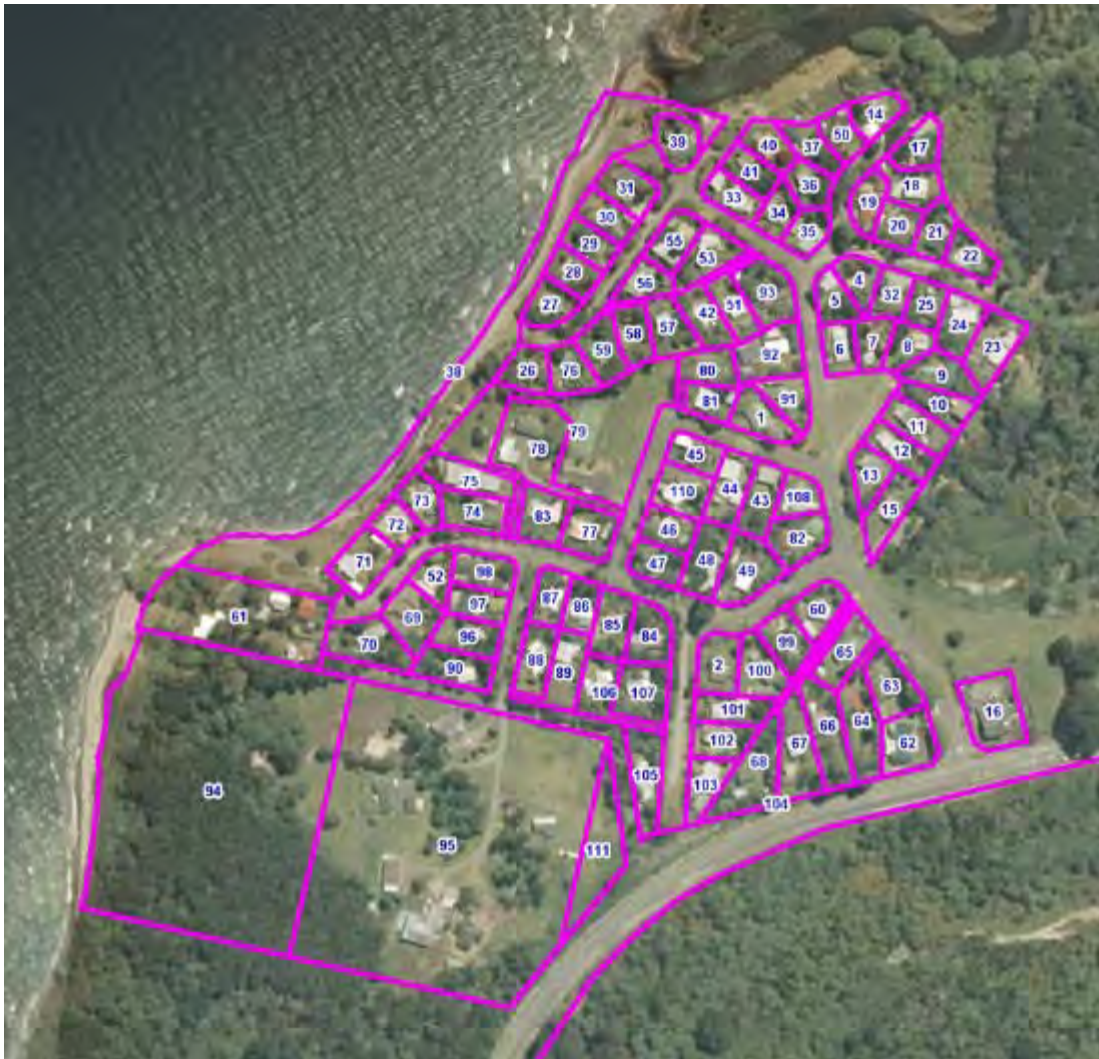
Figure 18 – Proposed survey extent for Hatepe community

The following map illustrates the Hatepe survey extent, as supplied by EW to the field survey contractor.

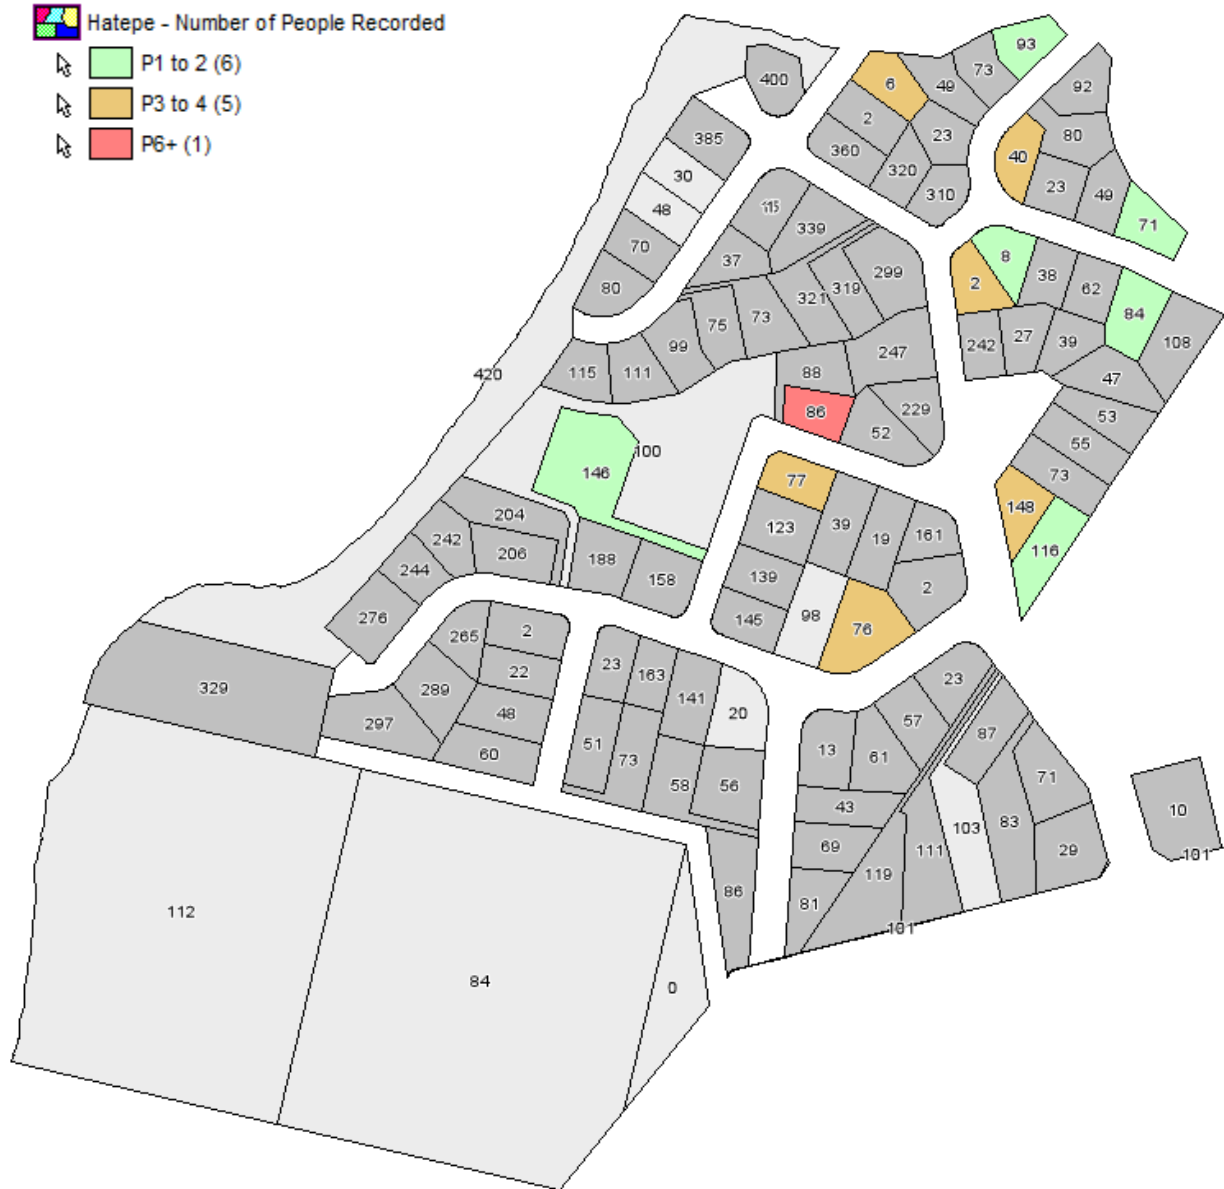
Figure 25 – Field survey recorded number of people per property in Hatepe community

The following map illustrates the field survey results for the number of people for each parcel. Again, parcels with no survey data, no septic tank recorded or no attribute information about septic tank presence, are shown as light grey. Parcels with a septic tank recorded but no people number information recorded are shown as dark grey.

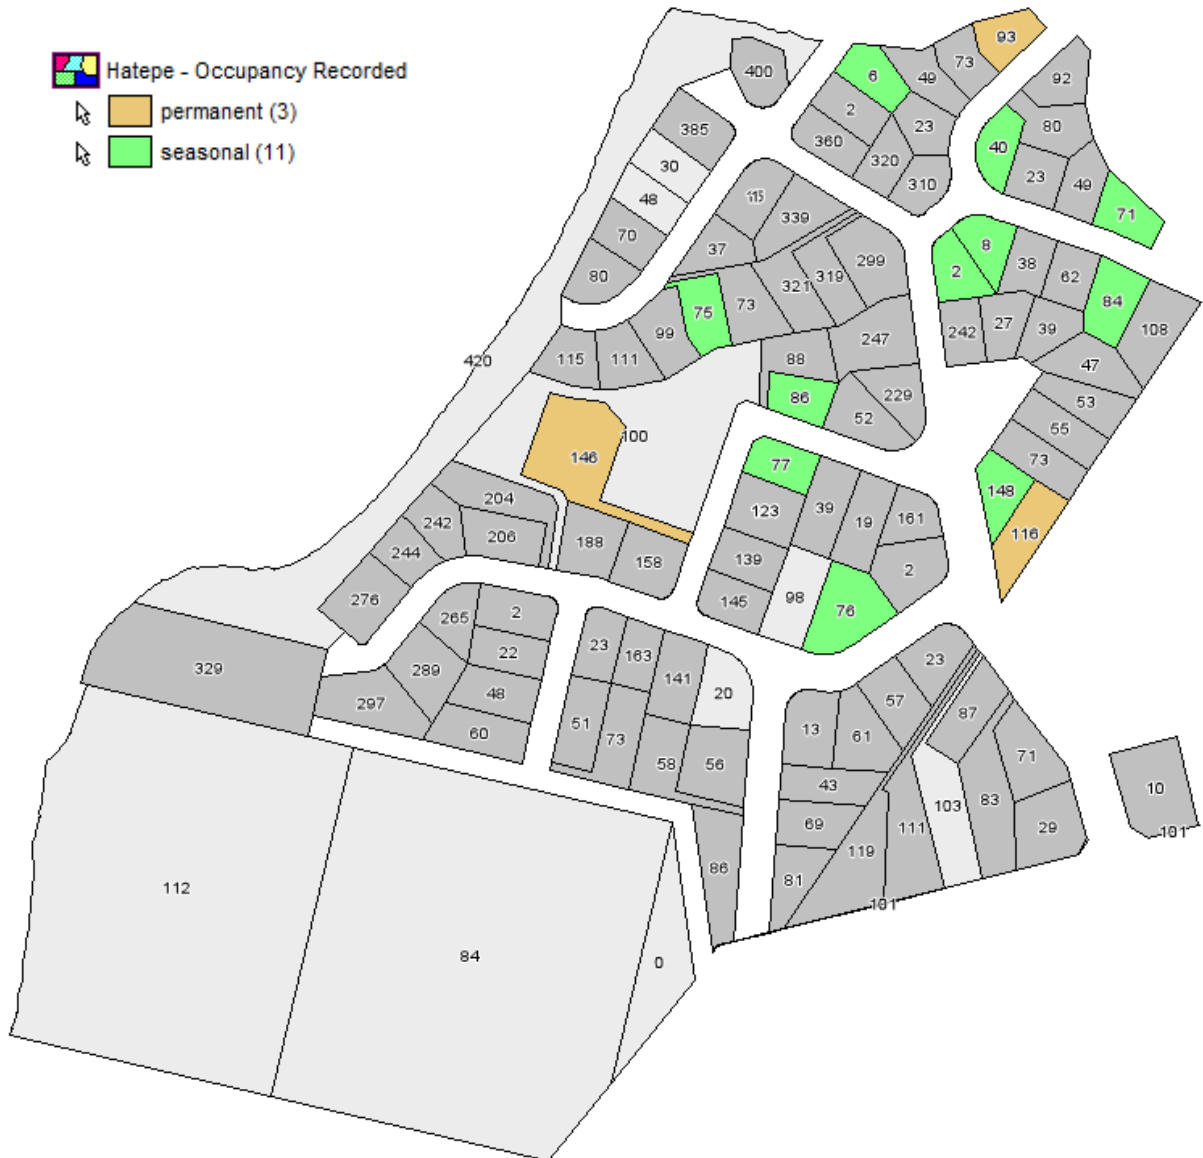
Figure 26 – Field survey recorded occupancy type in Hatepe community

The following map illustrates the field survey results for occupancy for each parcel. Again, parcels with no survey data, no septic tank recorded or no attribute information about septic tank presence, are shown as light grey. Parcels with a septic tank recorded but no occupancy information recorded are shown as dark grey.

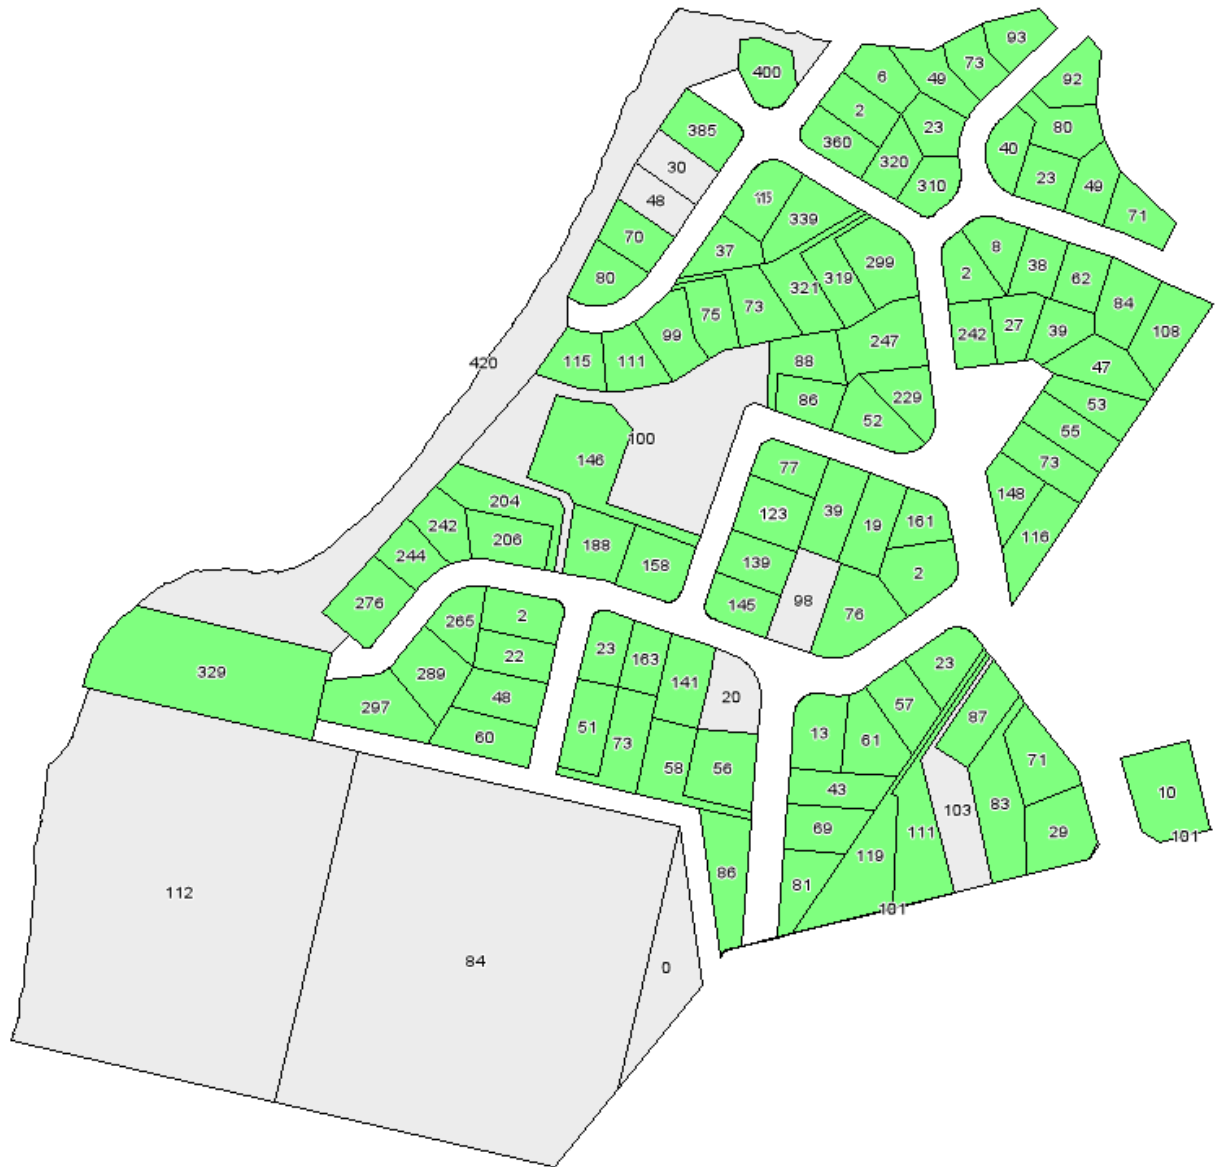
Hatepe - Grass Above Disposal Lines where Septic Tank Recorded
 N (108)

Figure 31 – Field survey grass above disposal lines issue in Hatepe community

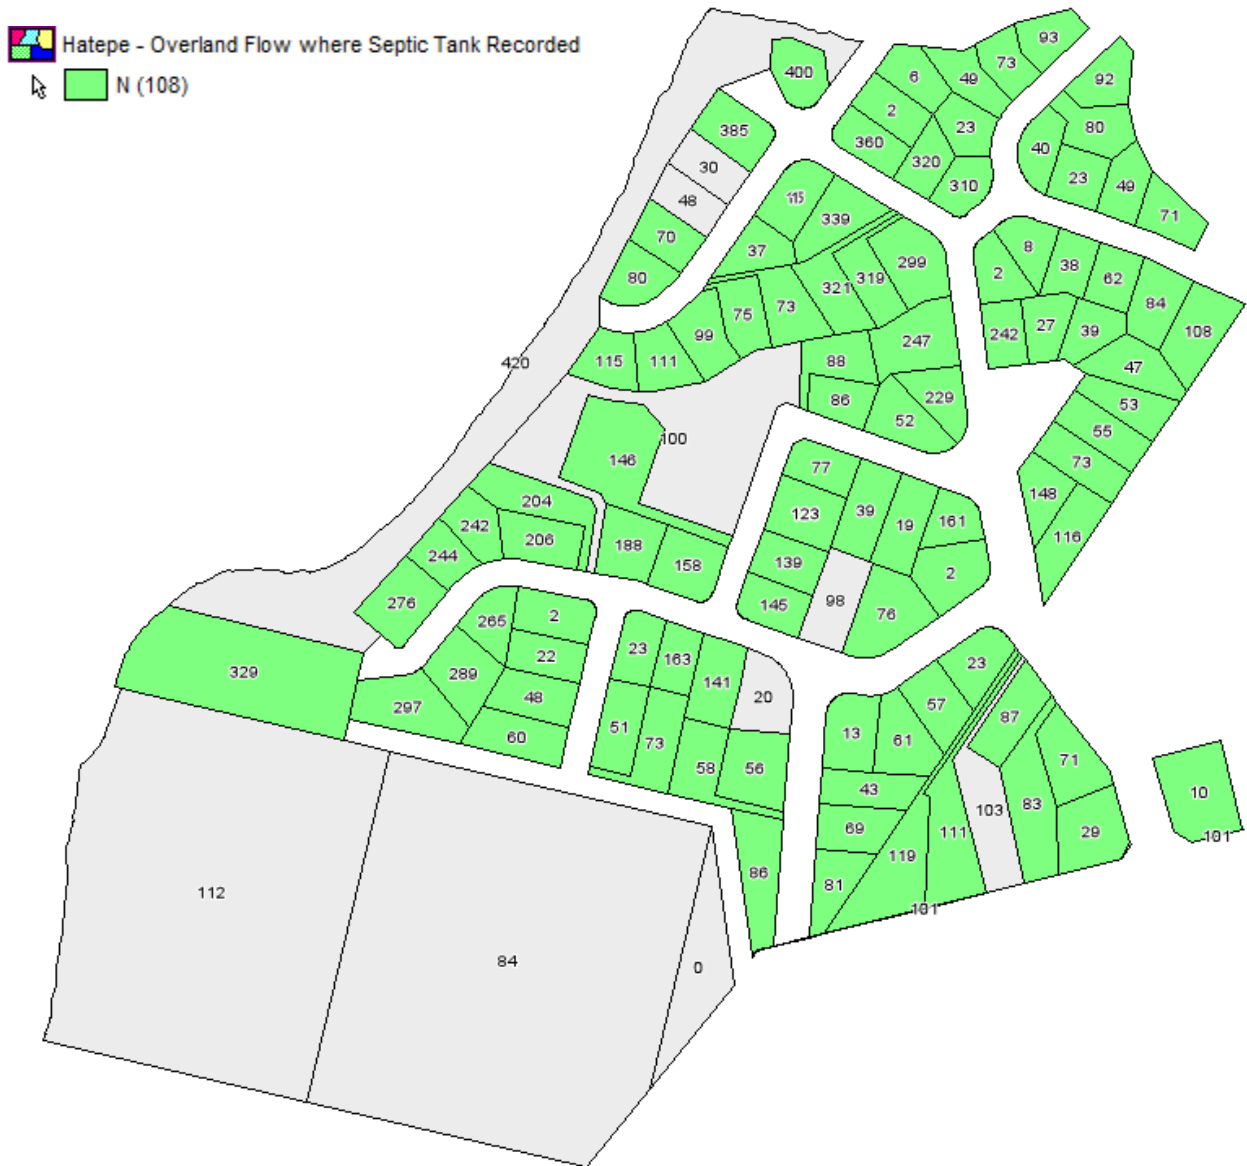
Figure 32 – Field survey overland flow issue in Hatepe community

The following map illustrates the field survey results for overland flow lines for each parcel. Again, parcels with no survey data, no septic tank recorded or no attribute information about septic tank presence, are shown as light grey.

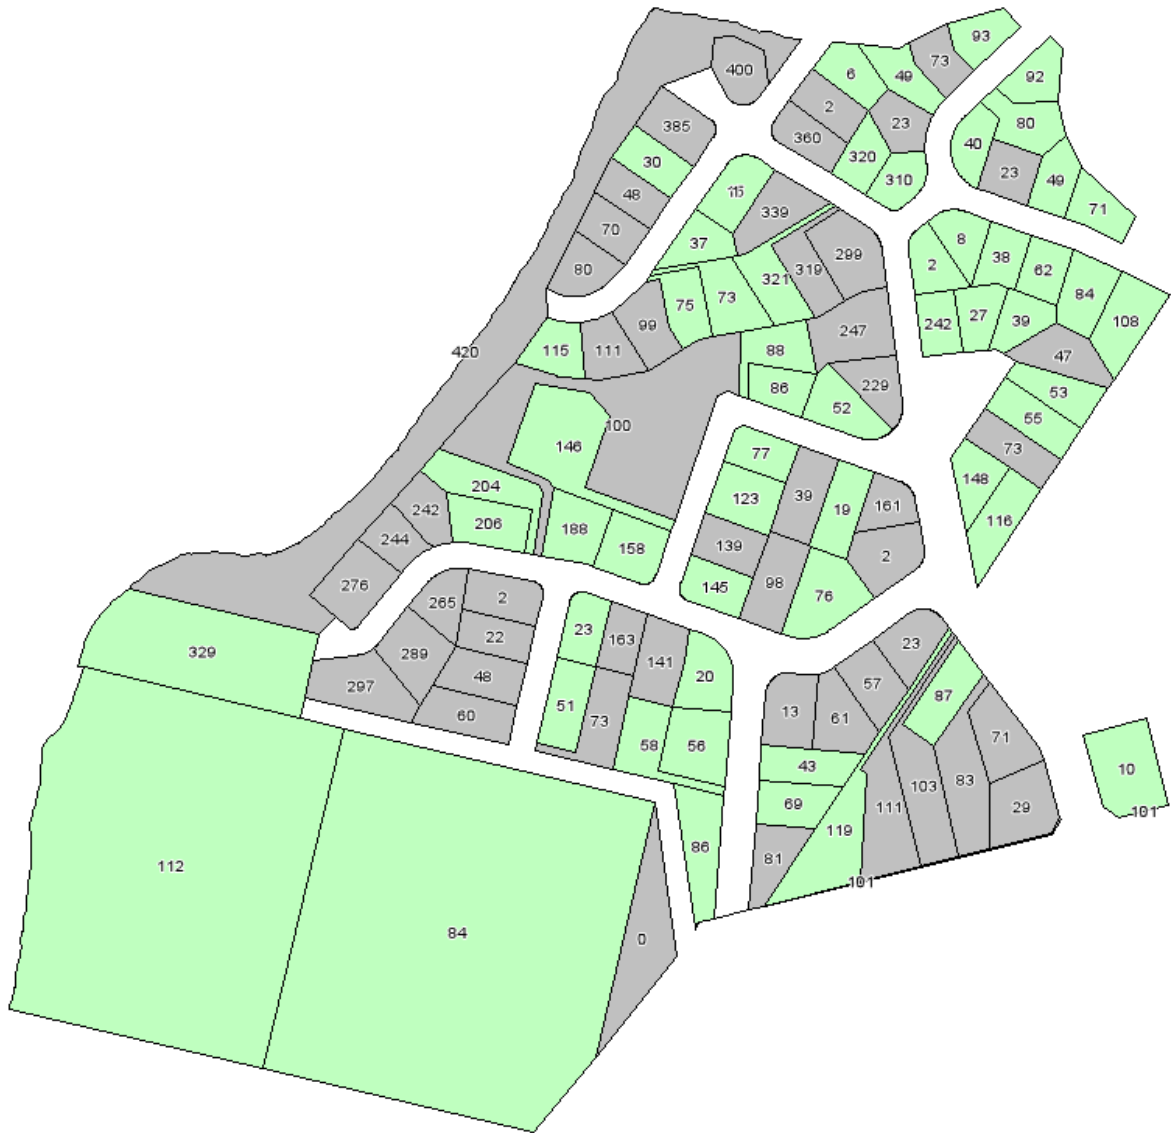
Figure 40 – Household survey responses in Hatepe community

The following plan illustrates the distribution of the responses received for the Hatepe community, where a green property indicates where a response was received and a grey property indicates where no questionnaire response was received.

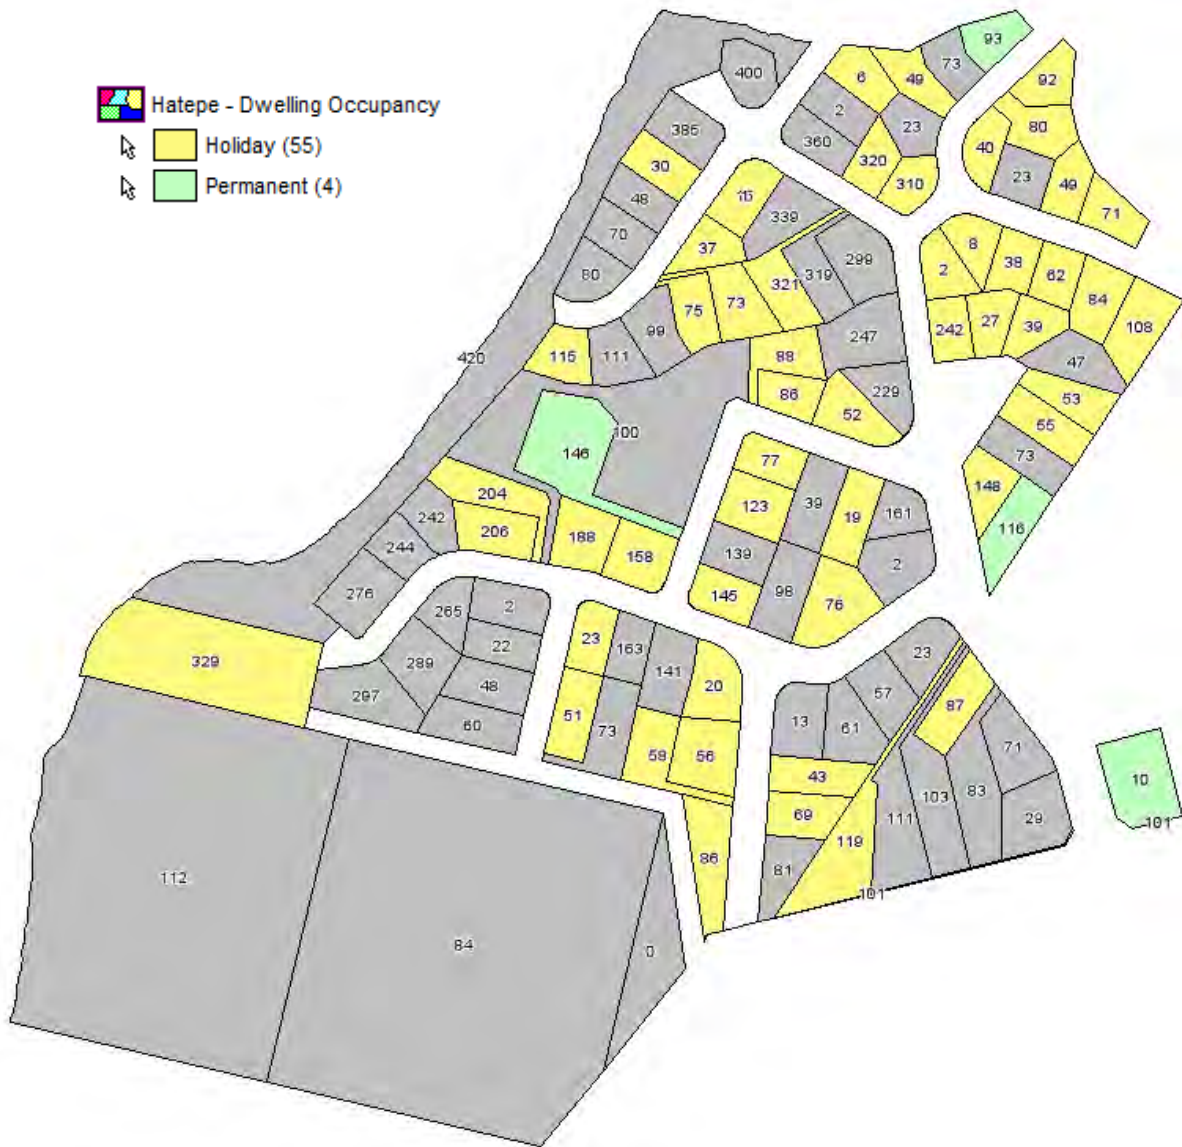
This plan illustrates the breakdown by dwelling type for Hatepe properties where a questionnaire response was received.

Figure 43 – Household survey occupancy type in Hatepe community
