# Pohue flood protection scheme design report

Prepared by: Megan Wood (Wainui Consulting Limited)

For: Waikato Regional Council Private Bag 3038 Waikato Mail Centre HAMILTON 3240

27 September 2013

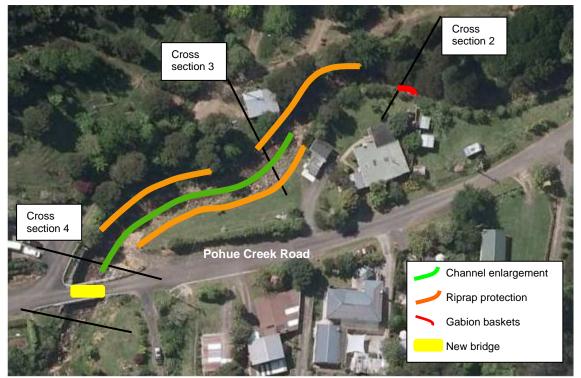
**Completed engineering works at Pohue Stream**

Council assessed what works could be undertaken within this budgetary constraint and works were undertaken as a part of the Peninsula Project during the summer 07/08. The works focussed on the length of stream from the new bridge upward as far as the budget would extend. The works extended along approximate lengths illustrated in the figure below.

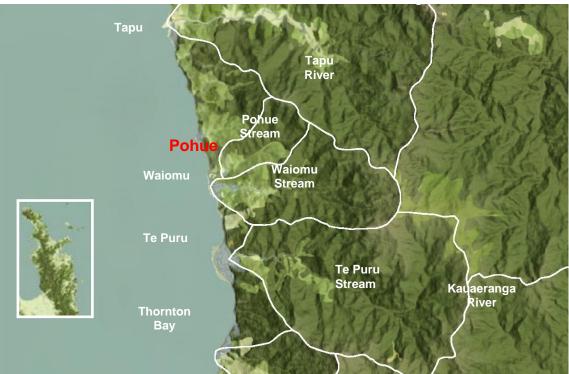
Figure 2 Pohue Stream catchment

The total area of the Pohue catchment equals 350 hectares (or 3.5 square kilometres). Around 96 percent of the catchment is covered by native forest while only 2.9 percent is in farmland. About 77 percent of the catchment is managed by the Department of Conservation (DOC). The urban area adjacent to the Pohue Stream makes up just 0.9 percent of the total catchment. Figure 2 below shows the boundary for the Pohue Stream catchment.

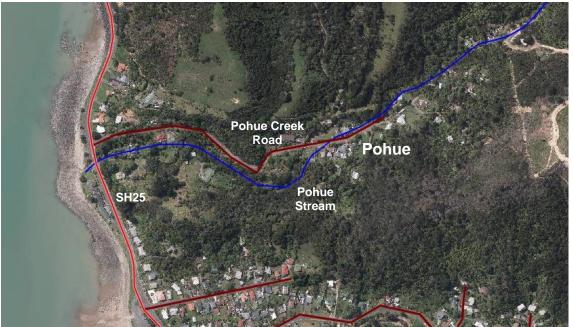
Figure 3 Pohue community

The Pohue Stream flows out of the Coromandel Ranges and through the Pohue community before discharging to the Firth of Thames (refer to Figure 3). The Pohue Stream drains a very steep, hilly area, and the stream channel is deeply incised as a result. The stream is fed by approximately eight smaller tributary streams that are also deeply incised. During periods of heavy rain it takes about 30 minutes for water to get from the top of the catchment to the bottom.

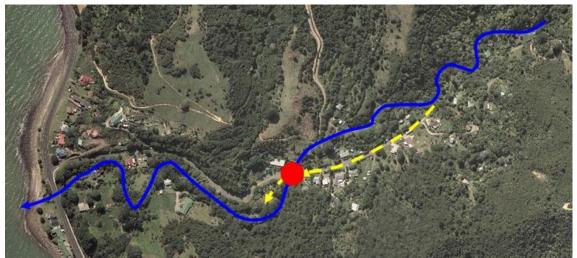
Figure 4 Predominant flooding mechanism at Pohue

During significant rain events the Pohue Stream breaks out of its banks and flows along Pohue Creek Road before re-entering the stream downstream of Pohue Creek Road crossing. A portion of the Pohue community is subject to a significant flood hazard from Pohue Stream. Figure 4 below illustrates the predominant flooding mechanism.

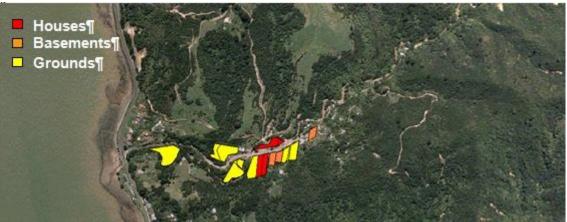
Figure 5 Property damage within the Pohue community during the 'Weather Bomb'

Figure 5 below illustrates the damage sustained to properties in the Pohue community during the 'Weather Bomb'. Damage within the Pohue community is focused on those properties located on the true left bank of the Pohue Creek.

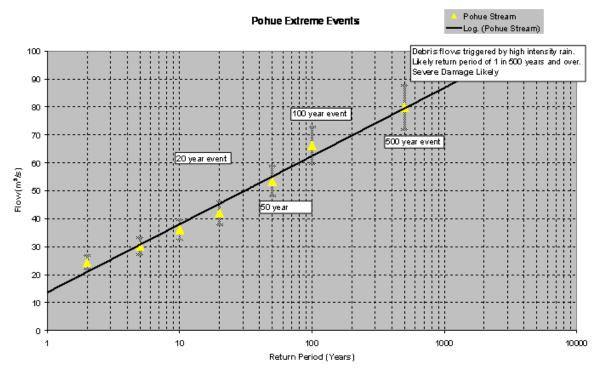
Figure 6Pohue Stream flood frequency graph

Using the Rational Method and using the physical characteristics as described above, a hydrological assessment was undertaken. A summary of the hydrological assessment completed for the Pohue Stream catchment is presented in the following figure.

This hydrological data was then used to inform the hydraulic assessment of the Pohue Stream.

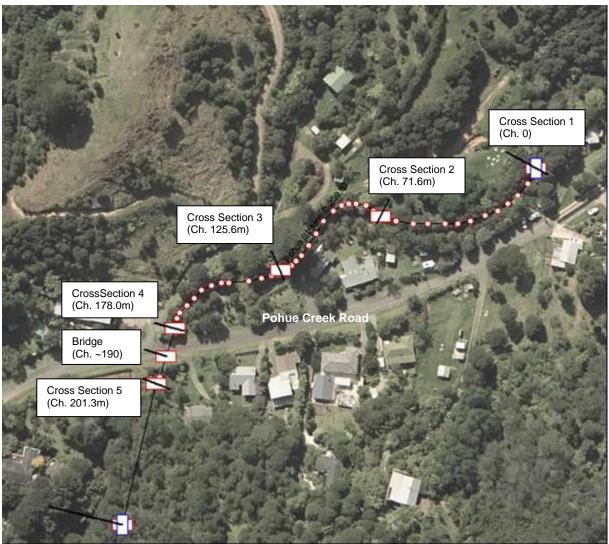
Figure 7 Location of works

Channel excavation works were proposed upstream of the new bridge. The existing channel had sufficient capacity at Cross Section 5; hence only minor works were required at this location to tie the bridge structure into the stream channel. Figure 7 below illustrates the location of works.

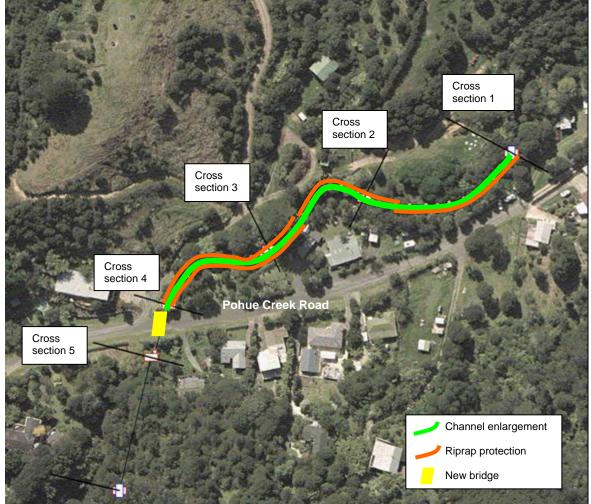
Figure 8 Proposed engineering works at Pohue Stream

3. Riprap protection (lower reach) <u>both sides</u> of the channel from a point 20m upstream of cross section 3 to cross section 4 (80m length).

The works are summarised in Figure 8 below. Further design details are provided in Appendix 1. Also refer to WRC DM#1073191 for design calculations.

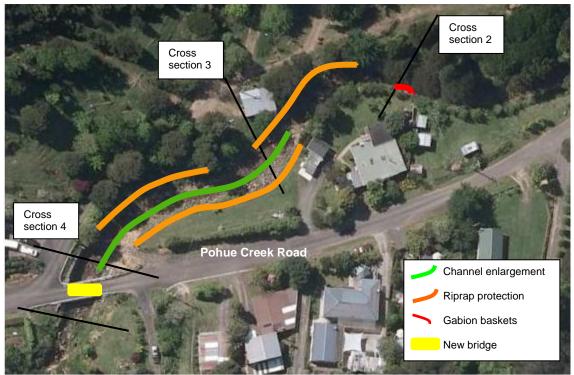
Figure 9 Completed engineering works at Pohue Stream

Council assessed what works could be undertaken within this budgetary constraint and works were undertaken as a part of the Peninsula Project during the summer 07/08. The works focussed on the length of stream from the new bridge upward as far as the budget would extend. Summer 2011/12, some gabion baskets were placed on the left bank of the stream in the vicinity of Cross section 2 to help provide bank stability. The works extended along approximate lengths illustrated in Figure 9 below.

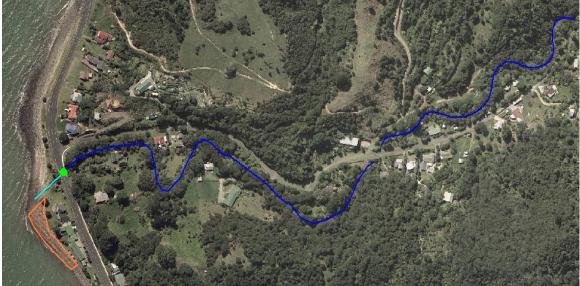
Figure 10 Extent of channel maintenance

The main channel of the Pohue Stream is monitored and periodically maintained by the Waikato Regional Council to remove accumulated sediment and debris (refer to Figure 10 for extent of maintenance). This work maintains the capacity of the Pohue Stream and reduces the risk to adjacent land that would otherwise be inundated more frequently, and also helps to maintain the performance of the flood protection scheme.

- The stream is walked over at least once a year to undertake a condition survey.
- Removal of accumulated gravel, sand and debris from a 560 m section of the Pohue Stream (refer to diagram for proposed extent).

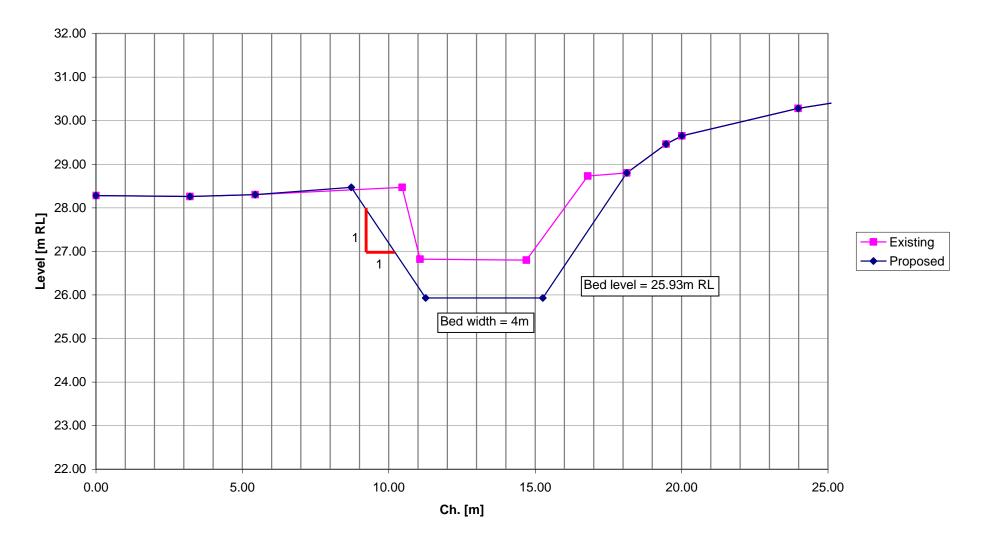
### Existing vs Excavated - Cross Section 2 (Ch. 71.6m)

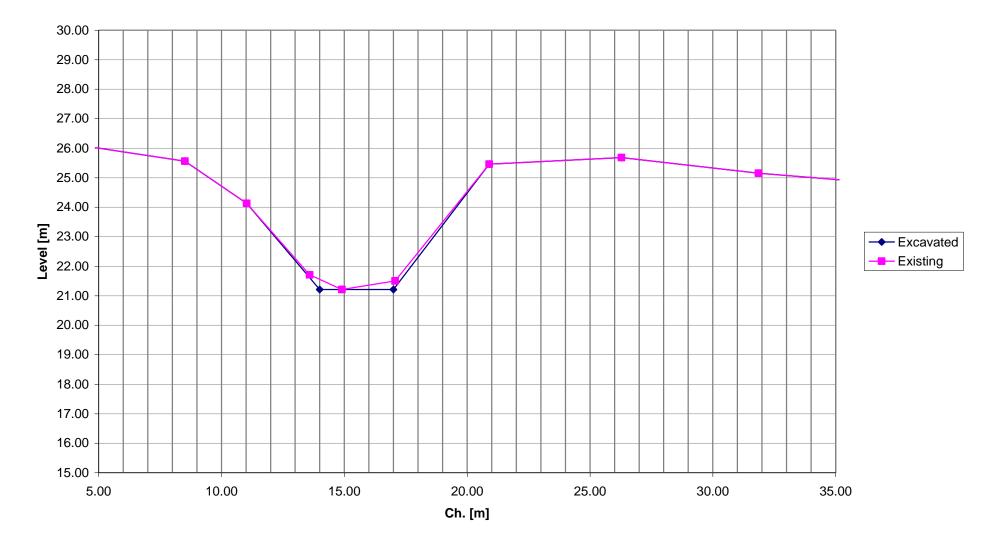
## Existing vs Excavated - Cross Section 4 (Ch. 178.0m)
