Ground penetrating radar survey of buried sinter at Armstrong Reserve, Waipahihi

Prepared by:
Bridget Lynne, Isaac J Smith and Gary J Smith (Geothermal Scientific Investigations Ltd)

For:
Waikato Regional Council
Private Bag 3038
Waikato Mail Centre
HAMILTON 3240

June 2020

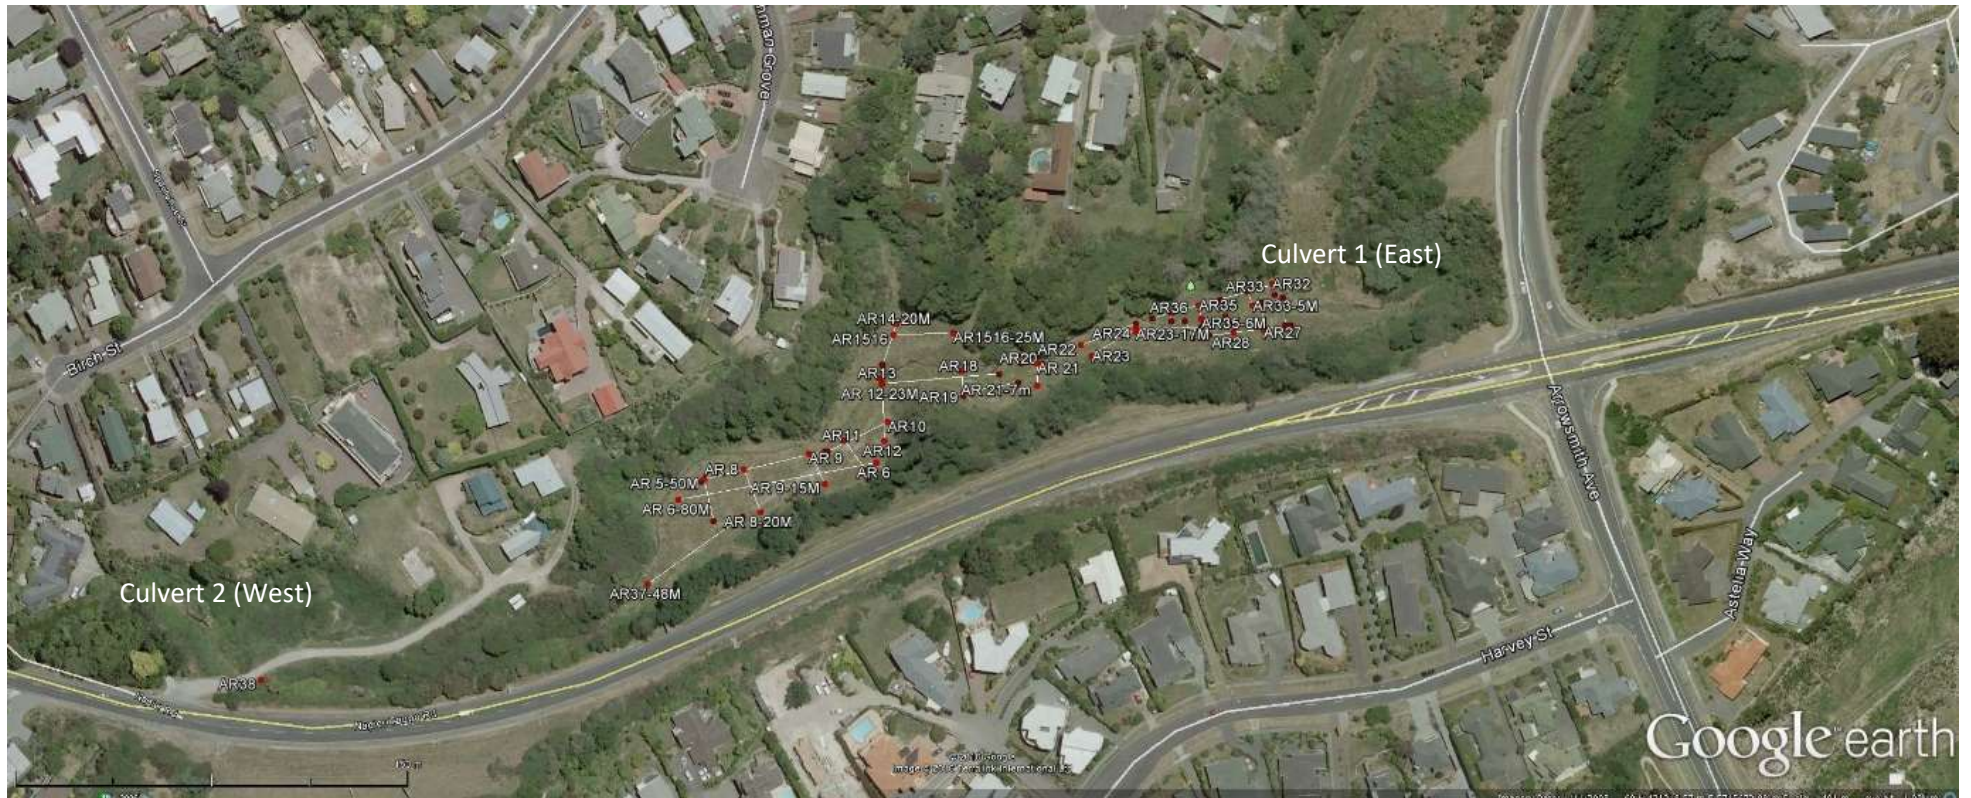
Figure 2: Overview of all GPR transect lines and their distribution at Armstrong Reserve.

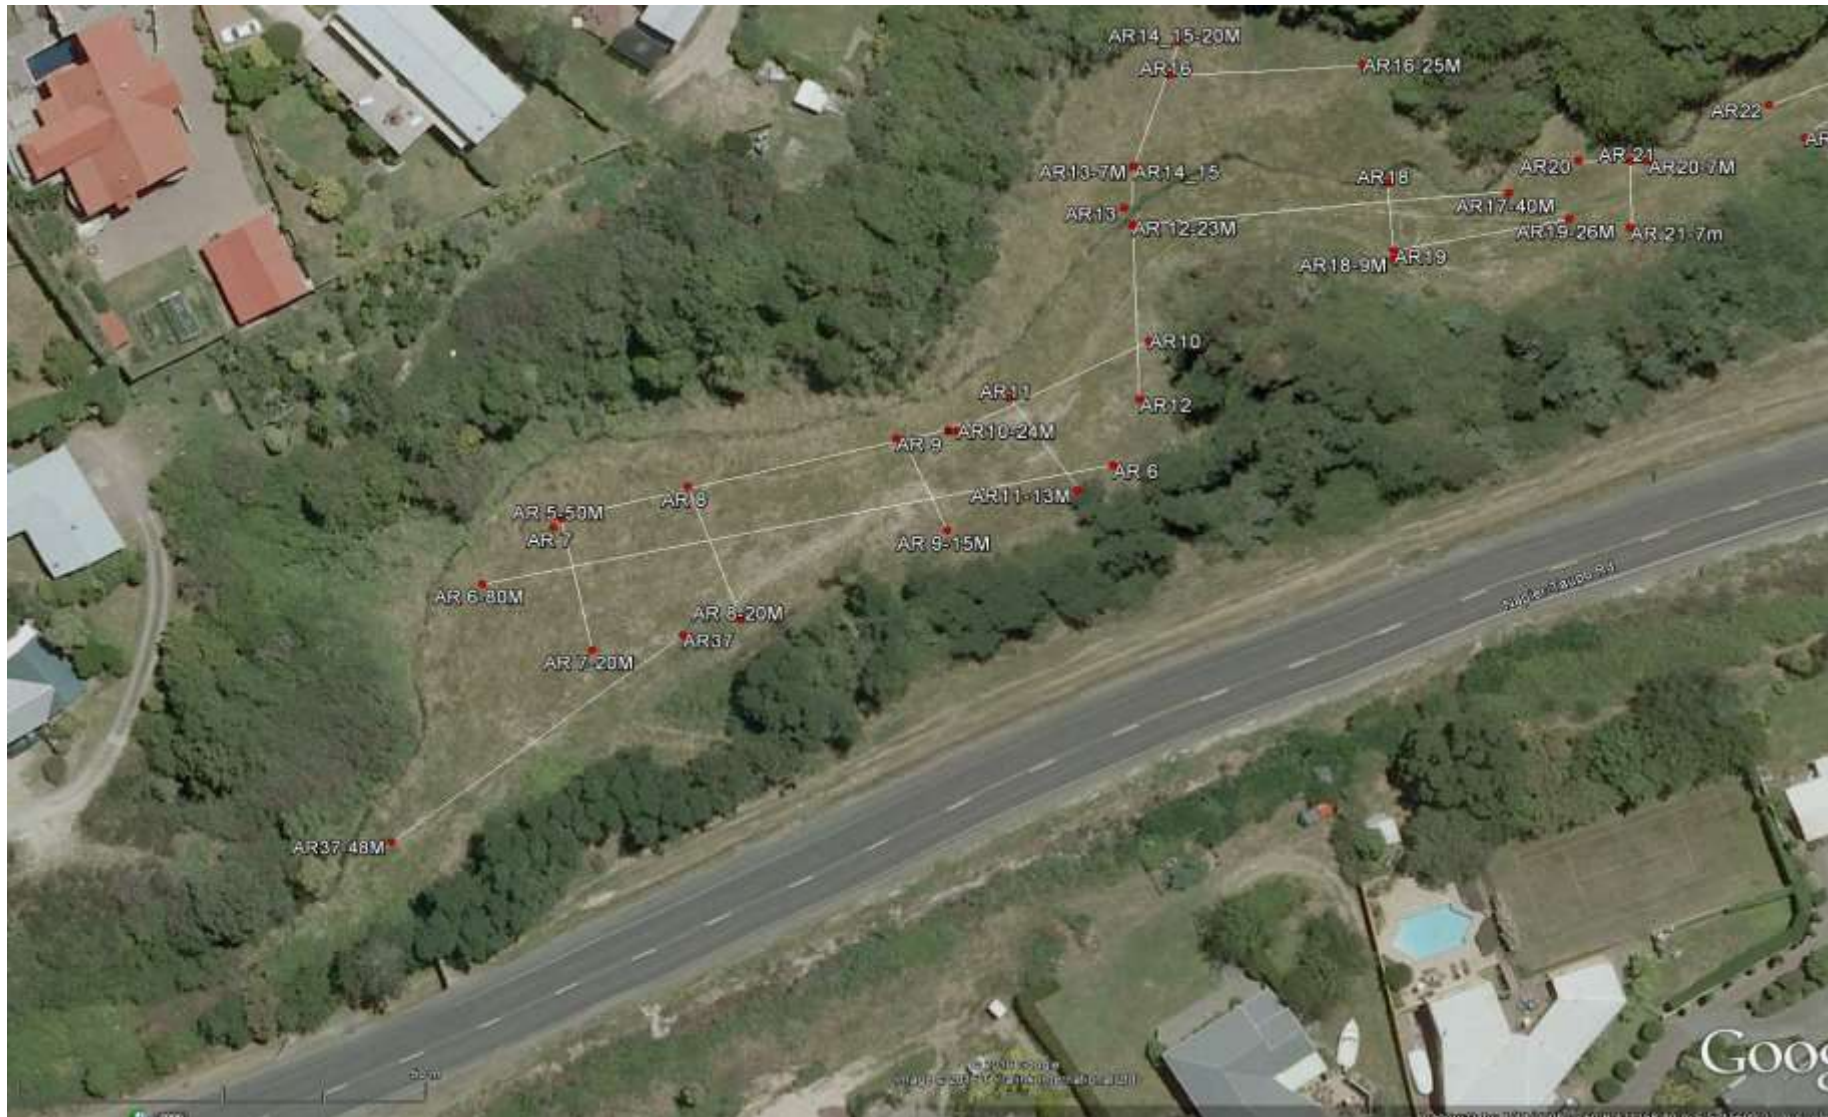
Figure 3: Overview of the western section of the study area showing individual GPR transect lines.

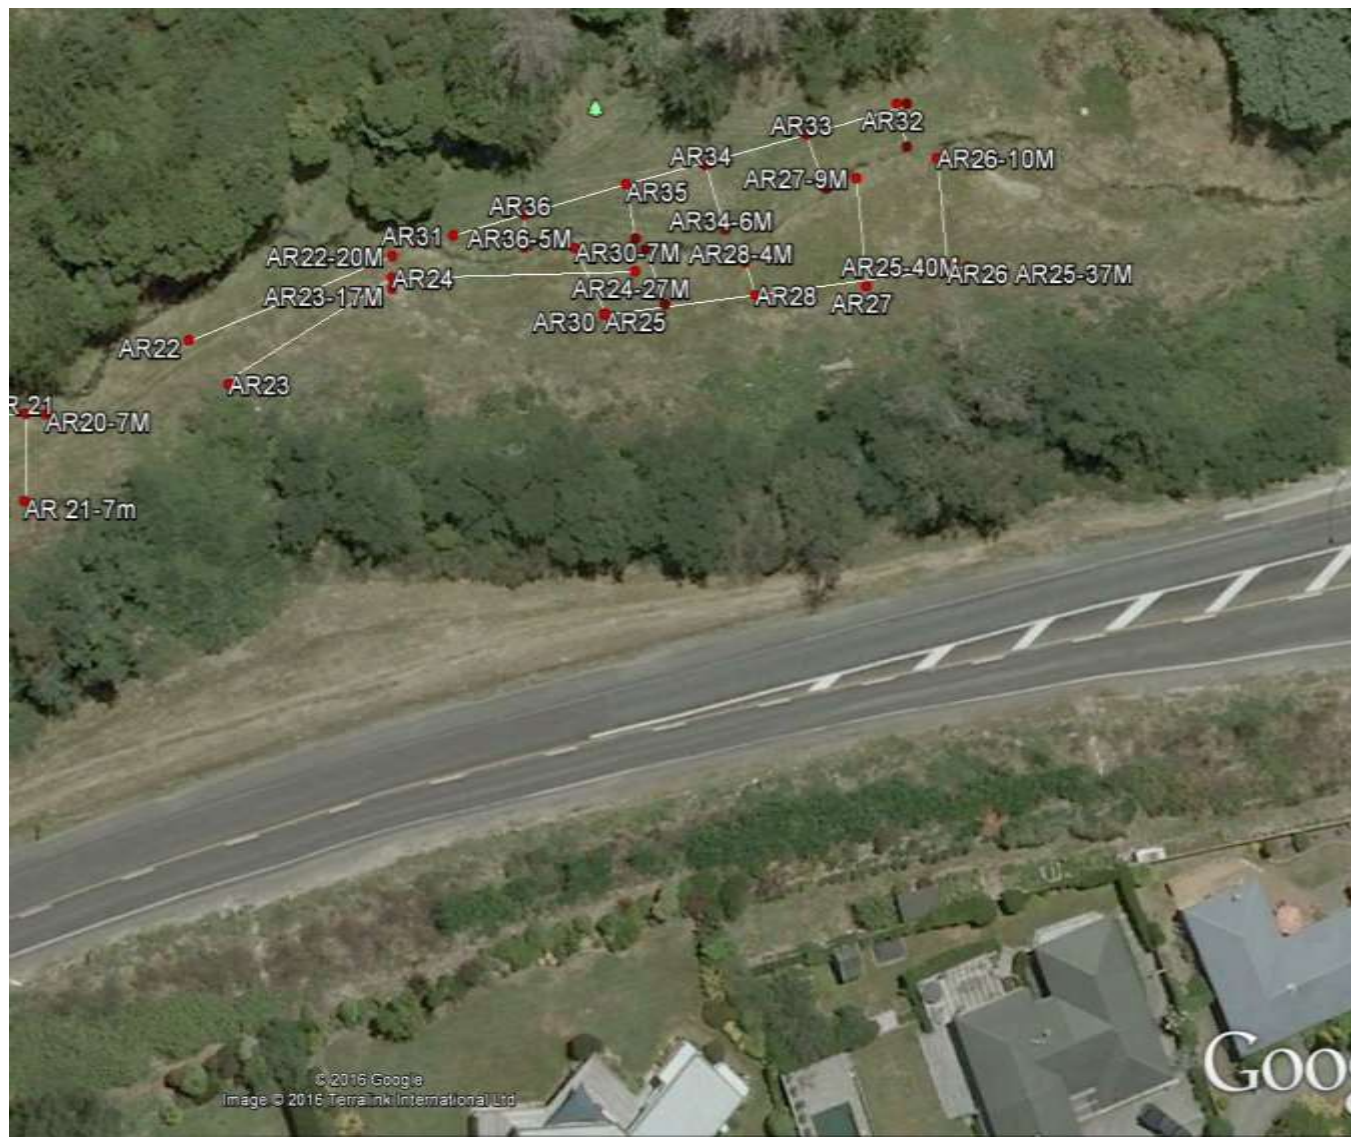
Figure 4: Overview of the eastern section of the study area showing individual GPR transect lines.

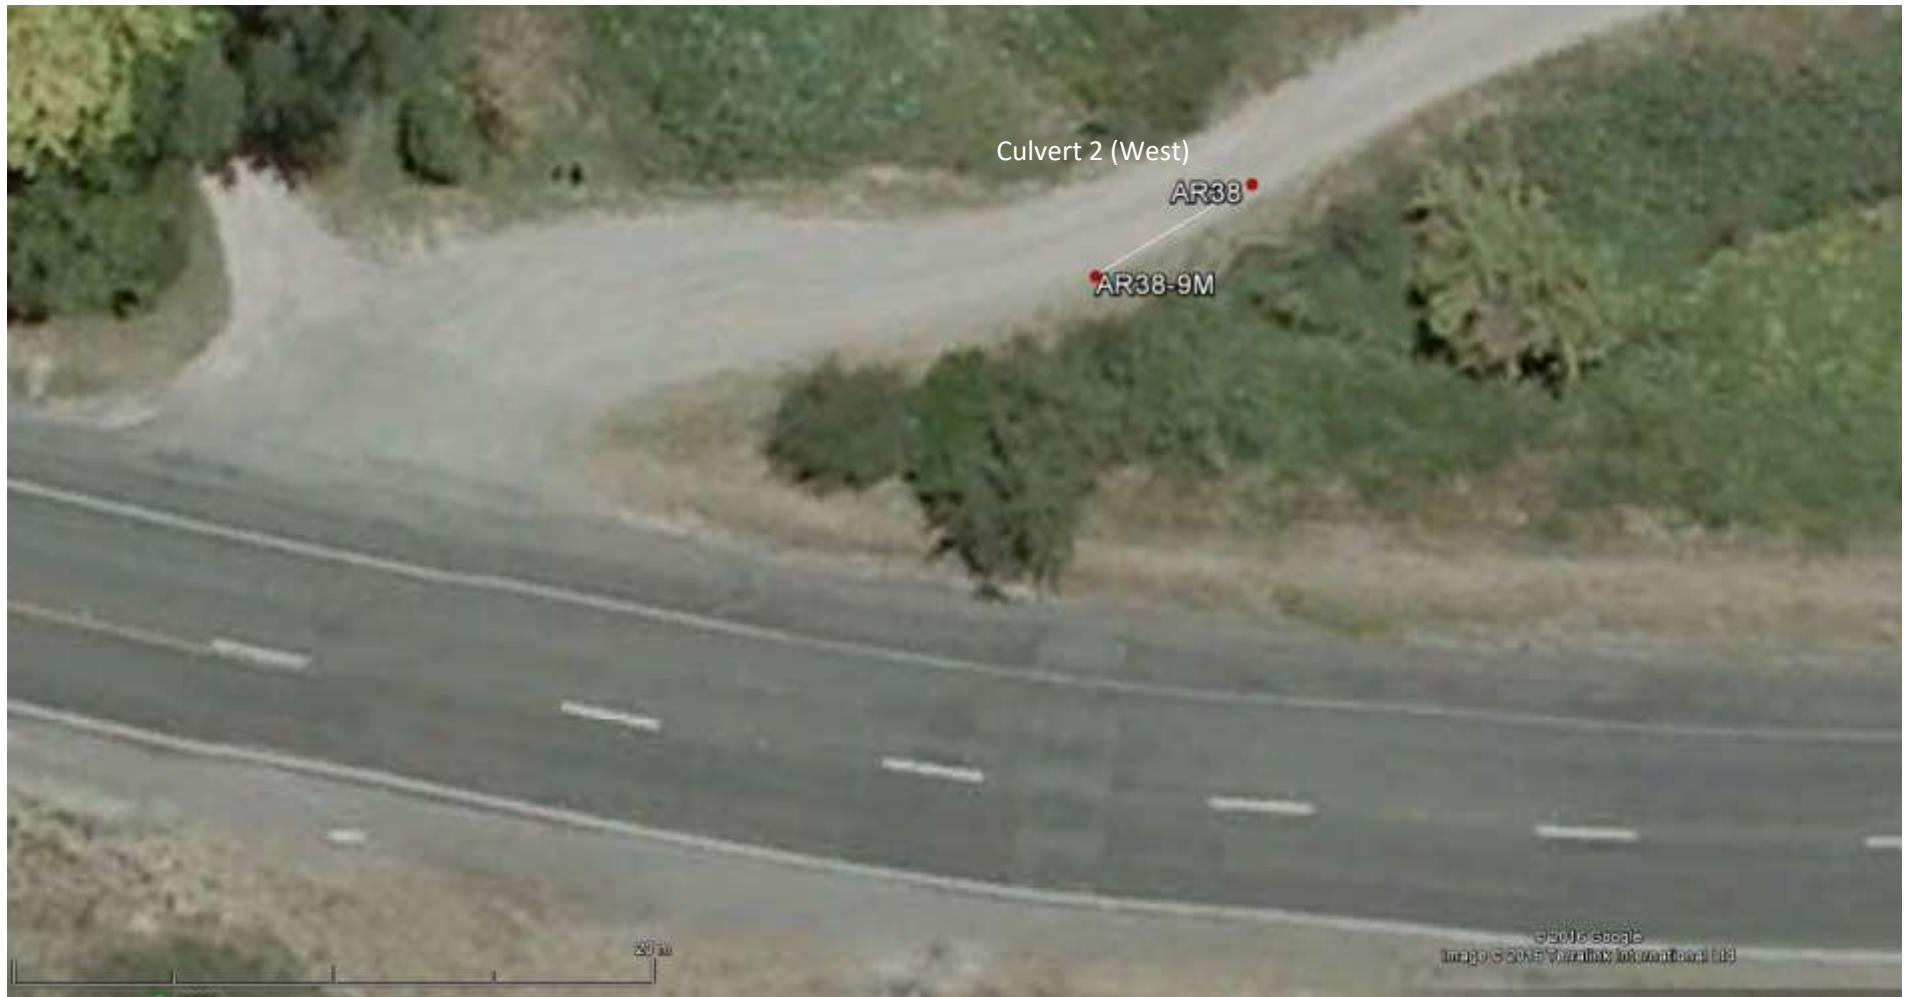
Figure 5: Location of transect 038 over the western-most culvert.

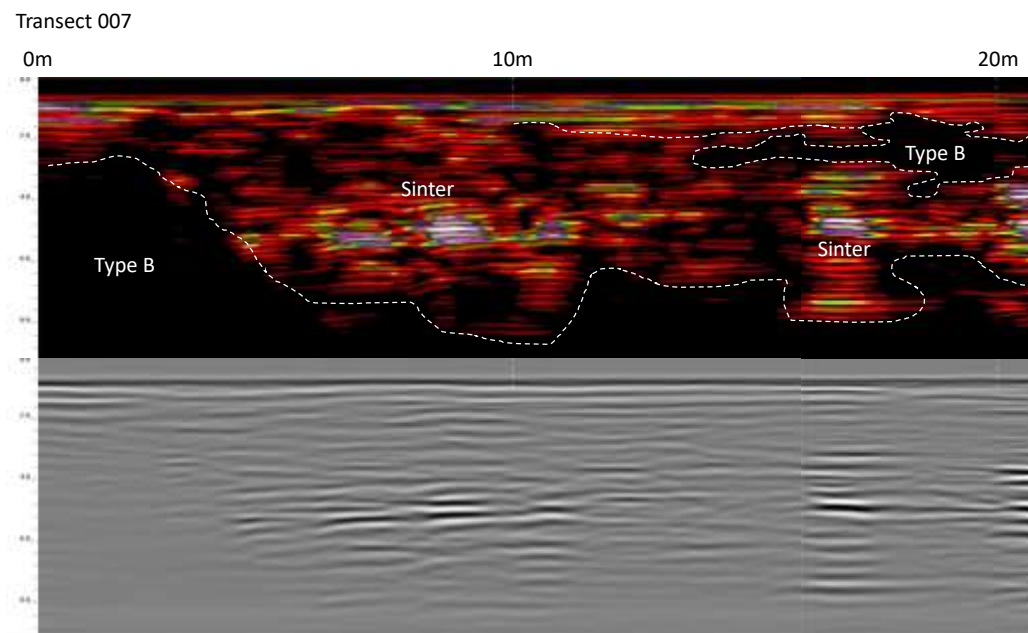
7.3 Transect 007

Figure 9: Transect 007. 20 m profile line. Sinter thickens between 0 and 5 m, with thick (up to ~ 8 m) horizontal sinter layers from 5 to 20 m.

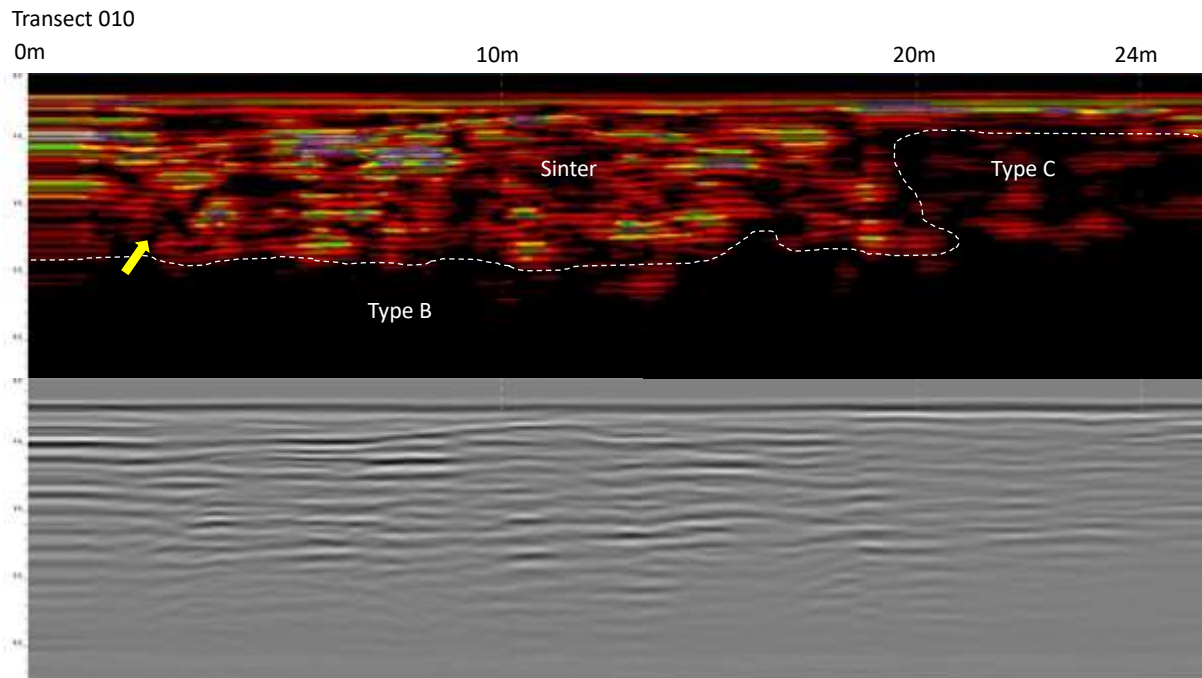
7.6 Transect 010

Figure 12: Transect 010. A 24 m long profile line showing sinter horizons between 0 and 20 m to a depth of ~6 m. From 20 to 24 m the sinter thins to ~ 1 m and Type C dominates this zone. Sinter layers are fractured (yellow arrow). Type B is present below the sinter.

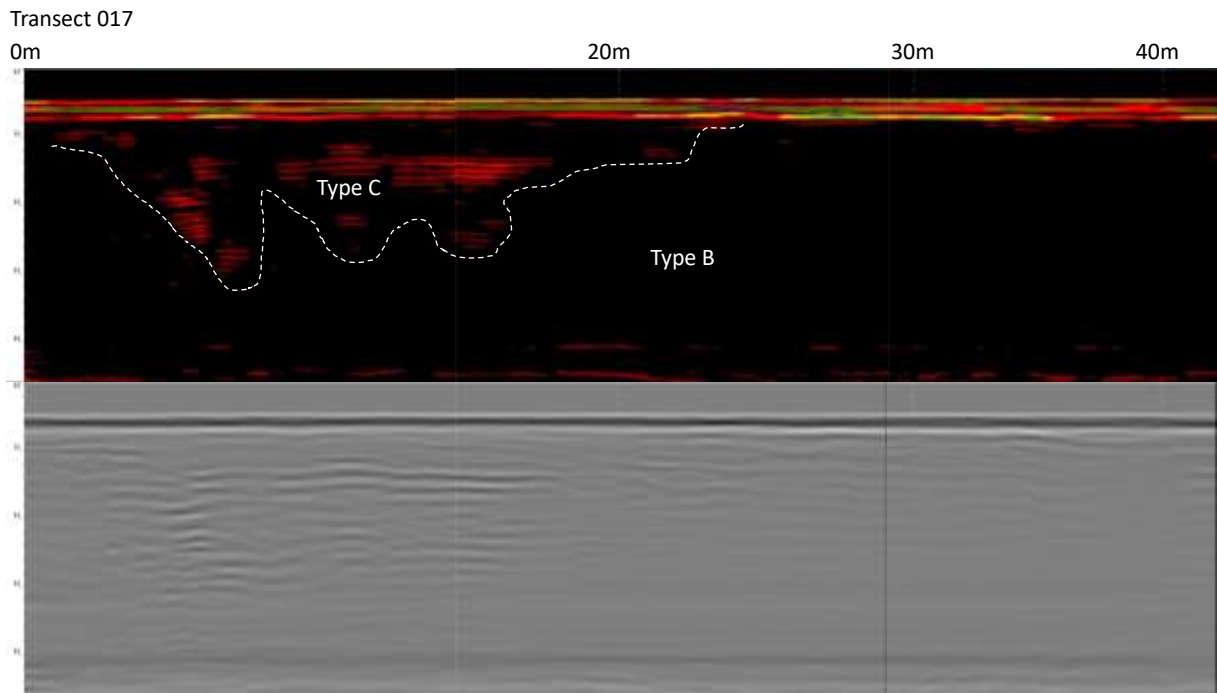
7.13 Transect 017

Figure 19: Transect 017. 40 m transect line. Type C is present between 0 and 20 m, varying from ~1 to 4 m depth. Type B occurs between 25 and 40 m at the surface and underneath Type C from 0 to 25 m.

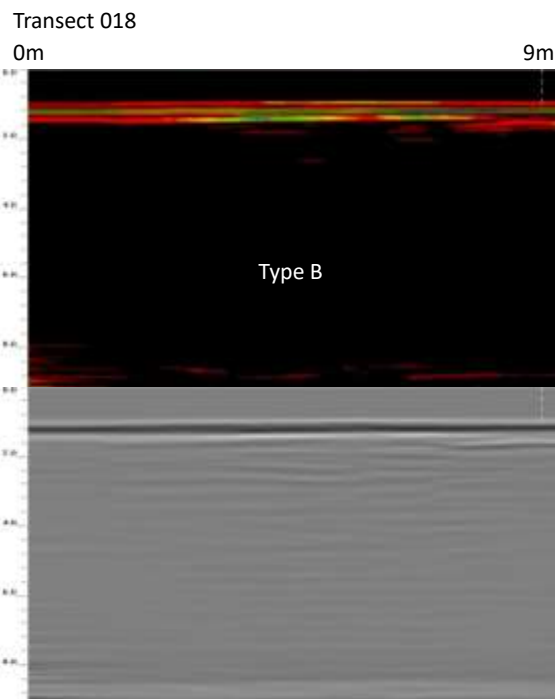
7.14 Transect 018

Figure 20: Transect 018. 9 m long profile showing Type B material.

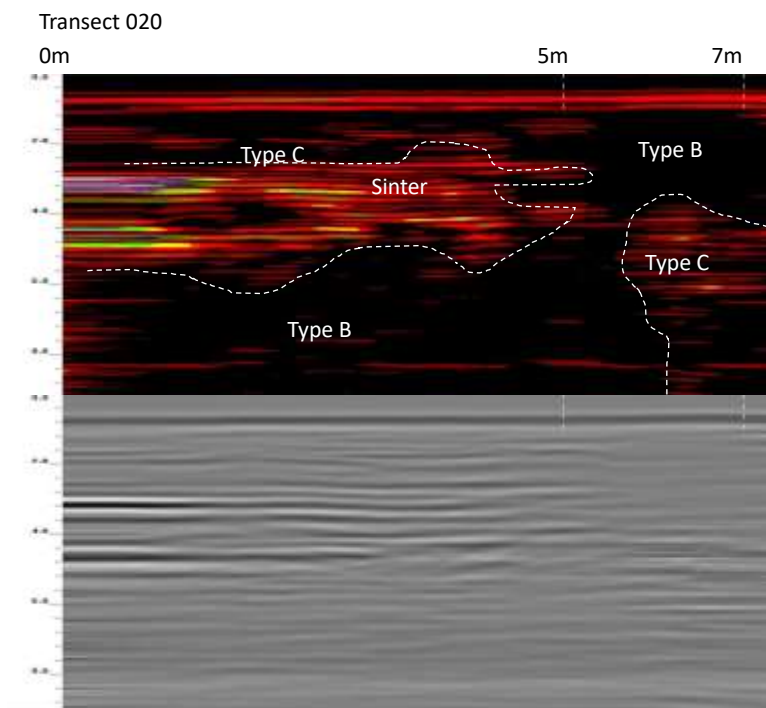
7.16 Transect 020

Figure 22: Transect 020. 7 m profile line. Horizontal sinter sheets are present at ~3 to 6 m depth and extend horizontally for 5 m. The sinter is surrounded by Type B and Type C material.

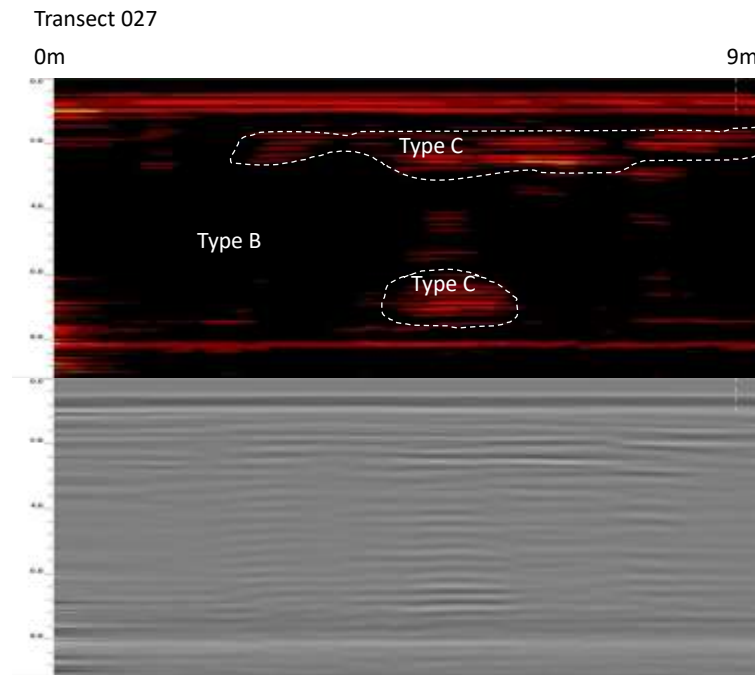
7.23 Transect 027

Figure 29: Transect 027. 9 m transect line. No strong sinter reflectors were imaged in this area. Small zones of Type C occur from 3 to 9 m, but the area is dominantly Type B.

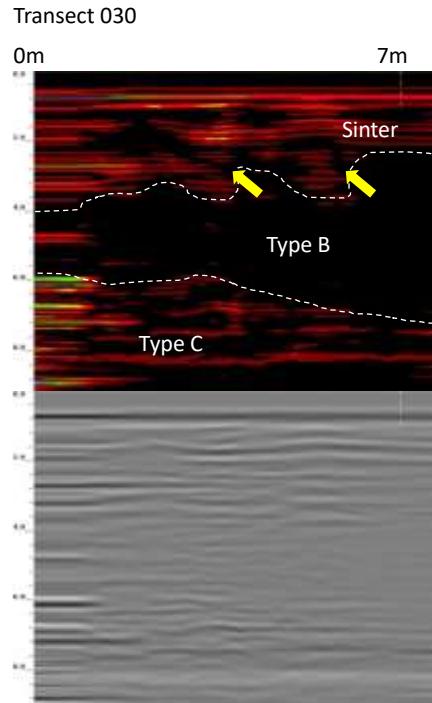
7.26 Transect 030

Figure 32: Transect 030. 7 m transect line. Sinter was identified along the transect line to a depth of ~ 4 m. Two fractures within the sinter with similar orientations are shown by the yellow arrows. Type B is immediately below the sinter, and Type C is below the Type B material.

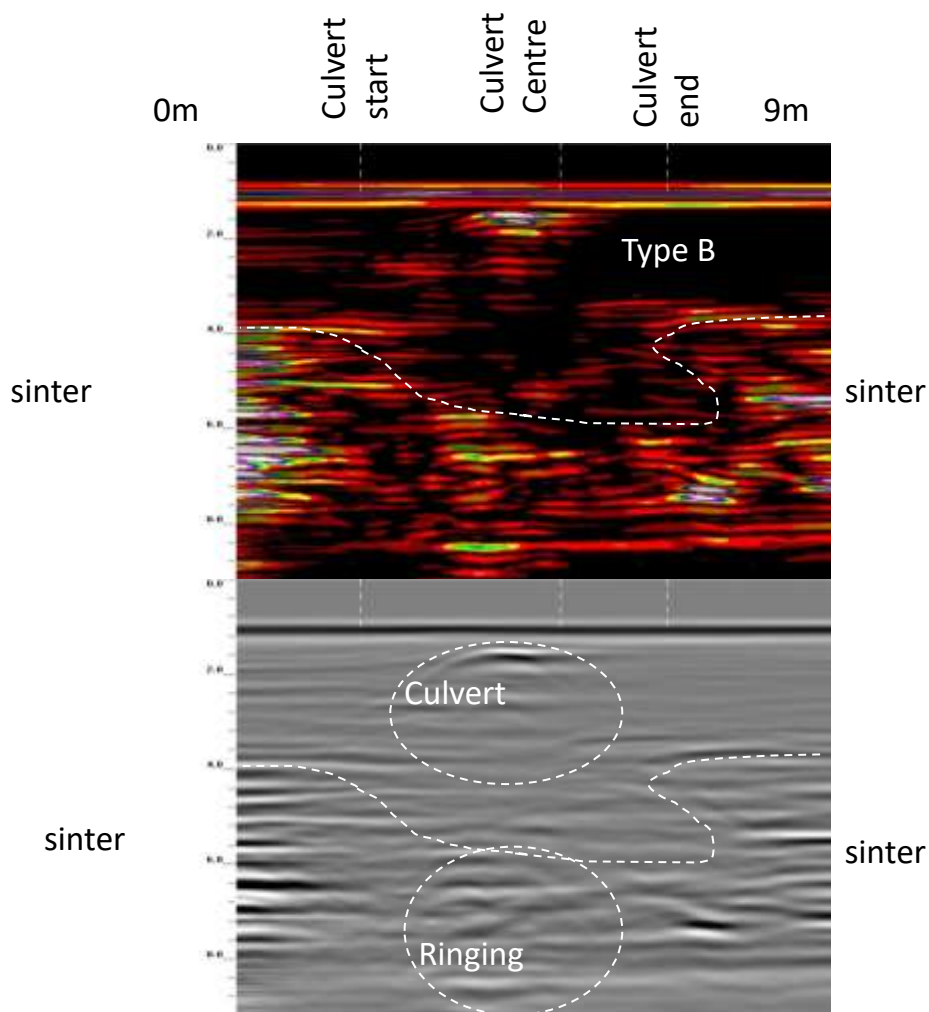
7.34 Transect 038

Figure 40: Transect 038. 9 m long profile. The upper 4 to 5 m depth is Type B. Sinter is imaged to the left and right below 4m depth. To the immediate left and right of the dotted white line designating both the culvert and ringing zones, images typical of saturated sub-surface conditions are visible. Given transect 038 is perpendicular to the topographic stream flow, it is possible these are subsurface water flow channels. It is not possible to tell from this image whether the possible flow pathways are naturally made or anthropogenic in nature. The culvert was identified by the hyperbolic reflections at the 4 m mark.

Culvert 2 (Western) was proposed to have a fractured sinter bed due to the installation of the culvert. No strong sinter reflectors were imaged on either side of the culvert at shallow depths (4 m). A potential sinter horizon was imaged below the base of the culvert, with strong reflectors at the south-western and north-eastern sides and weaker signatures in the middle. This weak signal return could be due to either; present-day or historic steam alteration, or present-day water saturation. There is also the possibility that the central faded area consists of another material (i.e., not sinter). However, this is less likely as the GPR reflections appear to be continuous along the profile. Ringing from the culvert pipe further complicates the interpretation directly under the culvert. Given Transect 038 lies perpendicular to the natural topographic water flow of the Onekeneke stream, it is probable that the central faded area imaged, is showing sub-surface water flow pathways. It is not possible from the GPR image to determine whether these potential flow paths beneath the culvert have formed by natural or anthropogenic means.

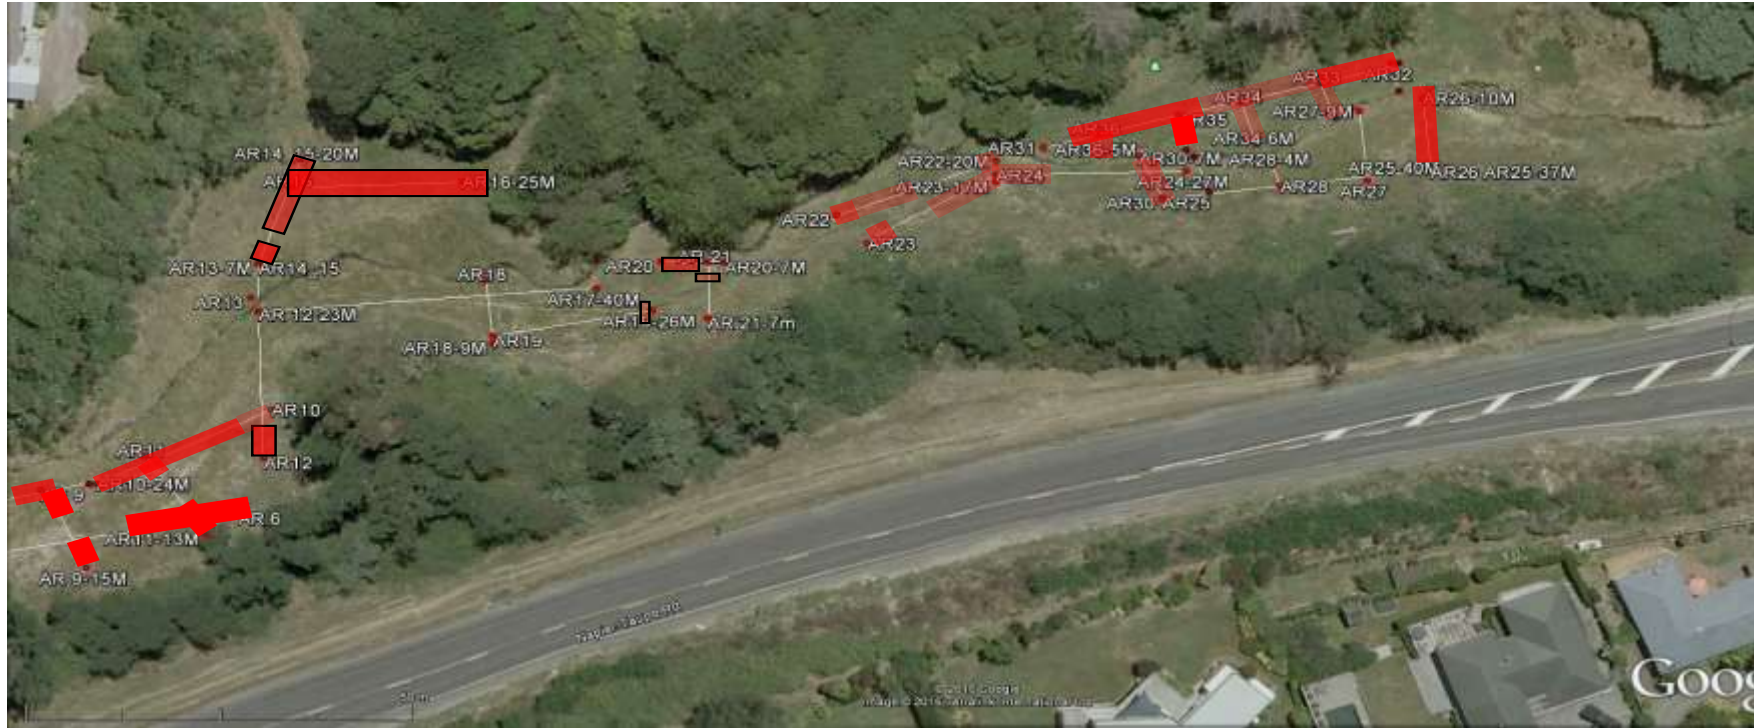
Figure 42: Map showing the thickness and spatial distribution of sinters in the eastern side of the study area.

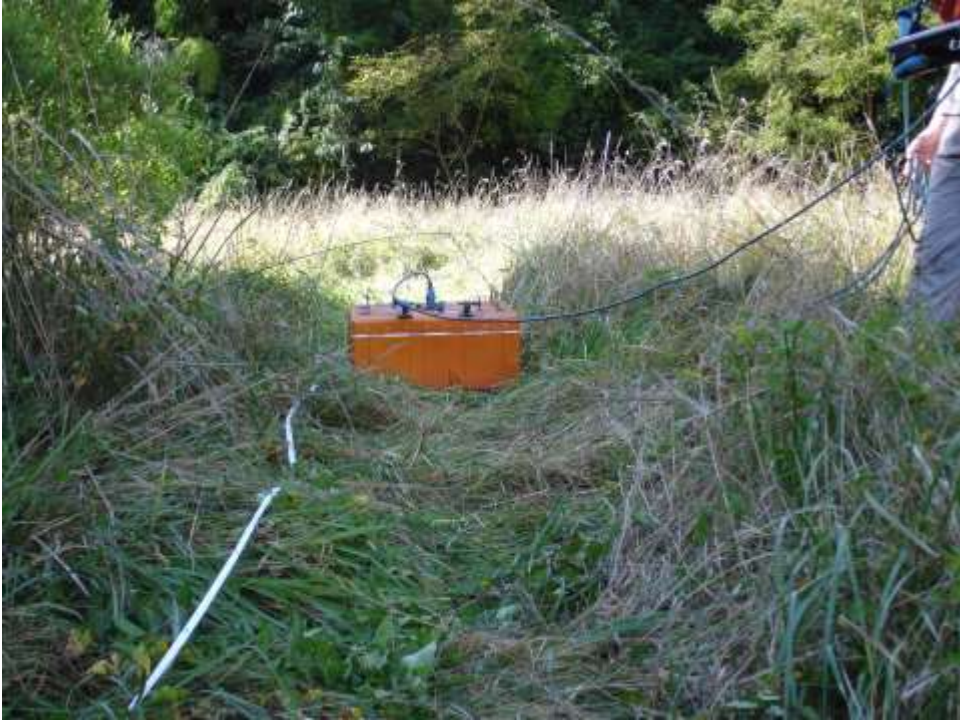
Figure 1: The Ground Penetrating Radar (GPR) unit imaged the subsurface using a 200 MHz GSSI antenna.

The GPR survey was undertaken using a Sir 3000 control unit with a 200MHz Antenna. Estimated maximum depth imaged at this site is 8 m. The colour scale view used in this report has been chosen to easily identify highly-reflective substrates, such as siliceous sinter. Poor reflectors such as soil appear as black areas in the colour images.

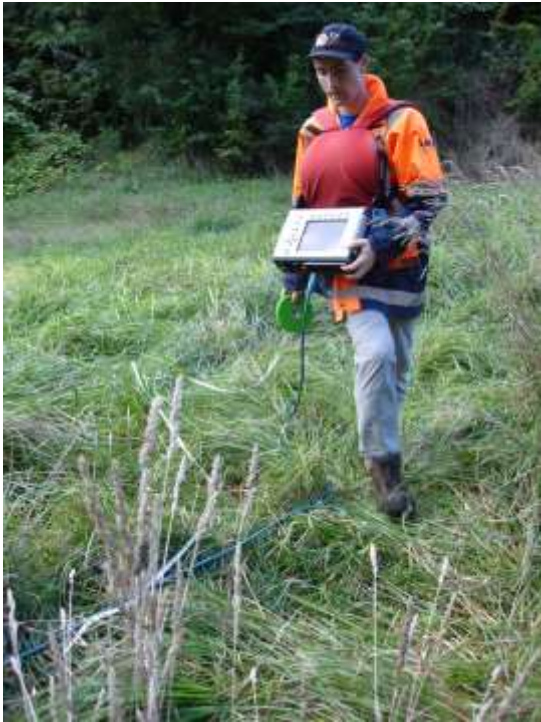
Figure 2: A SIR 3000 control module was used to collect GPR data.

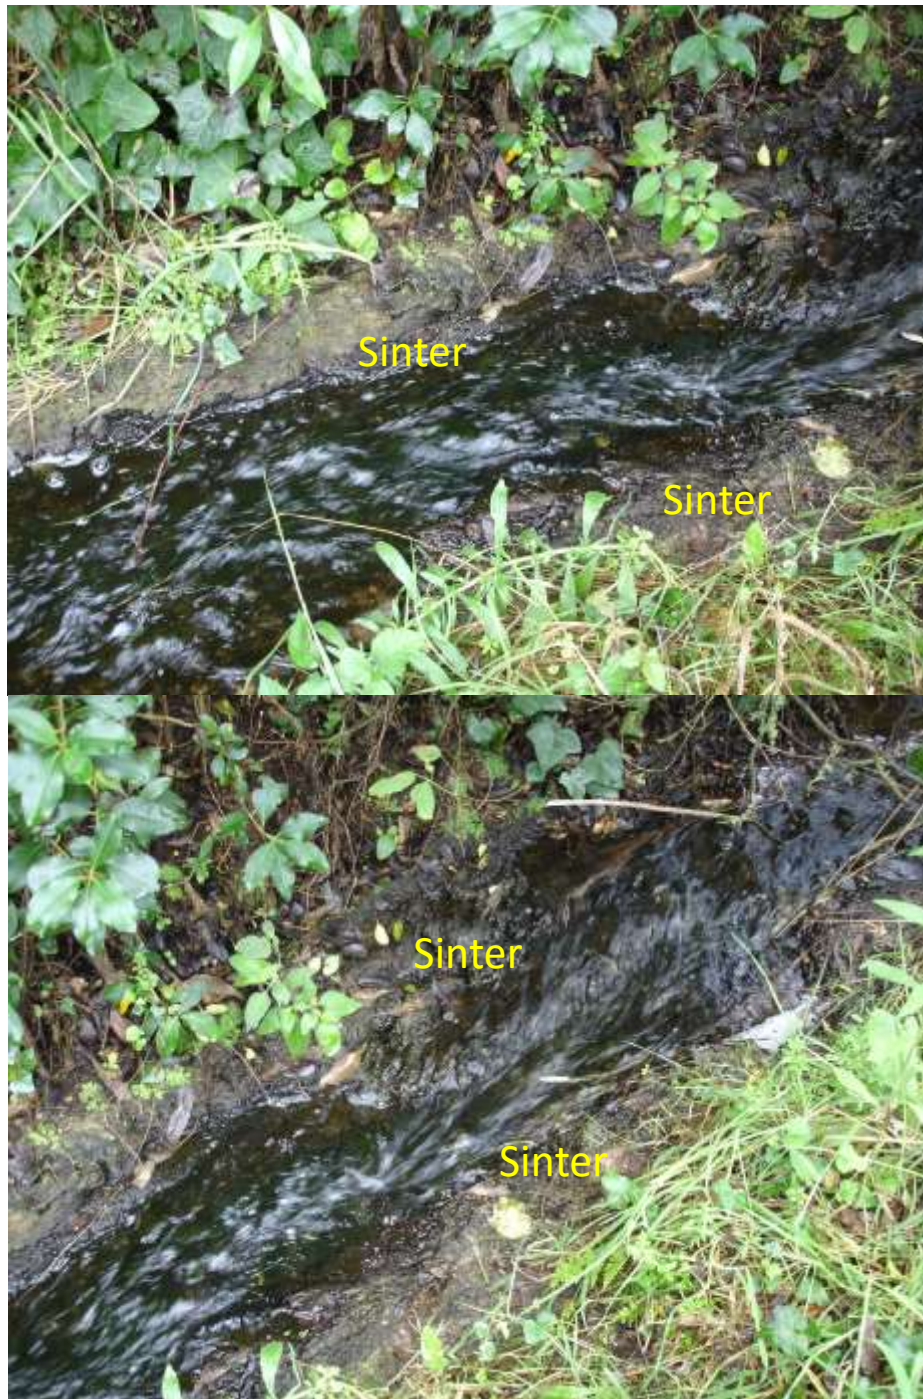
Figure 3: Sinter exposed in the stream.

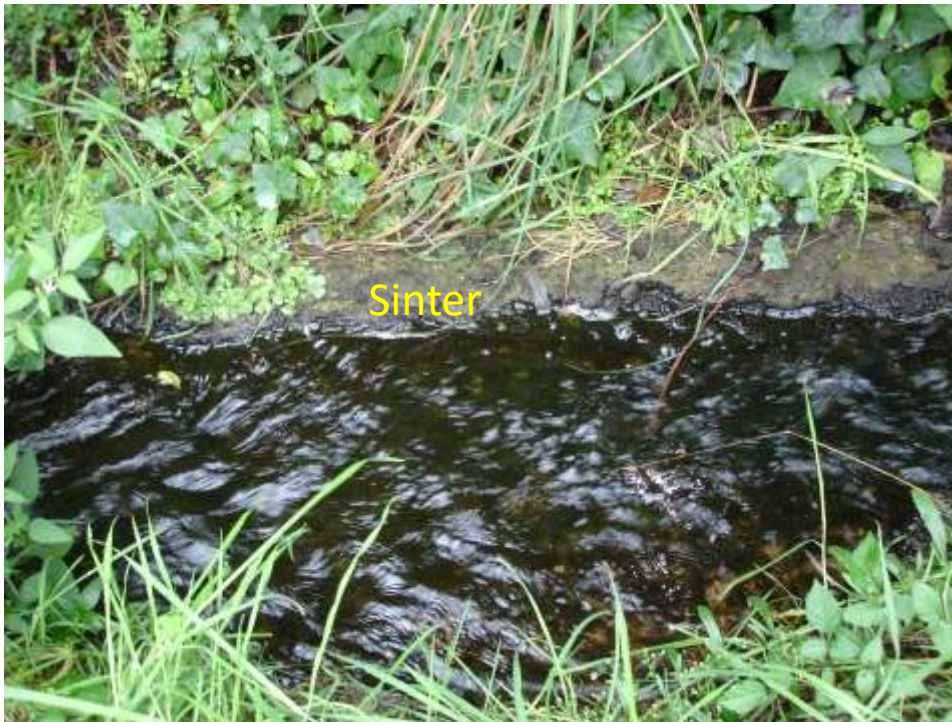
Figure 4: Sinter exposed in the stream.

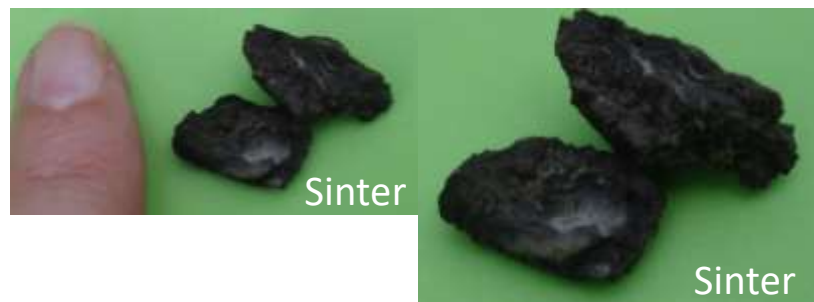
Figure 5: A view of the silica sinter rocks found at the stream.

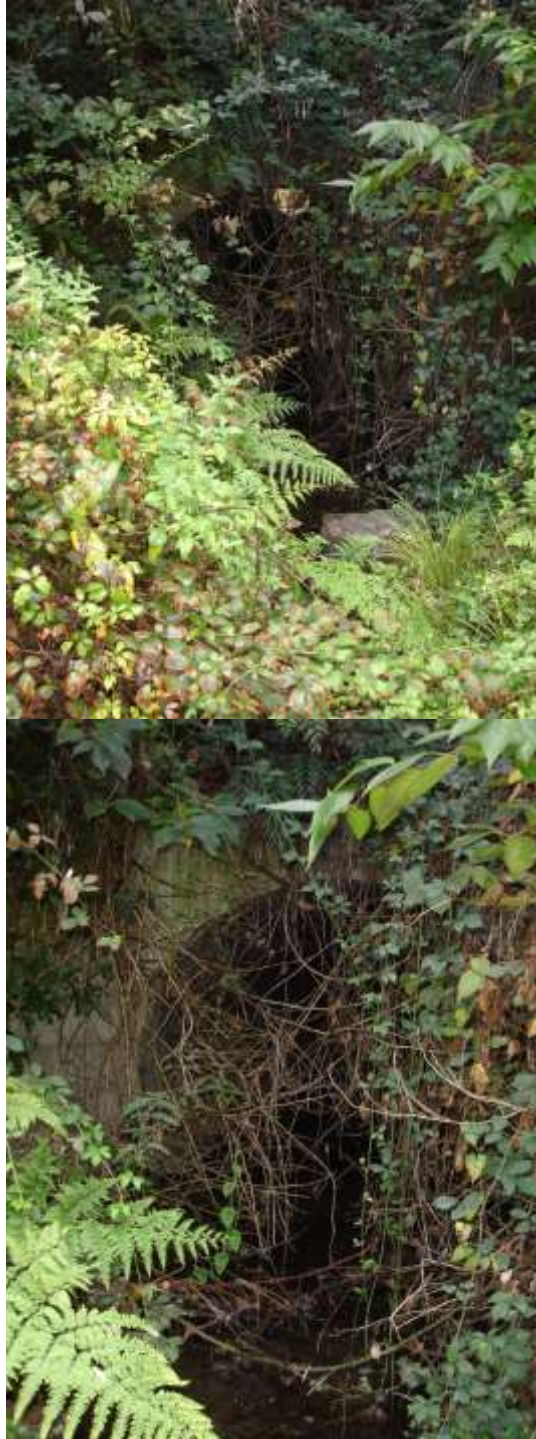
Figure 6: The culvert had a body of flowing water through it, making it impossible to scan with a GPR. The vegetation density and an uneven ground surface prevented GPR imaging.

Culvert 1 (Eastern) was not dry at the time of the survey and therefore could not be imaged.

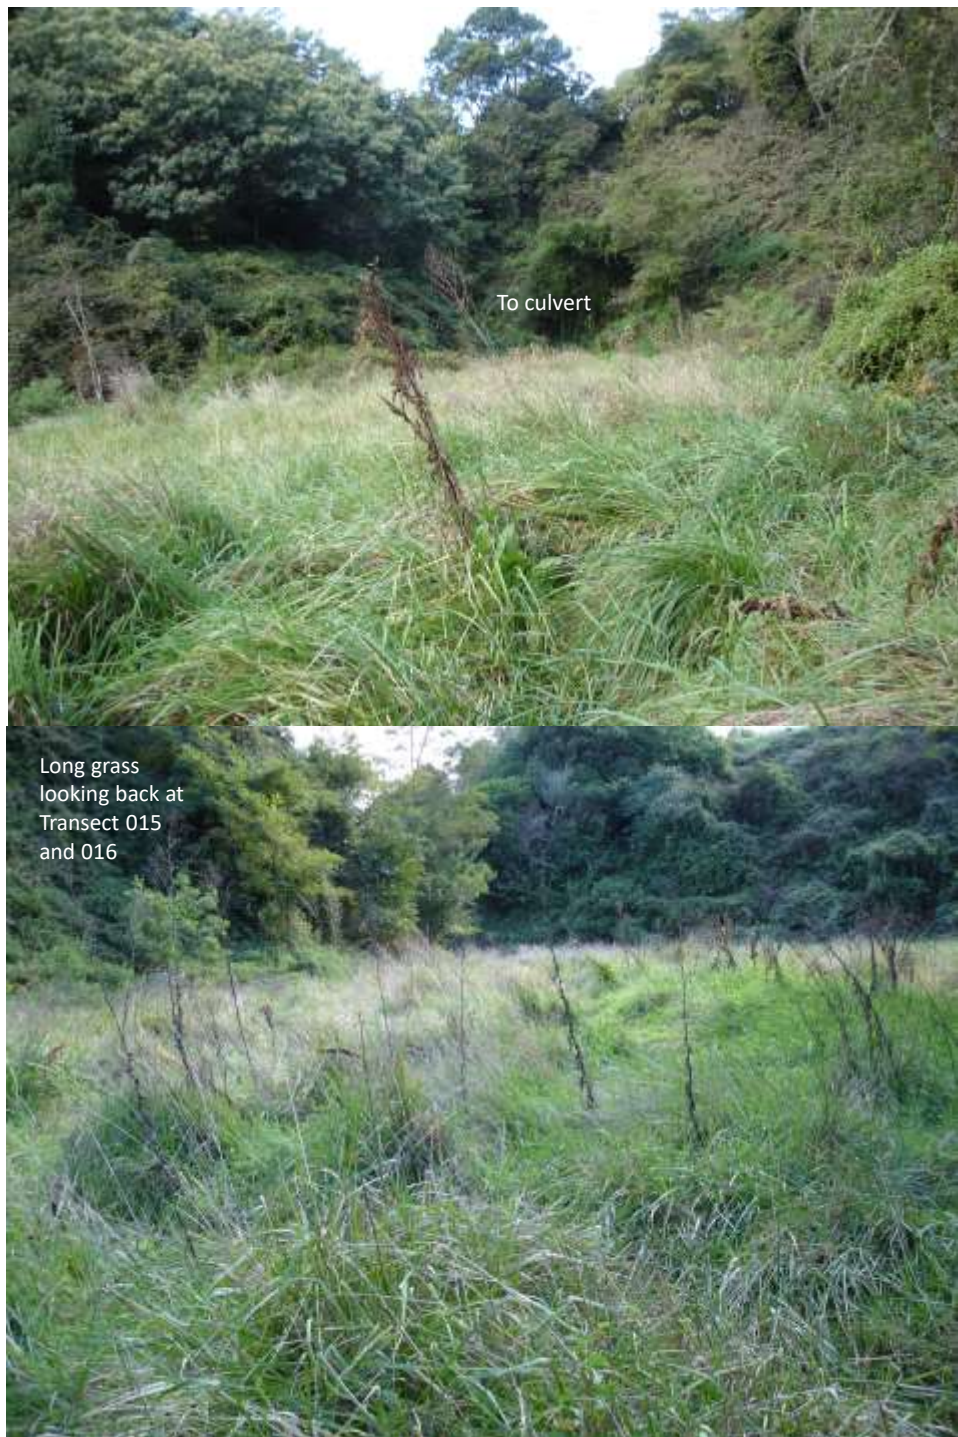
Figure 7: An overview photograph of the terrain encountered during the field trip. The long grass, blackberry vines and overgrown logs form the hummocky patches seen here and can restrict the placement of GPR transects.
