The Higher Lower Tongariro

Prepared by:
Graeme Smart
(NIWA)

For:
Environment Waikato
PO Box 4010
HAMILTON EAST

**NIWA Client Report: CHC2005-002
January 2005**

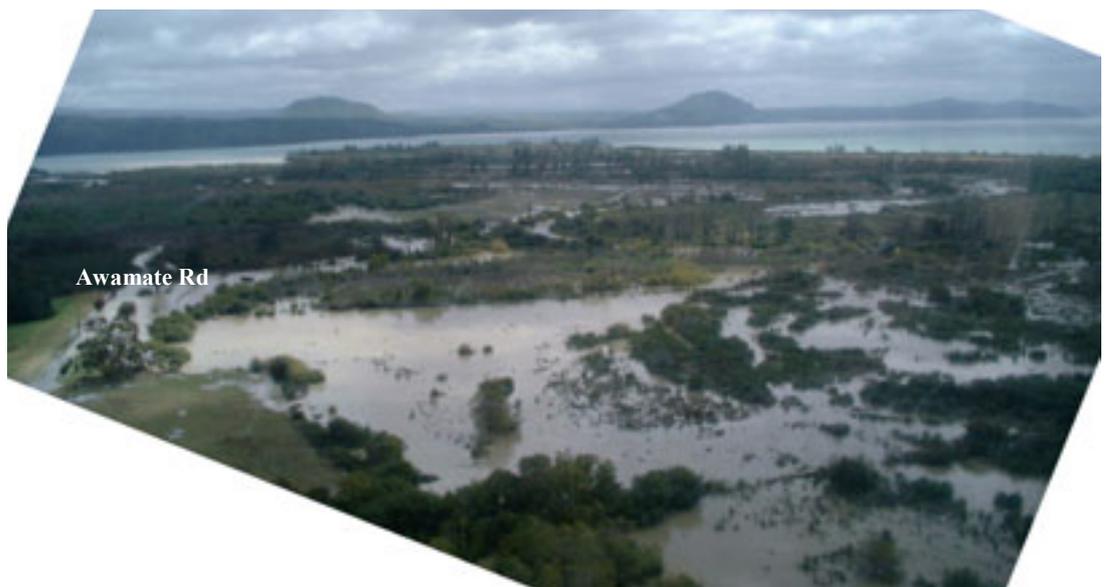
Figure 10: Tongariro Delta following Feb. 2004 flood (photo J. Bowler, 1/3/2004).

Much of the 2004 floodwater spilled from the main channel (see Figures 9 and 10) and there is little evidence of changes in channel position on the lower delta. Willow trees constrict river channels that would naturally migrate by lateral erosion.

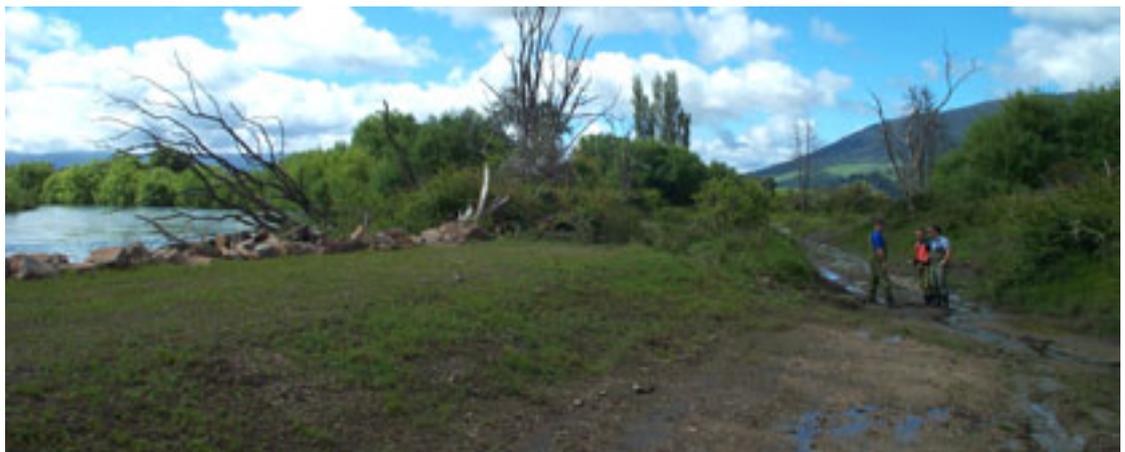
The high level of the river bed is evident in Figures 15 and 16 which show that land beside the river is lower than the level of water in the river. Here, water that seeps from the river during everyday flows or spills during freshes, flows into Deep Stream. There is a strong likelihood that the main river channel will divert towards Deep Stream in a future flood.

Figure 15: A low stopbank contains the Tongariro on the West side of Downs Pool. The river level is higher than ground level at the end of Awamate Rd.

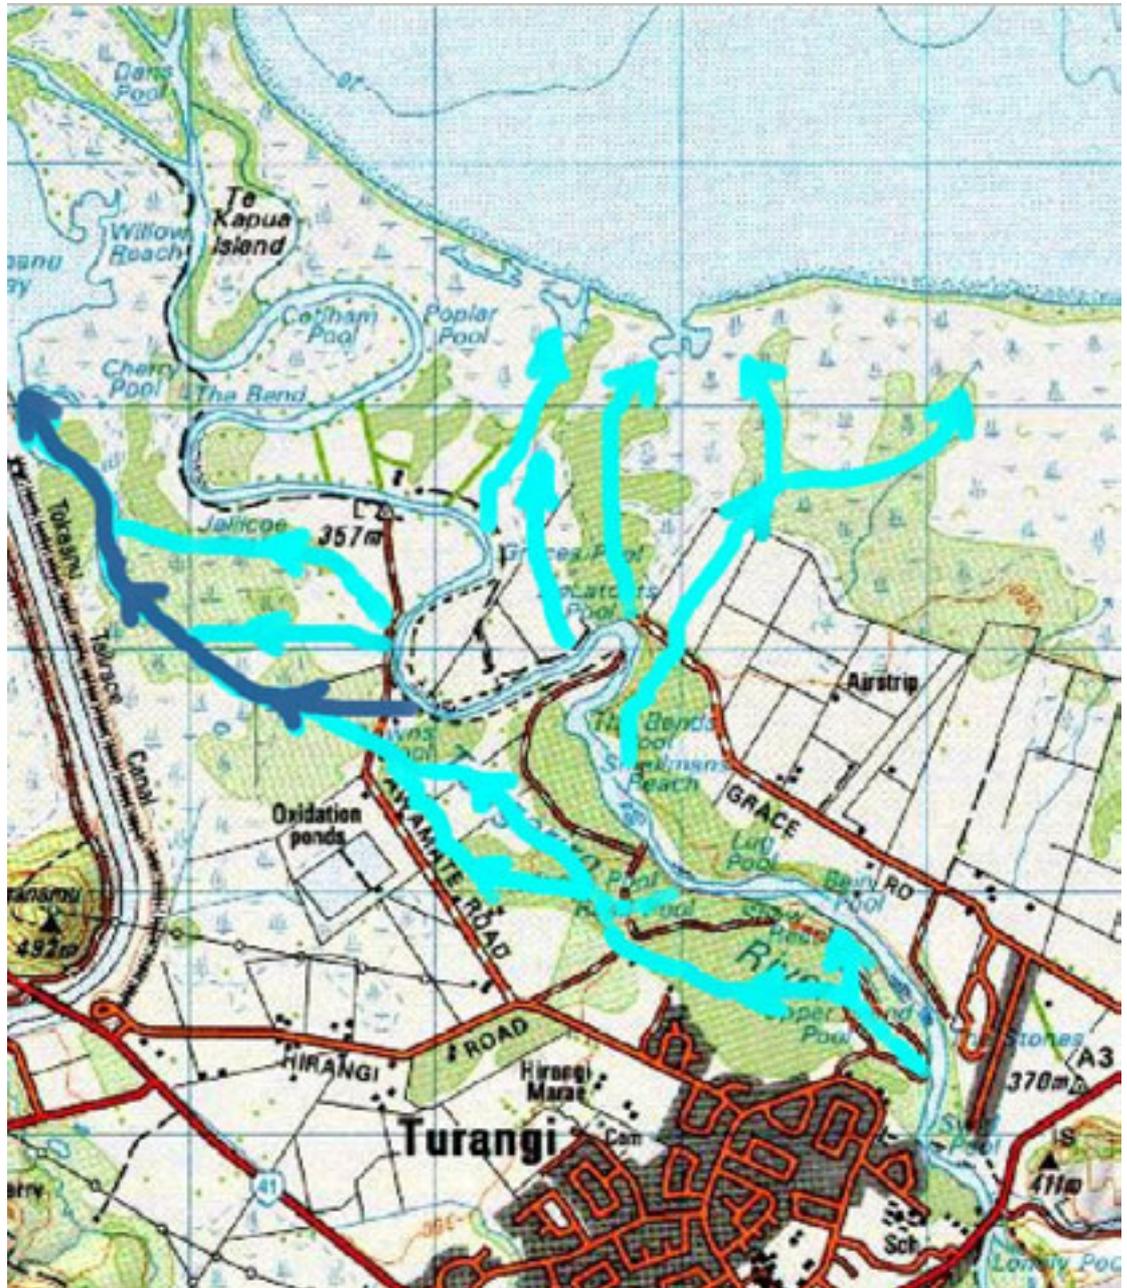
Overflow channels across Grace Road to Stump Bay and across Awamate Rd towards Deep Stream have become more established following the February 2004 flood and it is only a matter of time before the river will break out of its present course and take a new route to Lake Taupo. Possible breakout routes are shown in Figure 18.

In light of this evidence, unless some form of intervention is engineered, it is considered that the Tongariro will breakout of its present channel during a future flood. The most probable location of the new Tongariro River mouth will be alongside the exit of the Tokaanu tailrace (shown as a dark blue trace on Fig. 18).

Figure 18: Possible breakout routes and locations for the future mouth of the Tongariro River.

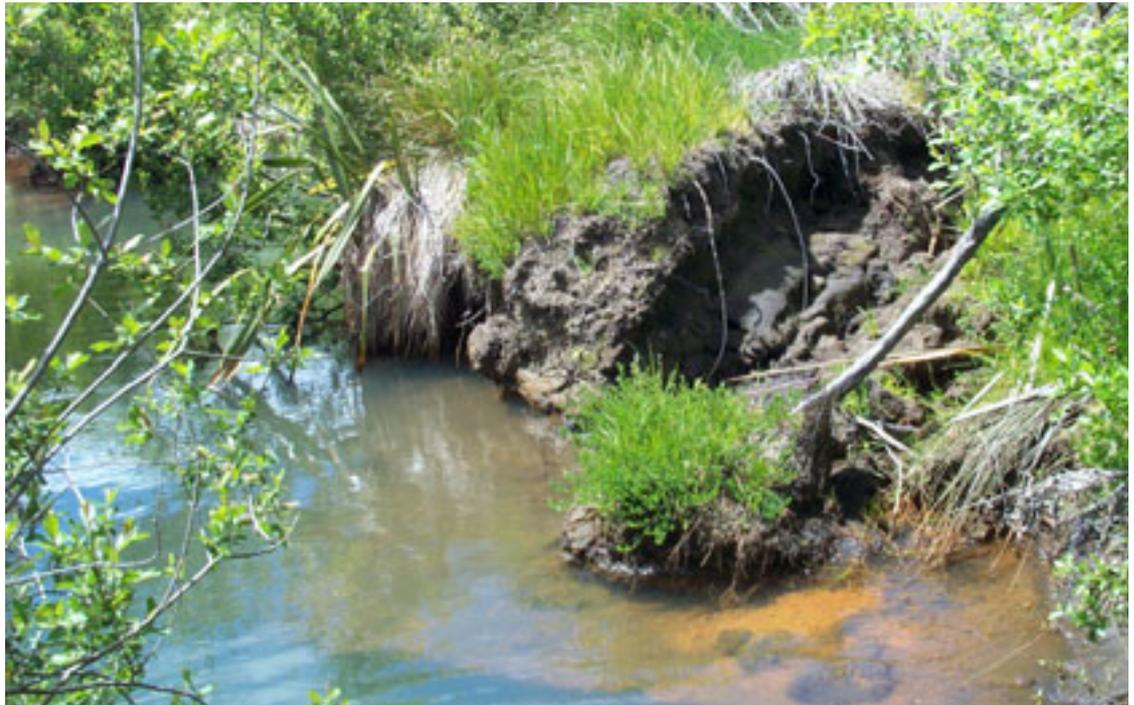
An inspection of the situation in November 2004 showed that the water level in Deep Stream is over a metre lower than the water level in the nearest part of the Tongariro River and Deep Stream is "head-cutting" towards the river as shown in Figure 19.

Figure 19: Floodwater spilling into Deep Stream is causing “head-cut” erosion which brings Deep Stream closer to the Tongariro River

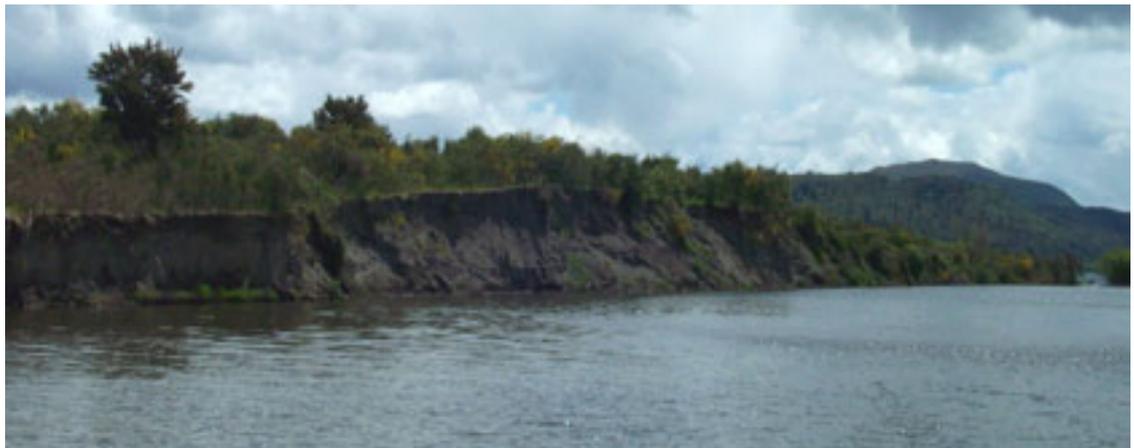
The large amount of floodwater that is escaping from the main Tongariro channel into Deep Stream is evidenced by erosion of its left bank (which adjoins the Tokaanu tailrace) as shown in Figure 20. The small catchment of Deep Stream could not produce sufficient flows to cause such erosion. The erosion of the western bank of Deep Stream is caused by floodwaters from the Tongariro River.

Figure 20: An indication of the volume of floodwaters exiting via Deep Stream is shown by the erosion caused to its left bank before it enters Lake Taupo (near the mouth of the Tokaanu tailrace).

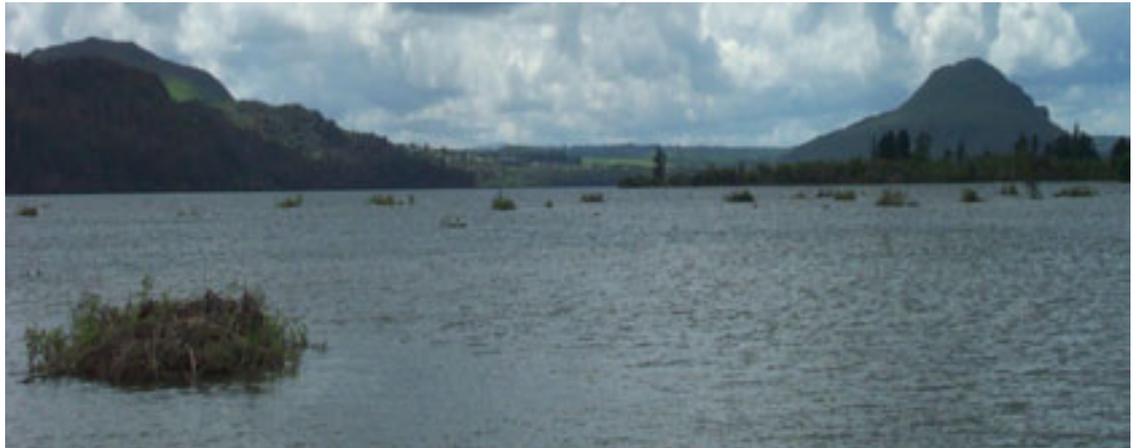
At the exit of Deep Stream there is a large quantity of flood debris deposited into Lake Taupo (Figure 21). This debris has been moved by floodwaters that have escaped from the Tongariro into Deep Stream.

Figure 21: Vegetation and debris entered Tokaanu Bay via Deep Stream in the Feb. 2004 flood.
