Estuarine Vegetation Survey

Wharekawa Harbour

Prepared by: Meg Graeme, Natural Solutions – Marine and Terrestrial Ecologists Ltd

June 2008

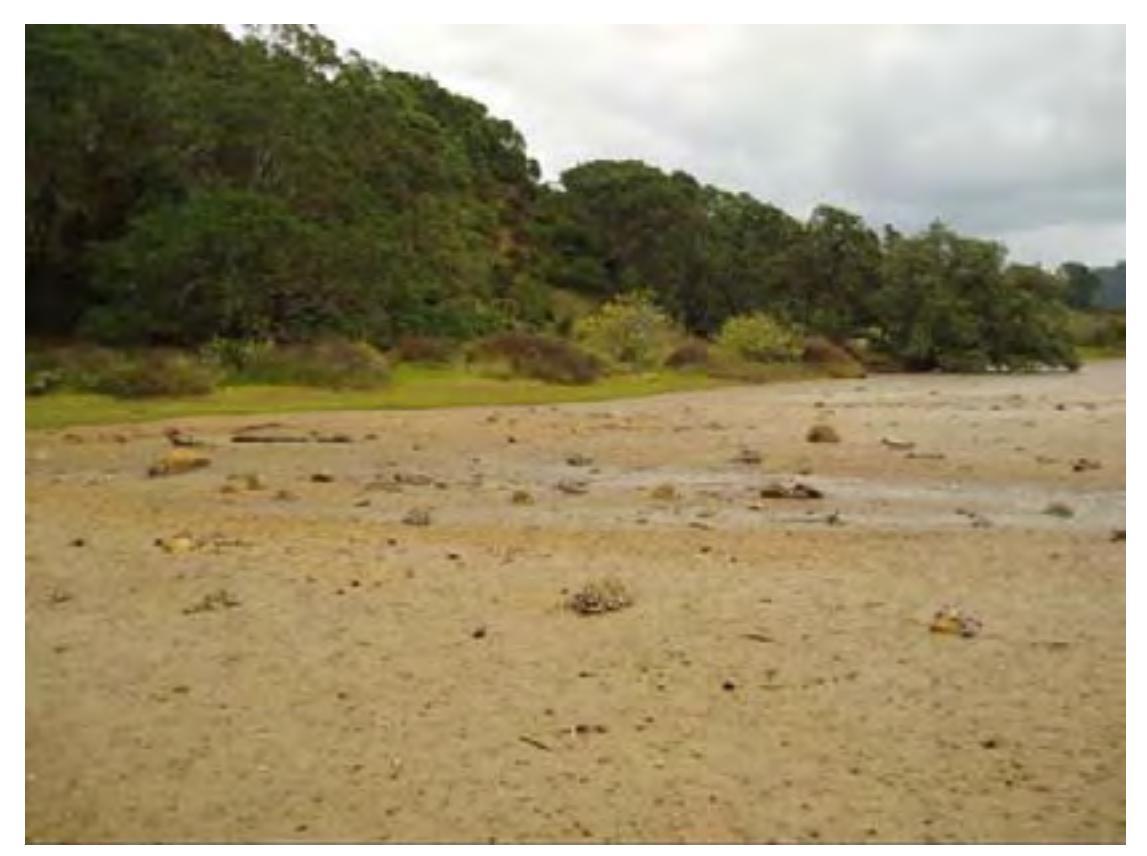
The farm land on the southern side of the harbour near the harbour entrance and **Ruahiwihiwi Point** has had some steep banks retired from grazing since the last harbour survey in 1997 (see Figure 2), and tidal embayments are now also fenced from stock (see Figure 3). Wilding pine removal has also being undertaken along this estuarine margin (e.g. see Figures 4, 7, 9, 10). These actions have improved the harbour values by reducing elevated sediments, nutrient and faecal runoff into the harbour and enhancing the native vegetation and wildlife habitat values of the estuarine edge by removing competing weed species. Bait stations for animal pest control were also noted which will help protect estuarine wildlife and their habitat. Saltwater paspalum (referred to as 'coastal mercer grass' in the 1997 report) is still dominant in many places along the coastal margin. Much of the **farmed sand spit** is also edged with knobby clubrush and buffalo grass (Figure 4). The narrow finger of the spit still supports coastal spear grass and remuremu mixed with saltwater paspalum (Figures 5, 6 and 7).

Figure 2: This photo is a repeat of the 1997 photo [28].Note the large pohutukawa leaning into the harbour, the green figs, the saltmarsh ribbonwood dominated by saltwater paspalum and hillside regeneration. The Papahuahua Stream mouth is in the background behind the left hand pohutukawa.

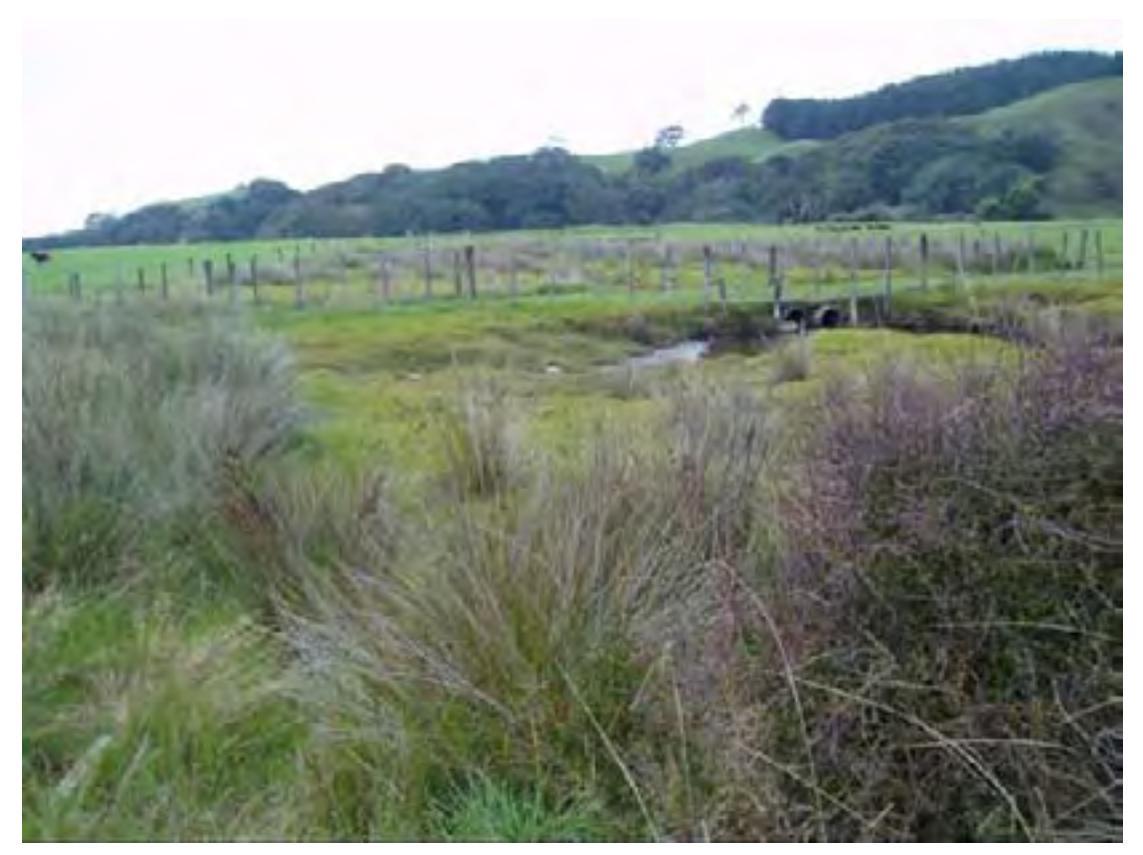
Figure 3: This small sea rush arm has been fenced from stock since the 1997 survey.

- 3. Undertake a feasibility study to control saltwater paspalum in the harbour.
- 4. Aim to exclude all farming activities from the CMA and river margins. The landowner/s on the south-eastern side of the harbour near the harbour mouth have fenced their stock from the CMA since the last survey in 1998. They have also fenced freshwater seepages on the property, allowed some steep land to naturally revegetate (see Figures 2 and 3) and removed planted and wilding pines from the coastal edge. This property is now a model example for others surrounding the harbour.

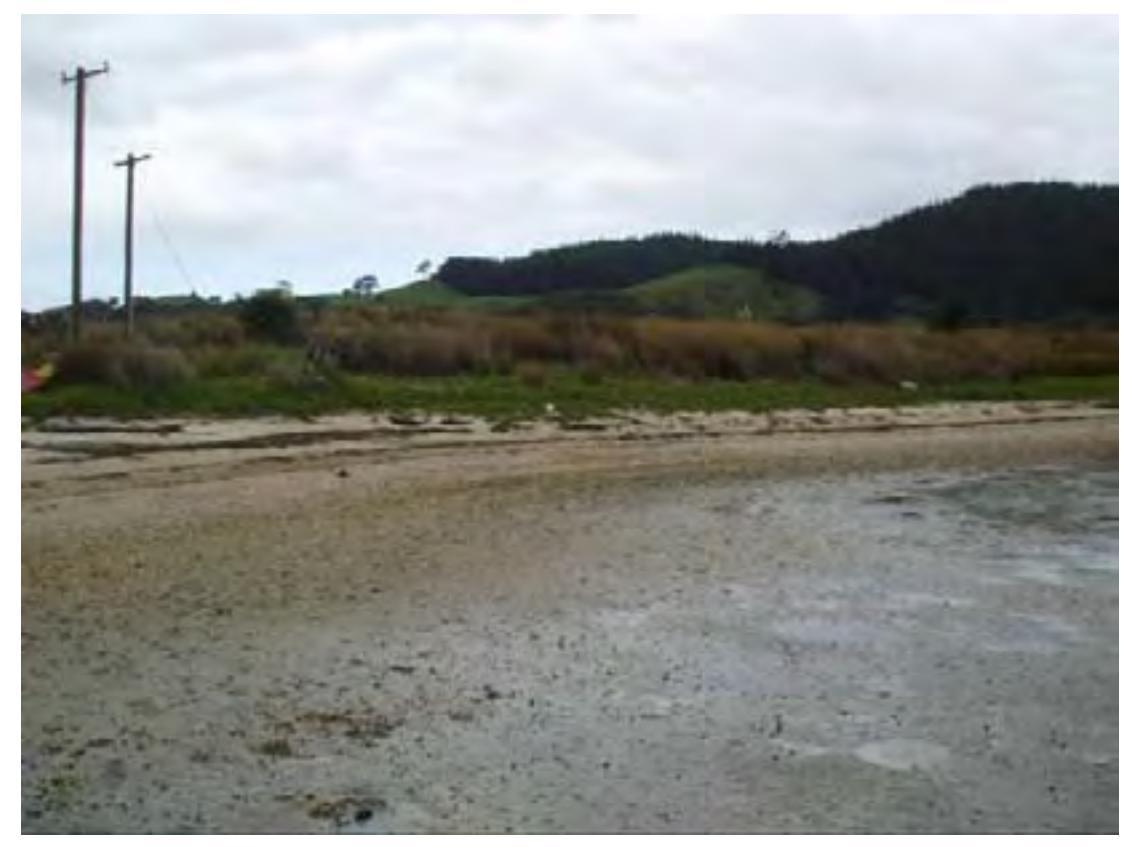
Figure 4: This photo is a repeat of the 1997 photo [29].The large pines have been felled but the knobby rush, buffalo grass and fringe of saltwater paspalum are still present.

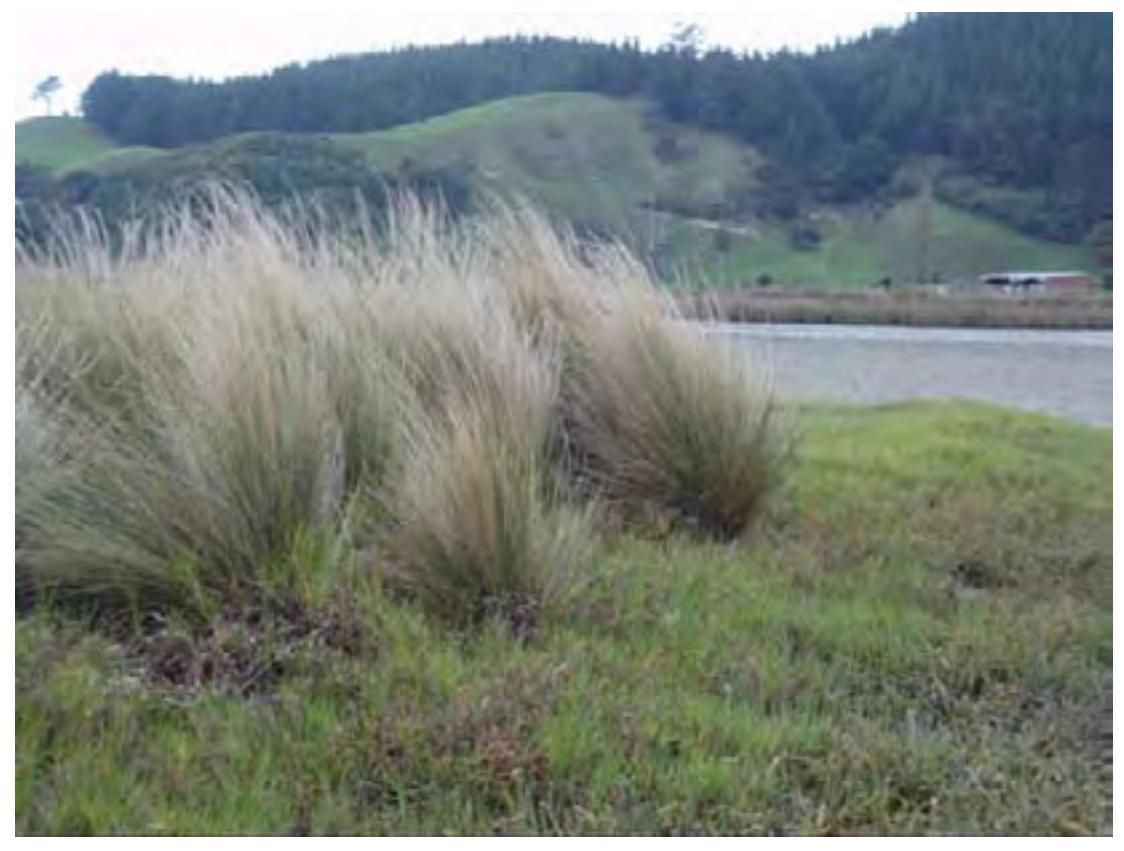
Figure 5: This photo is a repeat of the 1997 photo [30] showing coastal spear grass edged by glasswort and saltwater paspalum.

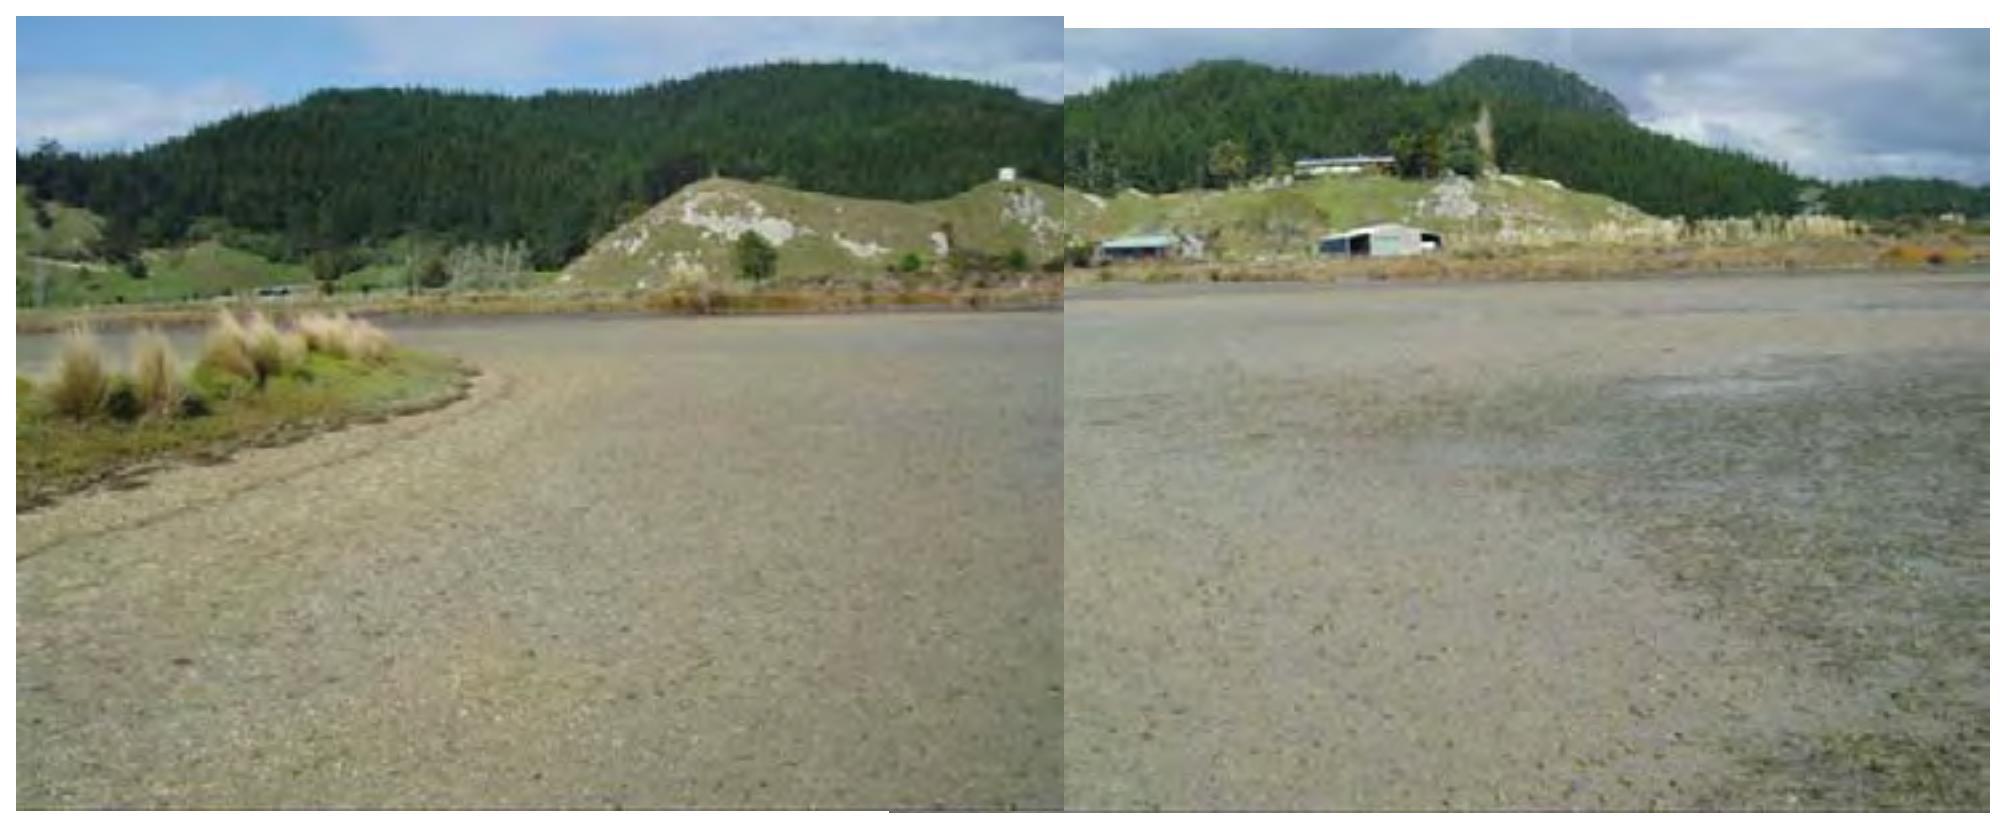
The seagrass bed east of the main channel still reaches its seaward limit within the lee of the farmed sand spit (Figure 7). It is still extensive although it has increased in area where mangroves have been removed, but decreased in area further upstream. A wide rush/sedge community extends upstream from the embayment protected by the sand spit (Figures 8 and 10). This is often backed by a band of saltmarsh ribbonwood which thickens to the south and grades into a freshwater manuka swamp. There seems to be indications that the complete removal of mangroves from this shoreline is exposing the rushland to erosion (Figure 9). Figure 11 replicates photo [37] from 1997. The shoreline has changed dramatically with the removal of mangroves and Figure 11 shows a shoreline dominated by low-growing saltwater paspalum. It seems that the removal of the protective mangrove belt has resulted in the exposure of the saltwater paspalum and seaward rush/sedge edge to increased erosion. Further upstream saltmarsh ribbonwood mixes with rushes edging the open harbour (Figure 12). Further upstream again, a small pocket of mangroves has been left undisturbed. Near these mangroves is a gap in the seagrass bed that extends almost to the main channel.

Figure 7: This photo is a repeat of the 1997 photo [34]. The lower house is new and the wetland is now fenced from stock.

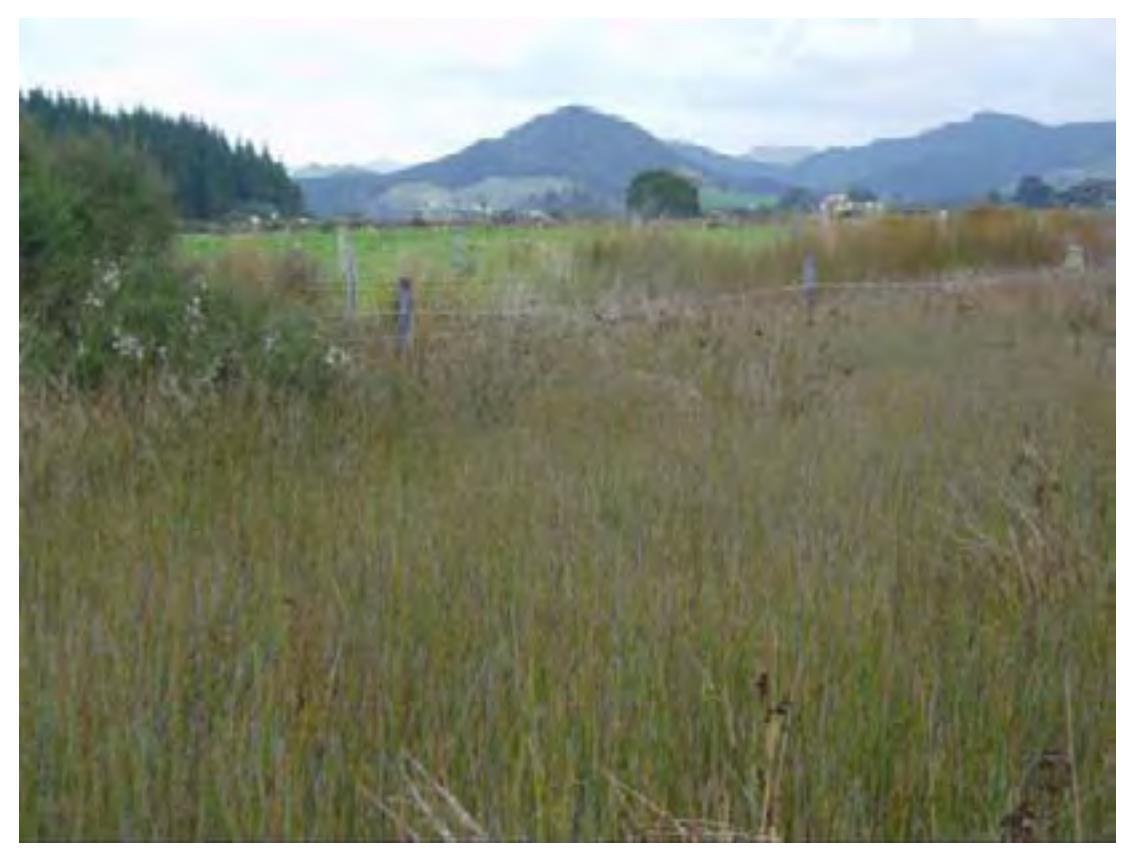
Figure 8: This photo is a near repeat of the 1997 photo [35] but is taken standing near a power pole. The pine to the right of the pohutukawa in the mid ground has been felled.

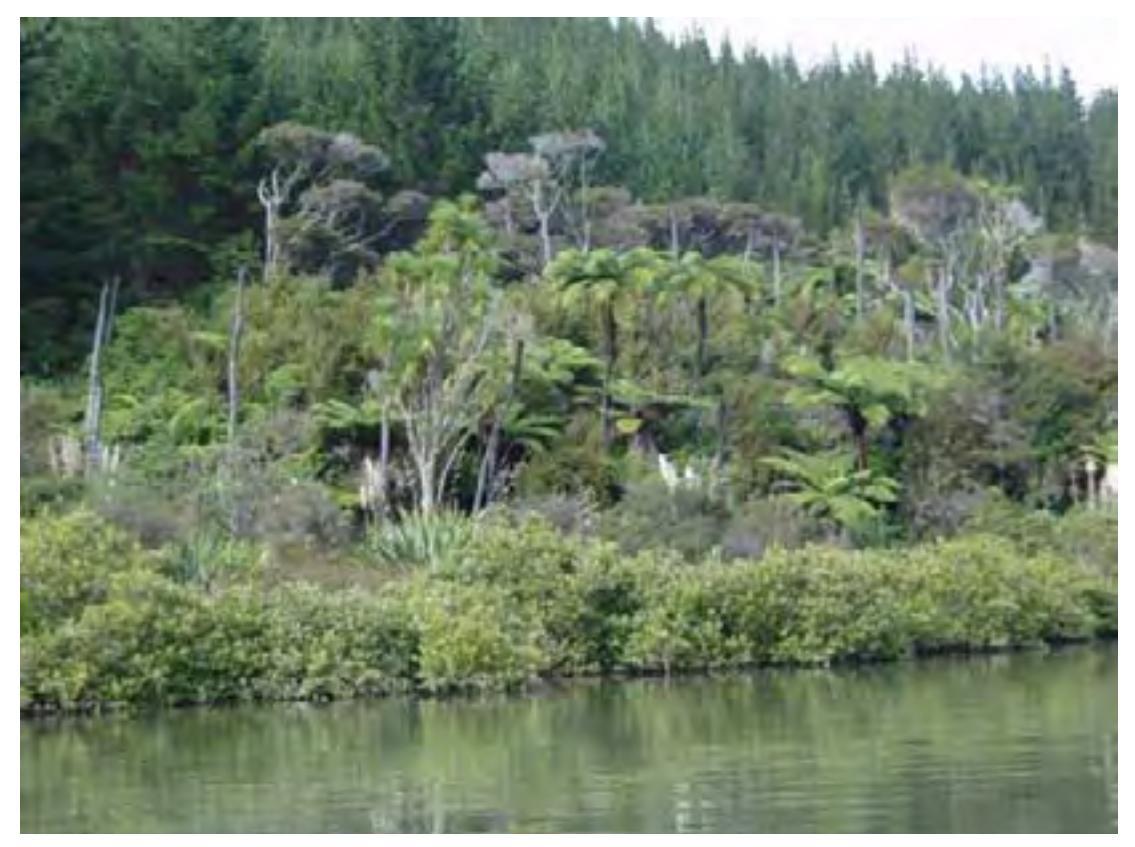
The largest remaining mangrove community (mangal) on the eastern side of the harbour extends upstream from the next small embayment. Figure 13 is a repeat of 1997 photo [39] of a native riparian strip left between the harbour and pine forest in this small embayment. Further upstream, saltmarsh ribbonwood and rushland begins to dominate with dense saltwater paspalum islands frequently forming the seaward vegetated edge.

Figure 13: This photo is a repeat of the 1997 photo [35] showing the native riparian margin behind the mangrove, rush/sedge and saltmarsh ribbon zones.

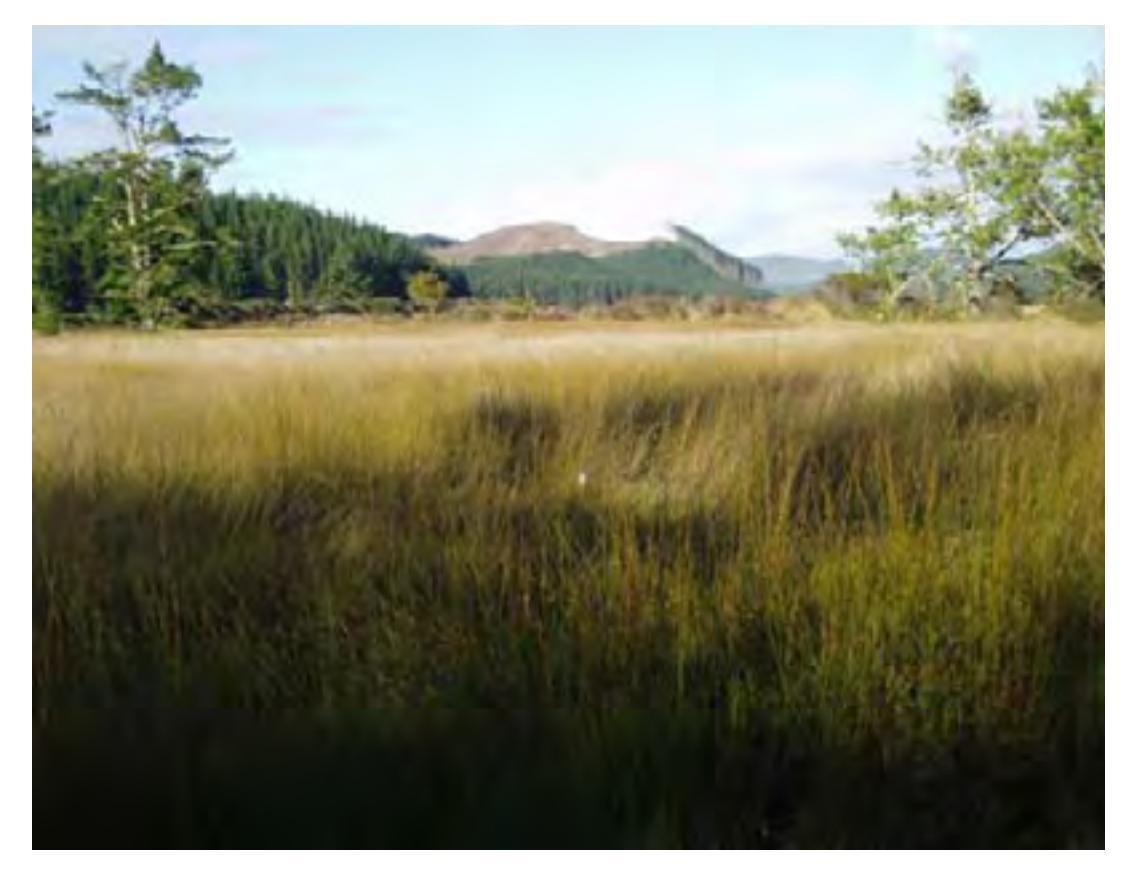
Broad rush/sedge communities are found around the **Rangipo Stream** and **Wharekawa River** mouths (Figure 14) and tidally influenced stream bends. The health of the rush/sedge communities at the top of the salt influence are compromised by the dominance of saltwater paspalum and continuing stock grazing (Figures 15 and 16). The saltmarsh ribbonwood zone has been severely limited in extent by farming activities. Despite this loss of the natural extend of native vegetation fernbird are still present in these areas.

Figure 14: This photo is a repeat of the 1997 photo [41] showing an extensive oioi sedgeland near the mouth of the Rangipo Stream.

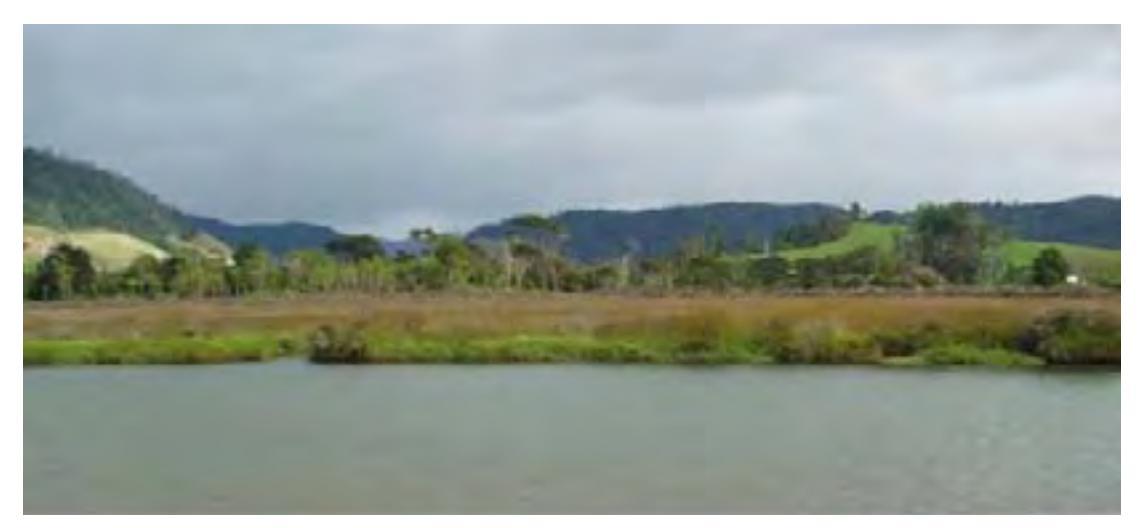
Of particular note are the uncommon and attractive remnant coastal wetland-forest communities along two of the lower TLB bends of the Wharekawa River. These lie within public land as well as on private land owned by the Palmers. Figure 18 shows an oioi bed grading into saltmarsh ribbonwood, backed by a remnant freshwater cabbage tree swamp with flax, kanuka and totara along the river edge.

Figure 18: This view shows saltwater paspalum lining the TLB of the Wharekawa River, backed by oioi sedgeland and then saltmarsh ribbonwood which grades into a freshwater cabbage tree and flax swamp, and then into kanuka and totara forest along the river bank further upstream.

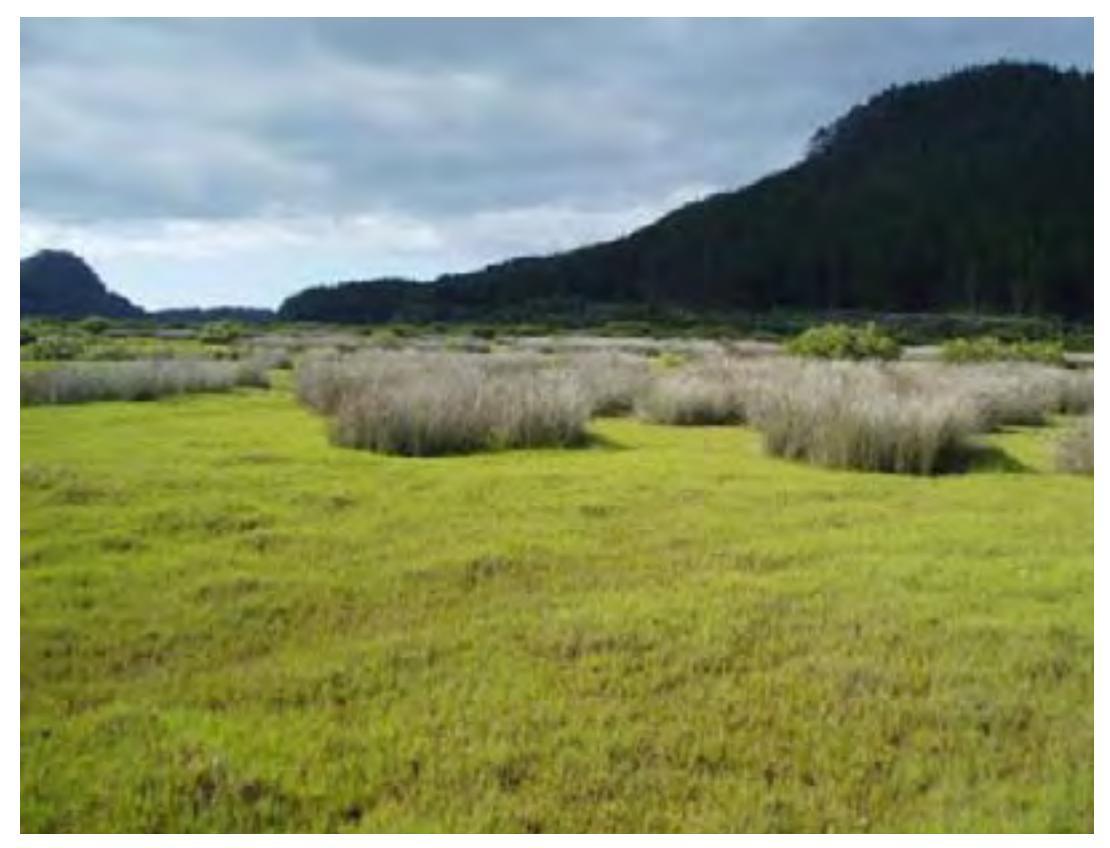
North of the Wharekawa River mouth the estuarine vegetation forms a mosaic of rush/sedgeland, saltmarsh ribbonwood, mangroves and saltwater paspalum, with small raised islands of flax and manuka (Figure 19). Small patches of sea meadow (glasswort and sea primrose) occur along the Wharekawa River side of this mosaic community. However the sea meadow species are struggling to survive amongst the aggressive and taller growing saltwater paspalum which is dominant along this side of the mosaic community. Mangroves are dominant on the **Tawatawa Stream** side of the mosaic, with rush/sedgeland generally found sheltered between the land edge and mangrove or saltwater paspalum communities. Saltwater paspalum is dominant along the upper tidally influences reaches of Tawatawa Stream (Figures 20 and 21). Mangroves have been illegally removed from the banks on the TLB of Tawatawa Stream (downstream of Figure 20) as shown in Figure 22. Further illegal mangrove removal has also occurred further downstream (Figure 23). A wide swath has been cut through the thick mangrove band to the open harbour flats. The thick mangrove band extends downstream to the Kapakapa Stream. Behind the mangroves is an extensive saltmarsh that extends up to the causeway and which is still open to cattle grazing and pugging from the adjacent farmland (Figures 24 and 25). Saltwater paspalum is uncommon but present in some open or disturbed tracked areas in the rush/sedgeland. There are small patches of saltmarsh ribbonwood and a number of fernbird are present in these areas.

Figure 19: Scattered mangroves and patches of sea rush amongst a carpet of saltwater paspalum. The Wharekawa River channel is to the right of the photo.

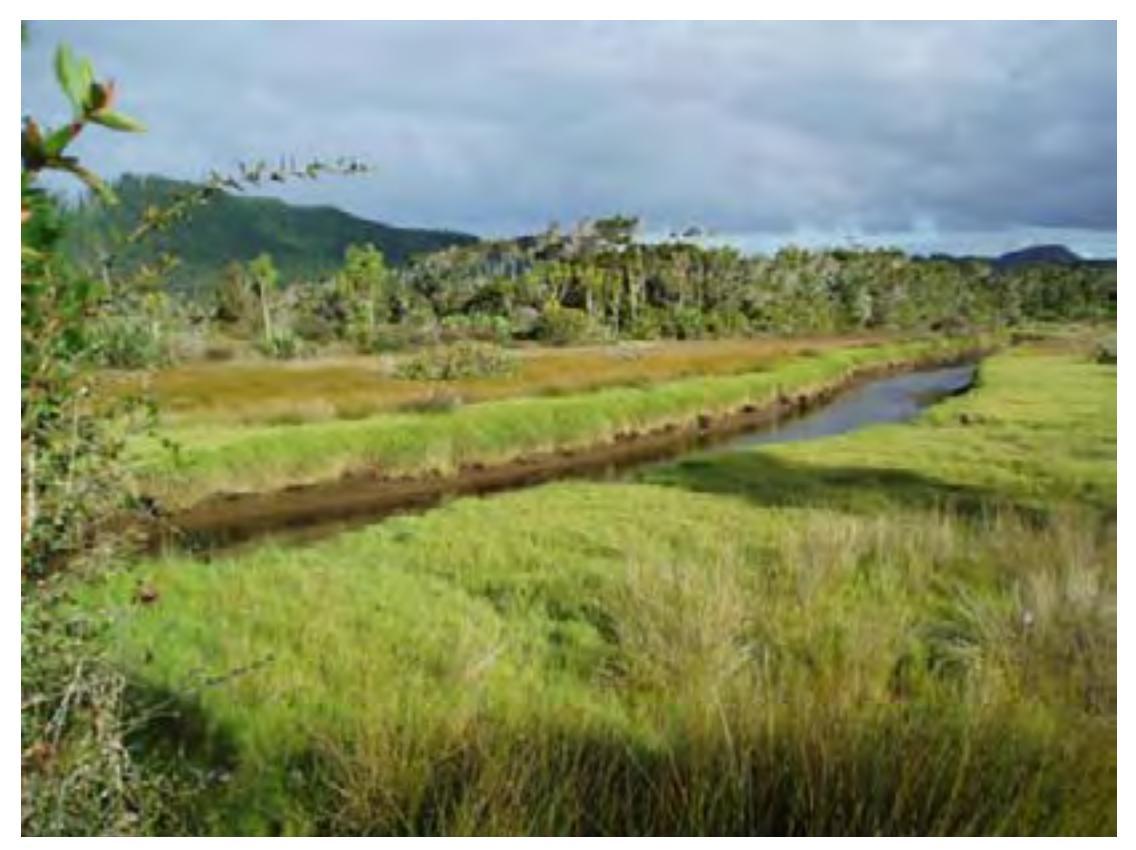
Figure 21: This photo is a close-up of Figure 20, and is taken from the middle left foreground of the 1997 photo [42] (near the subdivision fence line). The two mangroves in oioi sedgeland have remained present.

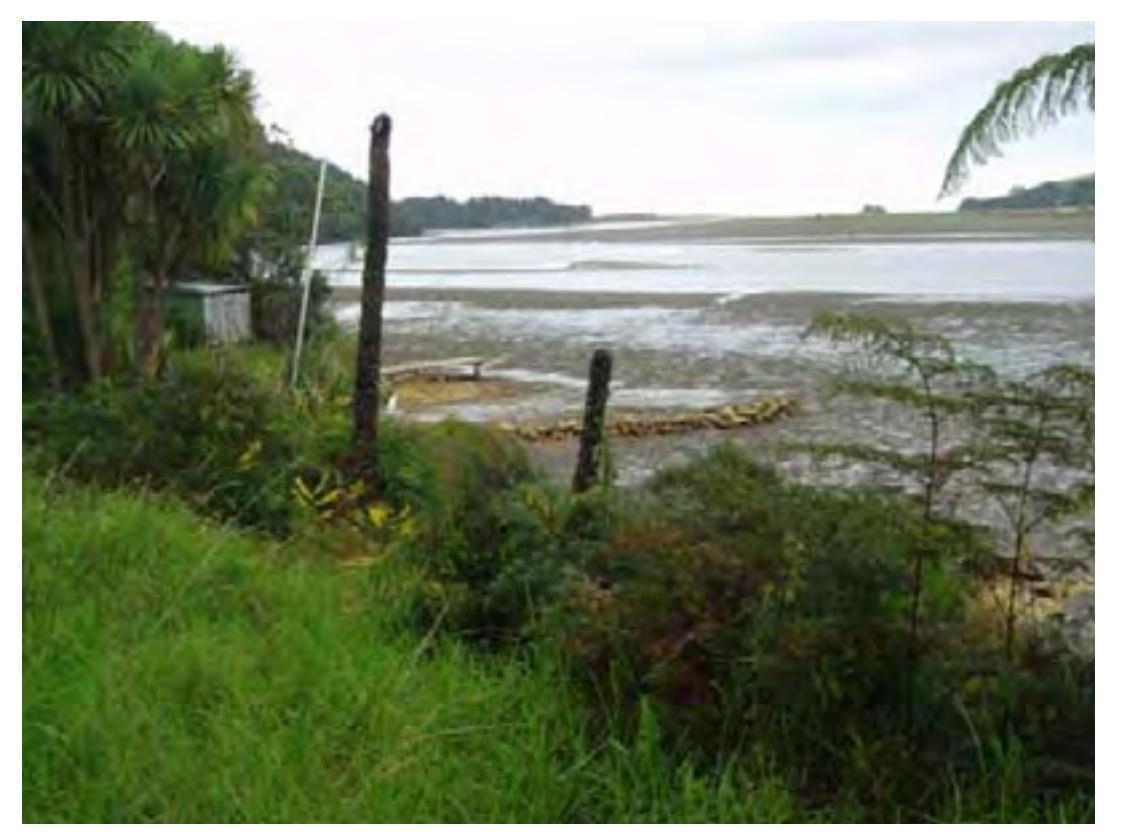
North of the causeway, mangroves form a thin, intermittent band along the coastline. Figures 26 and 27 show the extent of the seagrass beds in the middle harbour. Figure 28 gives a comparative view with the 1997 photo [63] (which showed the extent of mangroves either side of the main channel before they were illegally removed, and the pines on the farmed spit that have now been removed). Similarly Figure 29 shows a comparative view with the 1997 photo [64] of the mangroves now removed on either side of the harbour. The seagrass alongside the pohutukawa-lined road edge north of the settlement is still present (Figures 30 and 31).

Figure 26: This photo gives a similar view to the 1997 photo [59] over the seagrass beds of the middle harbour.

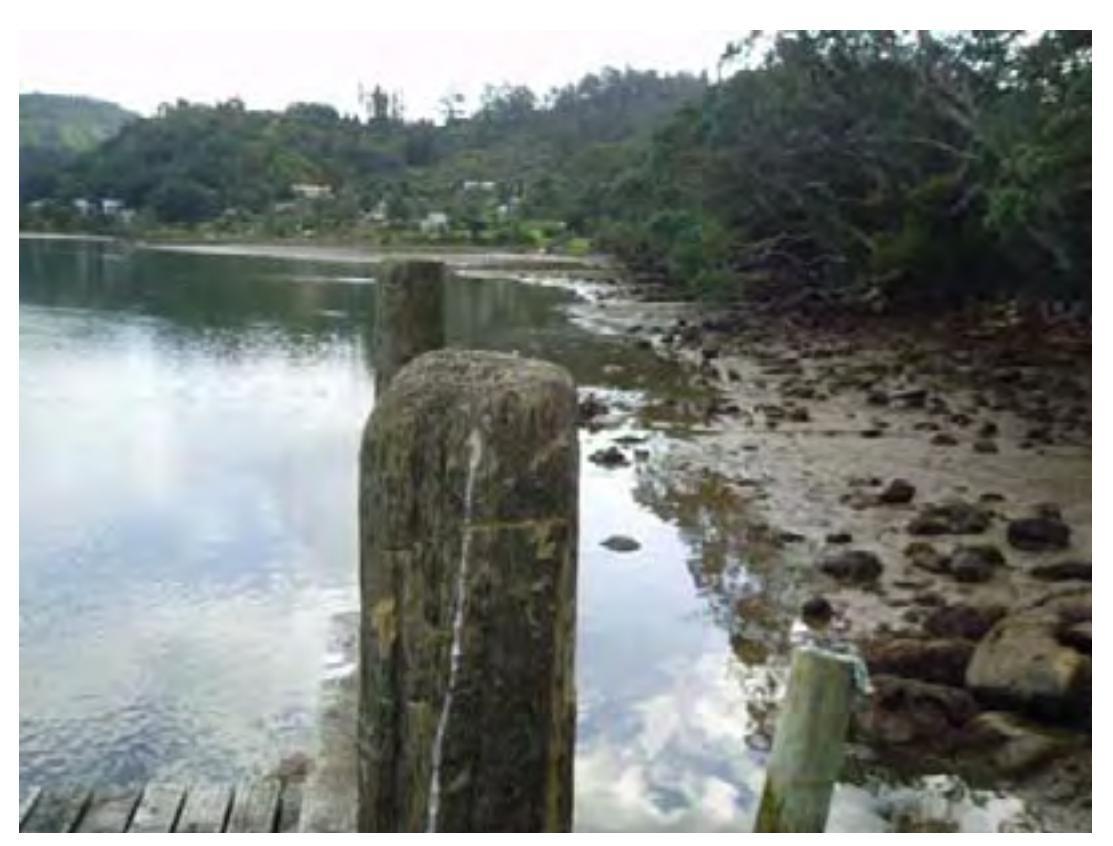
Figure 30: This photo is a repeat of the 1997 photo [66] looking west along the wooden jetty railings. Seagrass is still present along the rocky edges, although reduced in places.

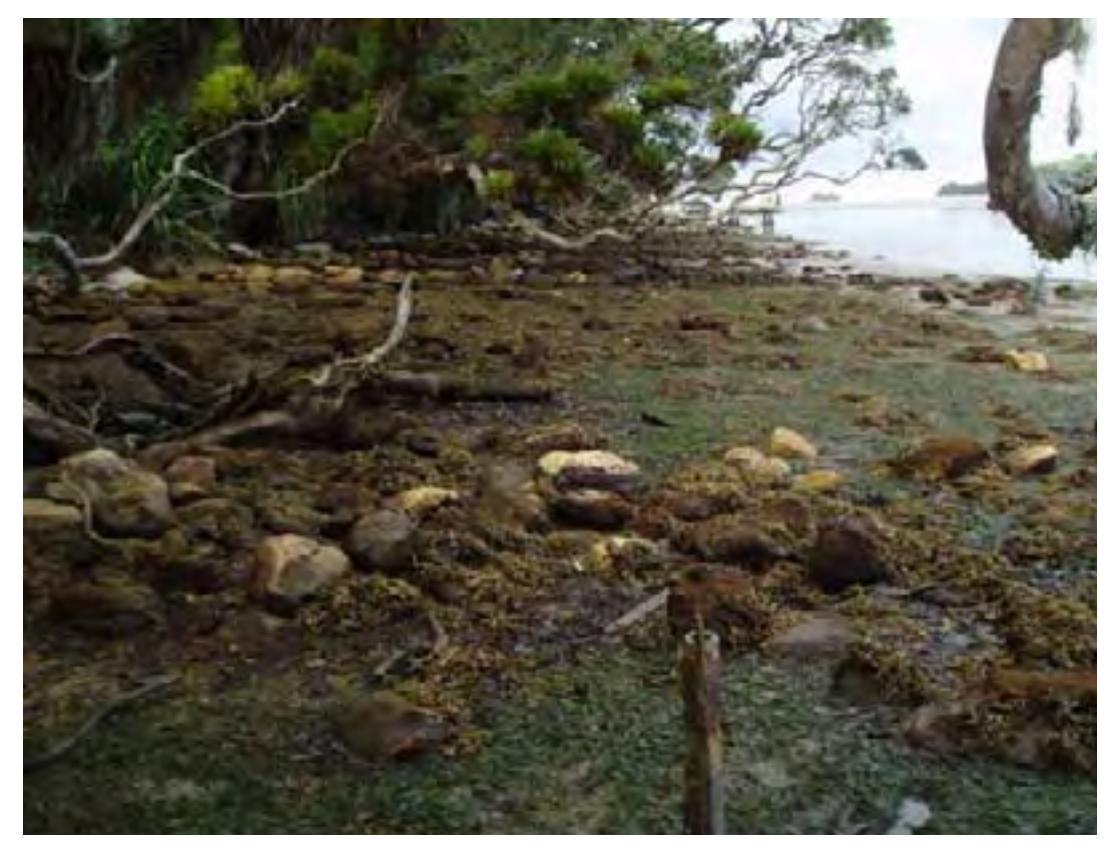
Figure 31: This photo is a repeat of the 1997 photo [67] looking back at the wooden jetty and harbour mouth. Compared to 1997 there is no *Entromorpha* alga, but the Neptune's necklace and sea grass is still present.

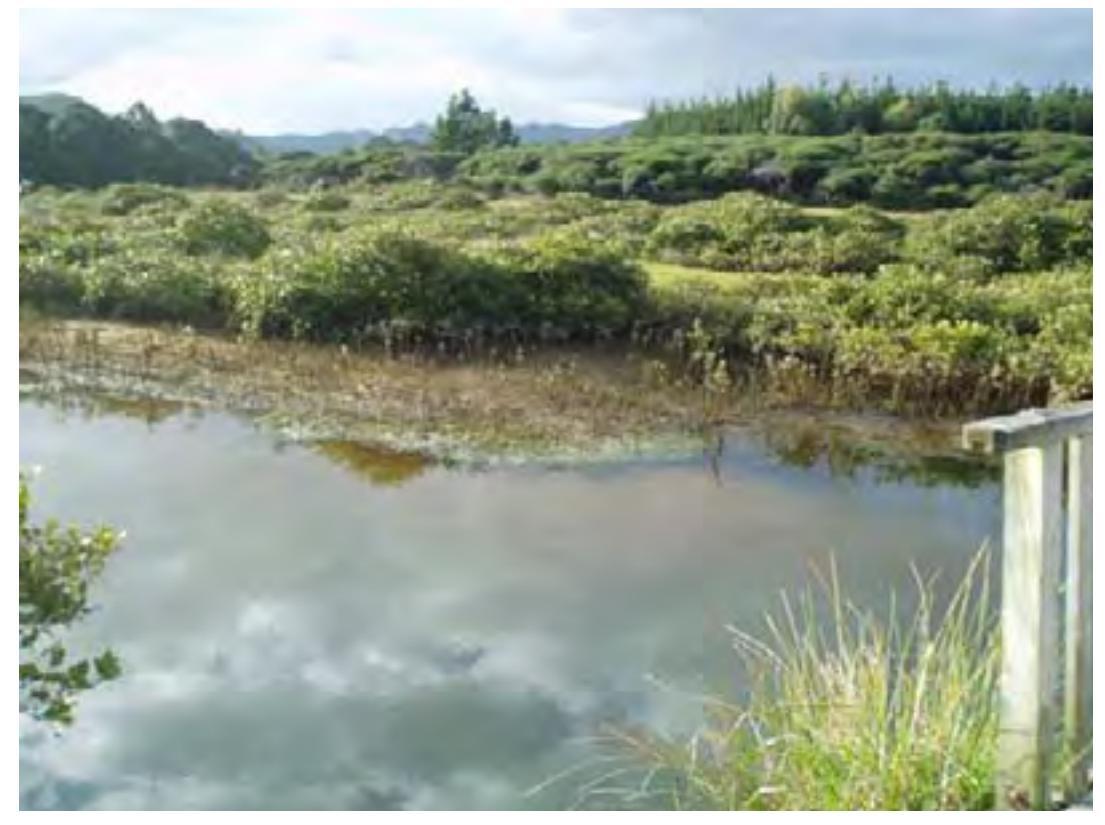
The seagrass beds widen out into **Wahitapu Stream bay**. Mangroves fringe the western side of the bay with rush/sedgeland dominant either side of the walking bridge. Saltwater paspalum is present all around the bay and up the stream to the upper tidal influence. Figure 32 shows the view upstream of the walking bridge to the wildlife refuge. The mangroves along the stream edge immediately upstream of the bridge seem to have grown in height more than in area. Figure 33 repeats the view from the 1997 photo [69] looking up the Wahitapu Stream from the entrance to the campground.

Figure 32: This photo is a repeat of the 1997 photo [68]. The stream side mangroves have grown up, blocking the view of the saltwater paspalum and saltmarsh behind.
